TO: Mercedes-Benz Dealer Principals, General Managers, Sales Managers, Service Managers, Parts Managers	FROM: Gregory Gunther, Department Manager, Vehicle Compliance and Analysis, Engineering Services
RE: <b>Recall Campaign Launch Notification – STOP DRIVE</b> <b>Inspect Brake Booster with Pedal Rework</b> <b>MY07-08 GL-Class, ML-Class, R-Class</b> <b>(X164, W164, 251 platform)</b>	DATE: May 28, 2022

Recall Campaign Launch Notification			May 28, 2022
Campaign No. :	NHTSA ID	Campaign Desc. :	<b>Inspect Brake Booster With Pedal Rework</b>
2022050014	22V315	22P4290006	
<p>This is to notify you of the Recall Campaign Launch to inspect the brake booster on <b>14,123</b> Model Year (“MY”) 2007-2008 GL-Class, ML-Class, and R-Class (X164, W164 and 251 platform) vehicles. The recall campaign will be visible on the <a href="http://www.safercar.gov">www.safercar.gov</a> website and may generate questions from customers. Affected VINs will be flagged in VMI as “OPEN” on <b>May 28, 2022</b>.</p>			
Background			
Issue	<p>Mercedes-Benz AG (“MBAG”), the manufacturer of Mercedes-Benz vehicles, has determined that on certain Model Year (“MY”) 2007-2008 ML-Class, GL-Class (W164/X164 platform) and R

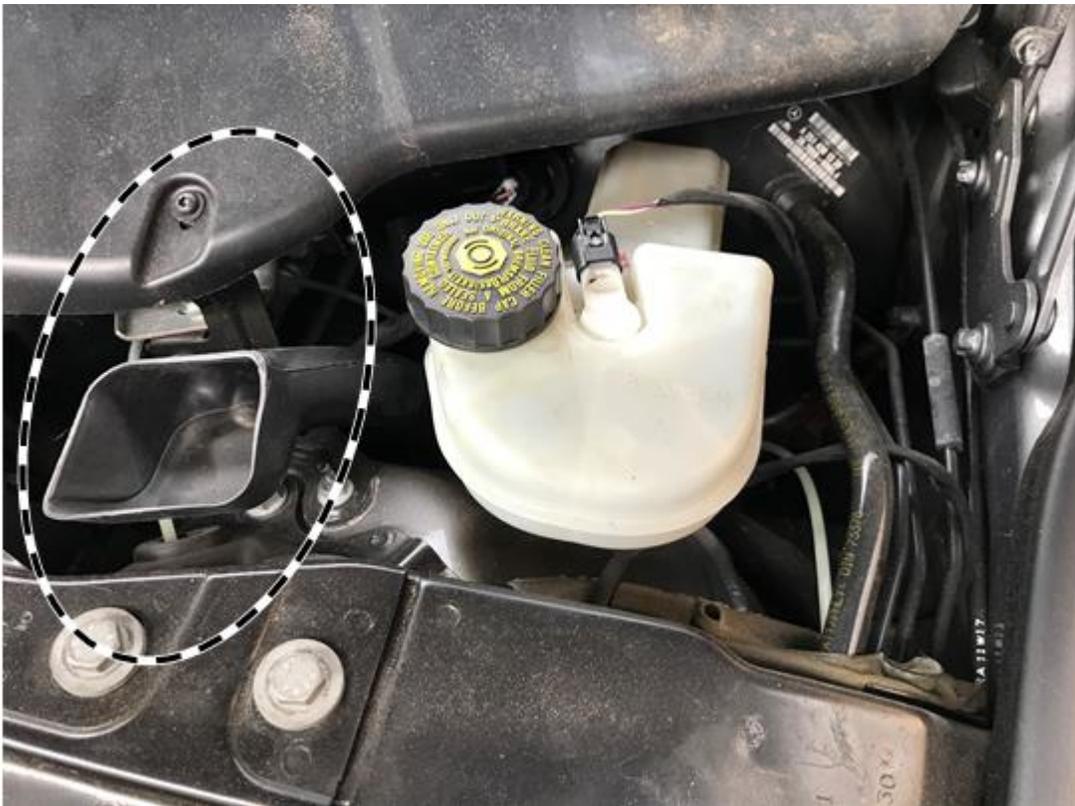
Figure 1

1. Open the hood and check the water drains (**marking, figure 1**) for correct installation and ability to drain.

**i** Clean and correctly install water drains if necessary.

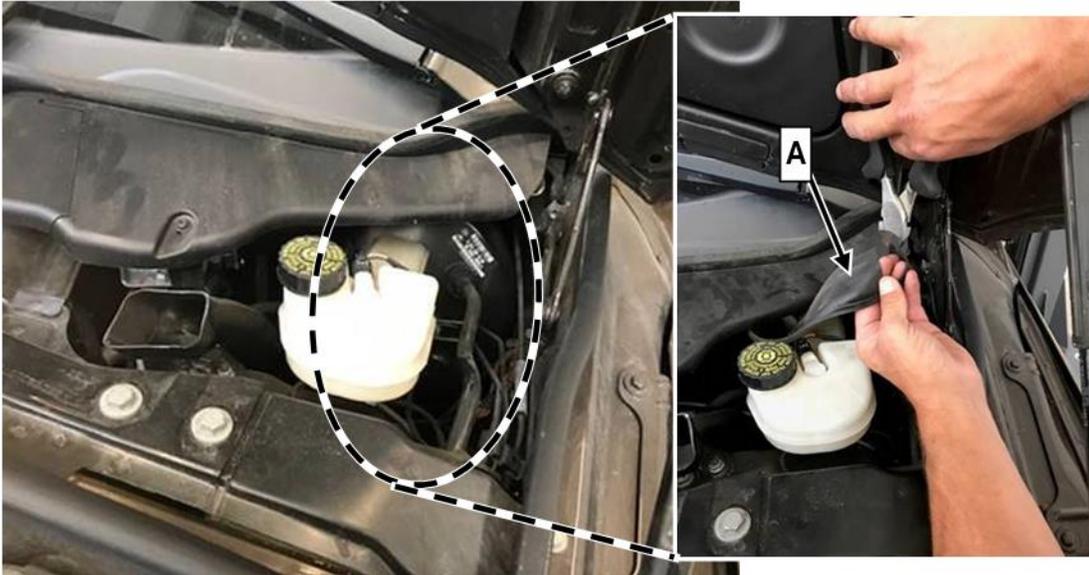
Figure 2

2. Remove the rubber sleeve wrapped around the brake booster (**A, figure 2**) with a suitable tool (hook and side cutting pliers). If the rubber sleeve is not present, please proceed to check/test procedure **A1**.

**i** The rubber sleeve should be separated above the barcode label on the brake booster as seen in (**A, figure 2** and **B, figure 4.1**).

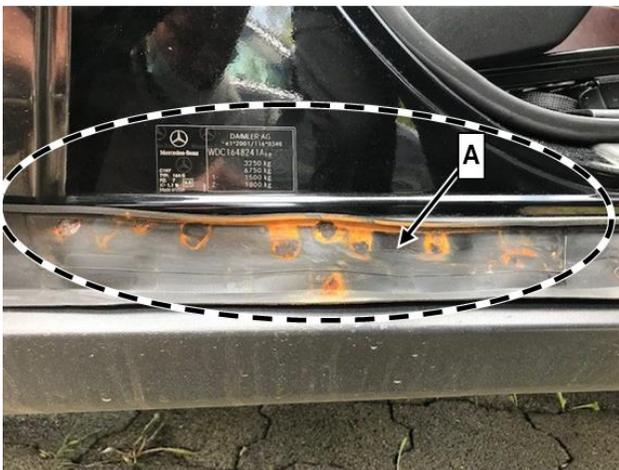
Figure 3

3. Take a photo of the rubber sleeve with the VIN label of the B-pillar (**A, figures 3 and 4**) and store to a local HDD/computer storage location with the vehicle service file and attach it to the warranty claim in EVA.

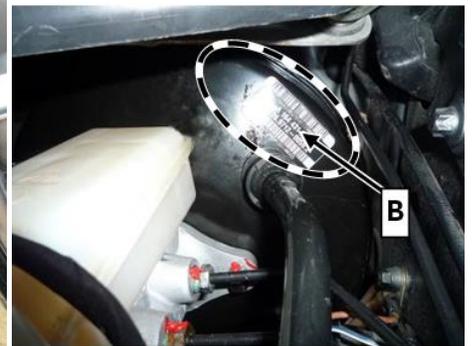
Figure 4.1

**i** If the rubber sleeve on the brake booster is **not** present, please take a photo of the barcode label (**B, figure 4.1**) on the brake booster and store to a local HDD/computer storage location with the vehicle service file and attach to the warranty claim in EVA. Then continue with **check/test procedure A1**.

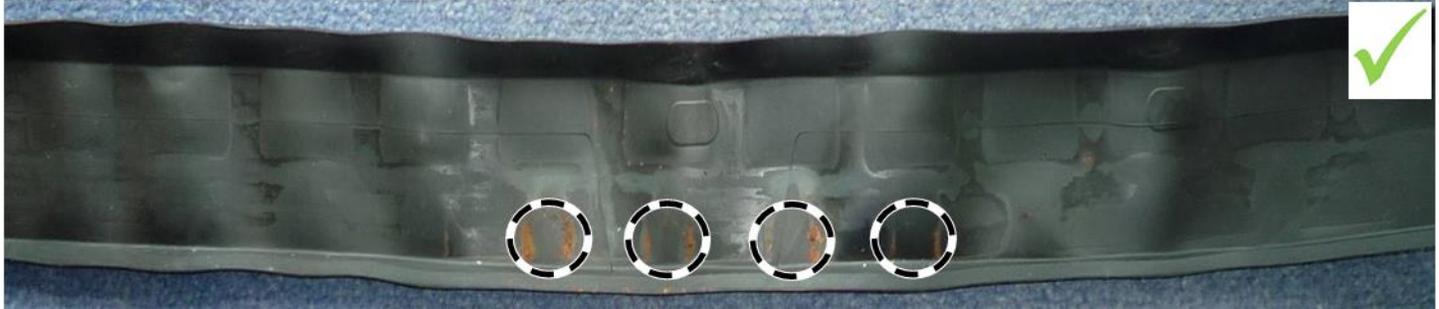
Figure 5 OK

Multiple point-shaped corrosion marks (**figure 5**) are permissible.

- a. Corrosion measurements **Exceeds thresholds-NOK**: Carry out **check/test procedure B - XENTRY/DAS**.
- b. Corrosion measurements **Does not exceed threshold-OK** (figure 5, 6 or 7): **End measure**.  
(**Certificate of Passed Initial Diagnostic Brake Test not required**).

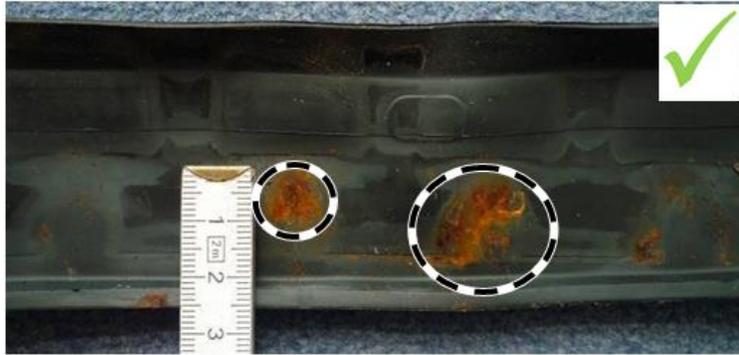
Figure 6 Ok

A maximum of **one point-shaped corrosion mark** with a diameter **greater than 15 mm** (**figures 6 and 7**) is permitted.

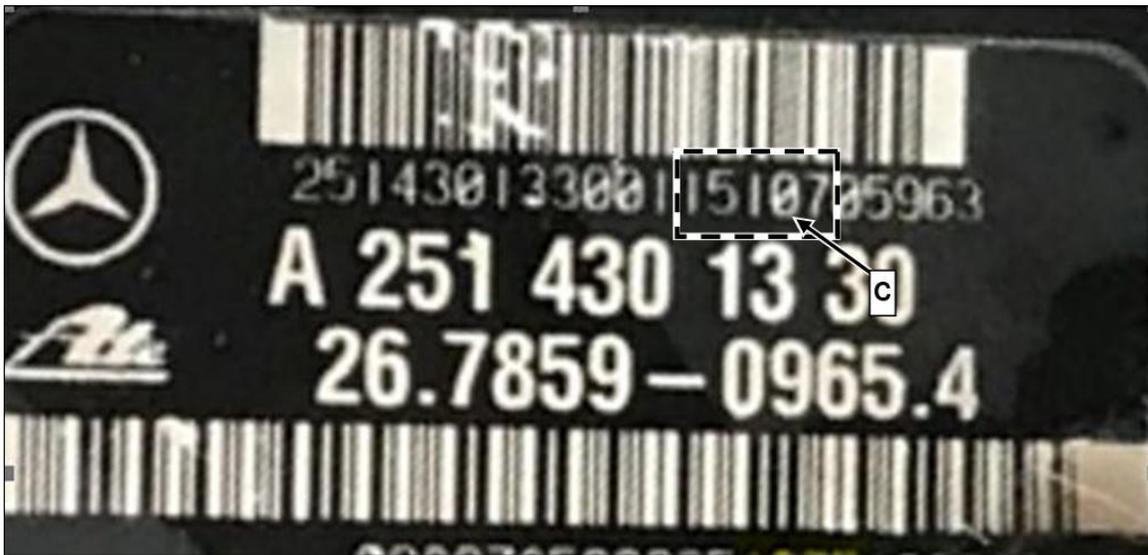
Figure 4.2

1. Check sequence of numbers on the barcode label (**C, figure 4.2**).
  - a. IF the sequence of numbers is **less than** "15126" starting from the 13th number: Perform **check/test procedure B - XENTRY/DAS**.
  - b. If the sequence of numbers is **greater than or equal to** "15126" starting from the 13th number: **End the measure**.
