TO: Mercedes-Benz Dealer Principals, General Managers, Sales Managers, Service Managers, Parts Managers	FROM: Gregory Gunther, Department Manager, Vehicle Compliance and Analysis, Engineering Services
RE: Updated Recall Campaign Launch Notification – STOP DRIVE Inspect Brake Booster with Pedal Rework MY07-08 GL-Class, ML-Class, R-Class (X164, W164, 251 platform)	UPDATE: July 22, 2022

IMPORTANT RECALL CAMPAIGN UPDATE

Campaign No. 2022050014, May 2022

Inspect Brake Booster – with Pedal Rework

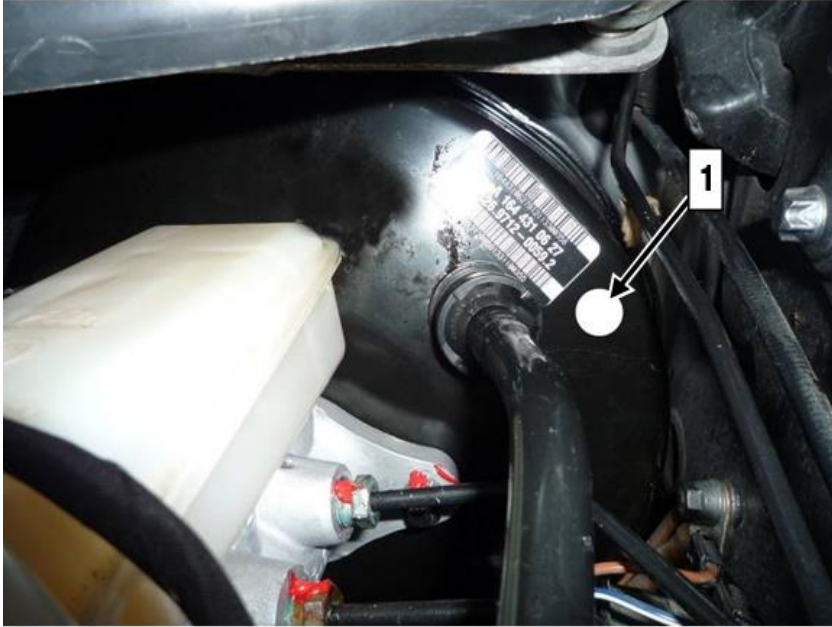
Figure 10

2. Apply marking with **white touch-up paint pen (1, figure 10)** to the inspected brake booster.

i Under no circumstances should you treat the brake booster with anti-corrosion agent/paint.
