# Recall Campaign Bulletin

Campaign No. 2022050015, May 2022

SUBJECT: **Model GL-Class, ML-Class, and R-Class (X164, W164 and 251 platform)**  
**Model Year 2006-2012**

## **Inspect Brake Booster – without Pedal Rework**

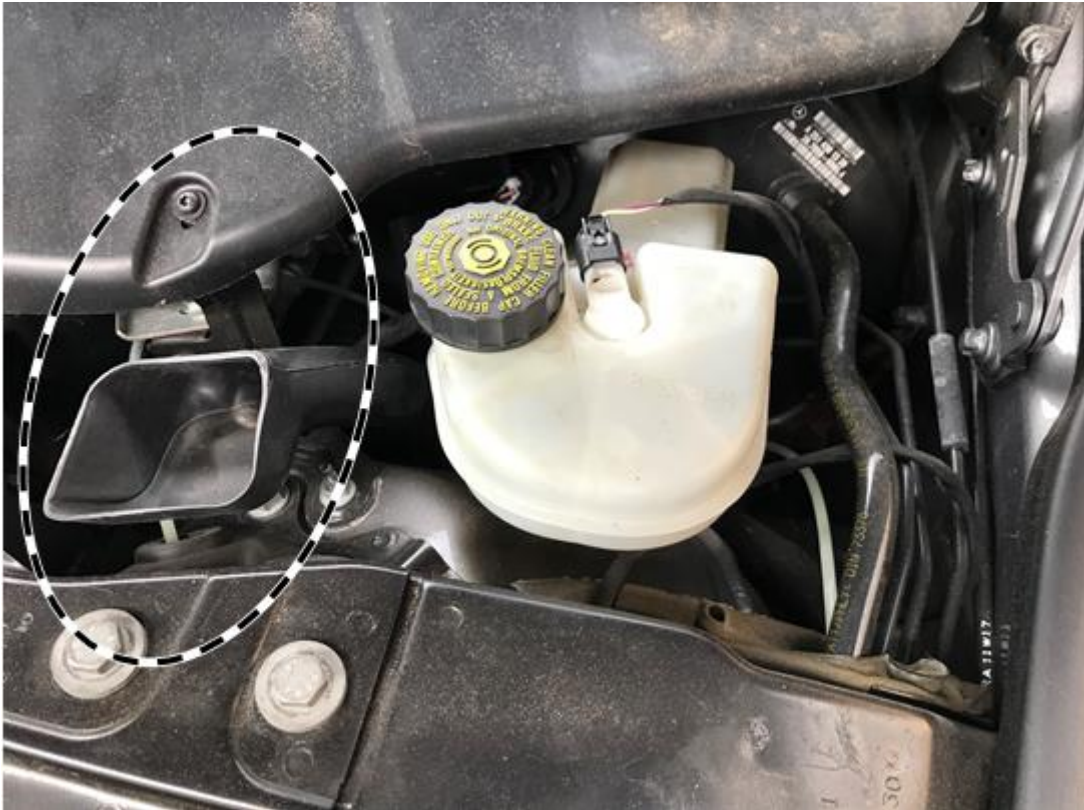
**Figure 1**

1. Open the hood and check the water drains (**marking, figure 1**) for correct installation and ability to drain.

**i** Only for model 251

**i** Clean and correctly install water drains if necessary.

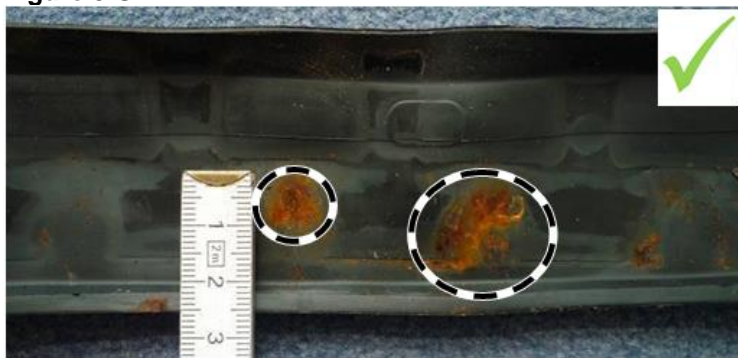
Figure 6 OK

A maximum of **one point-shaped corrosion mark** with a diameter **greater than 15 mm** (**figures 6 and 7**) is permitted.

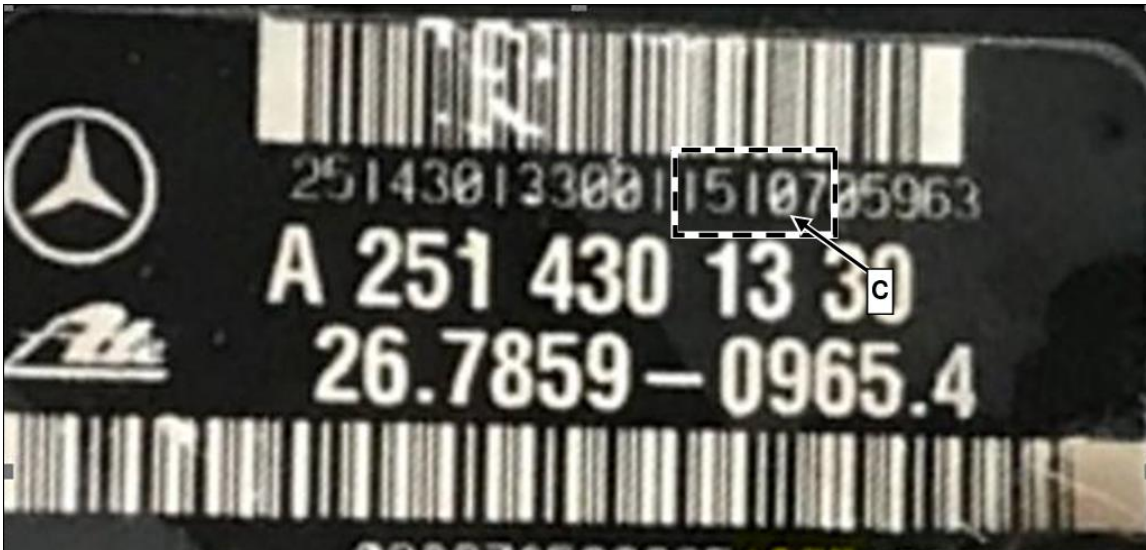
**Figure 9**

1. Check sequence of numbers on the barcode label (C, figure 9).
  - a. If the numeric sequence between numbers 13 and 17 is **less than** "15126": Carry out **scope of testing B - XENTRY/DAS**.
  - b. If the numeric sequence between numbers 13 and 17 is **greater than or equal to** "15126": **End measure**.
