Recall Campaign Bulletin

Campaign No. 2022050015, May 2022

SUBJECT: **Model GL-Class, ML-Class, and R-Class (X164, W164 and 251 platform)
Model Year 2006-2012**

Inspect Brake Booster – without Pedal Rework

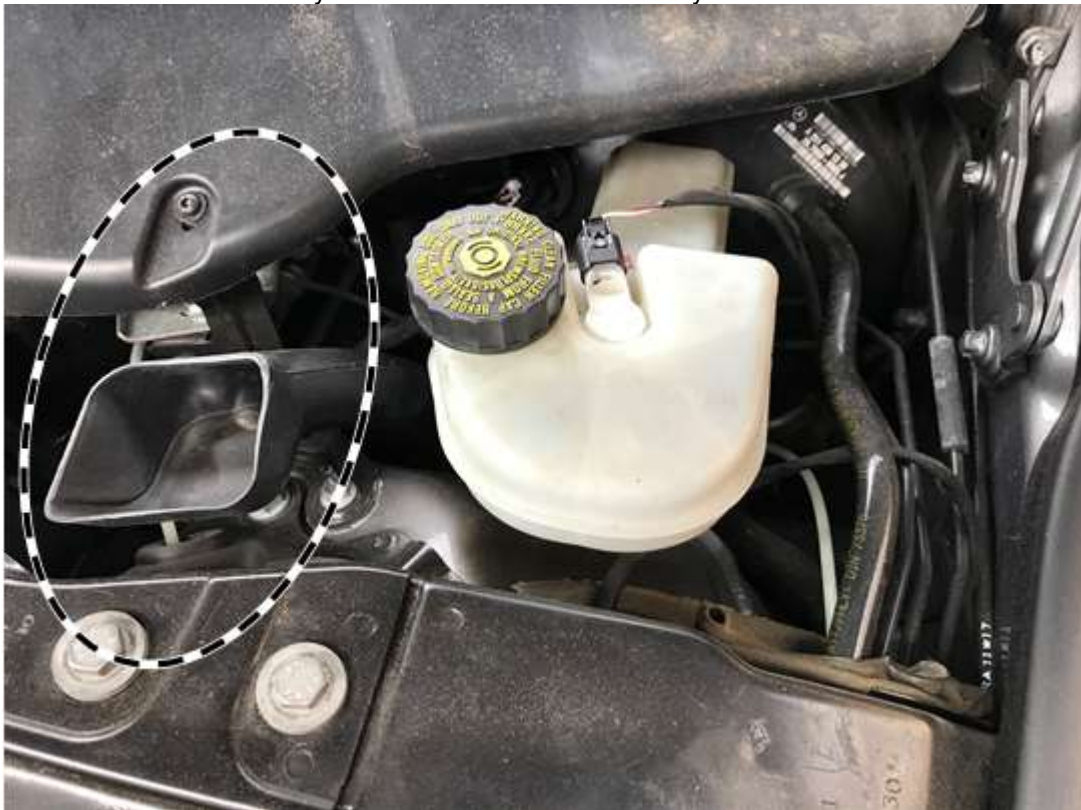
Figure 1

- Open the hood and check the water drains (**marking, Figure 1**) for correct installation and ability to drain.

i Clean and correctly install water drains if necessary.

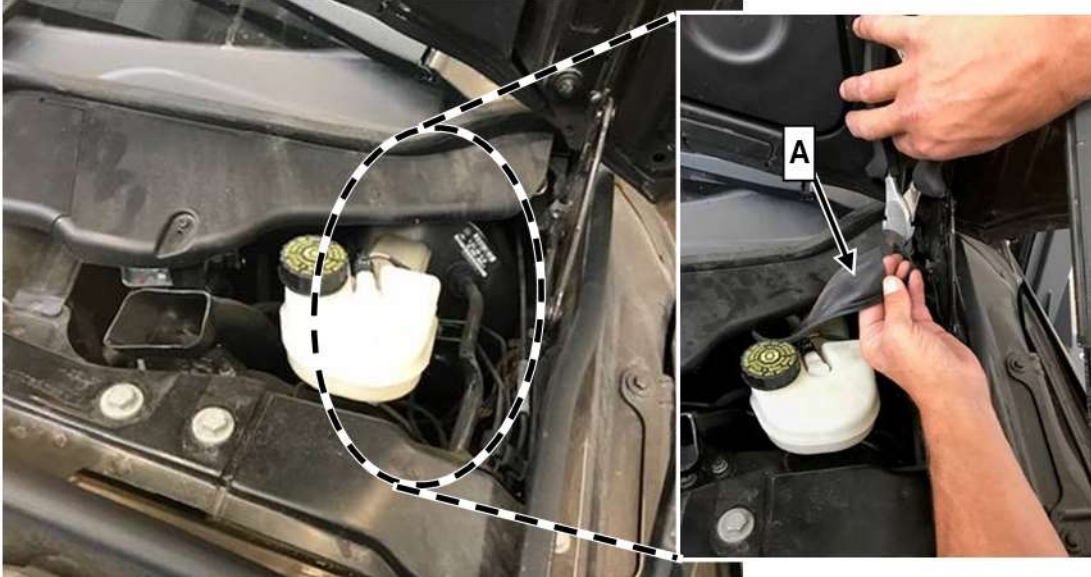
Figure 2

2. Remove the rubber sleeve wrapped around the brake booster (A, Figure 2) with a suitable tool (hook and side cutting pliers).
 - i** If the rubber sleeve on the brake booster is missing or *not* present, then continue with **check/test procedure A1**.
 - i** The rubber sleeve should be separated above the barcode label on the brake booster as seen in (A, Figure 2).

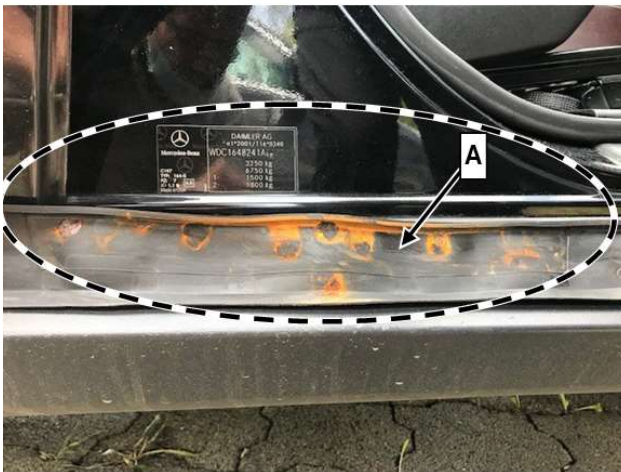
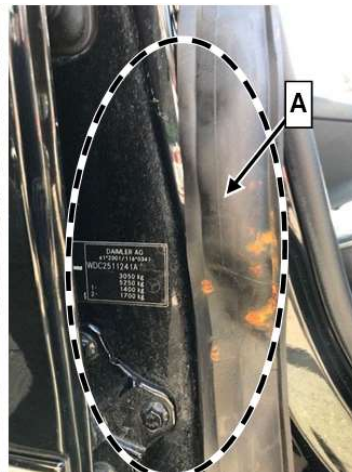
3. Take a photo of the rubber sleeve with the VIN label of the B-pillar (A, Figures 3 and 4) and store to a local HDD/computer storage location with the vehicle service file and attach it to the warranty claim in EVA.
 - i** These pictures serve as documentation of the current condition of the brake booster.

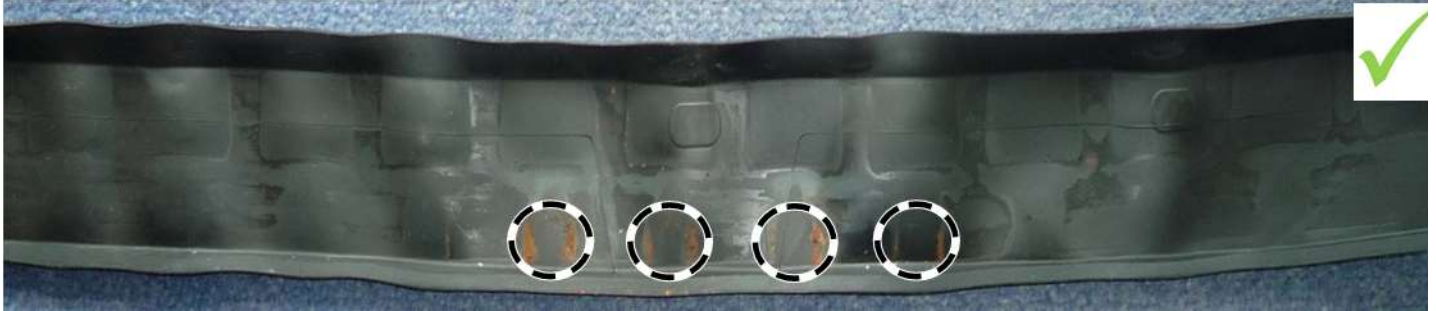
Figure 5 (OK)

Multiple point-shaped corrosion marks (Figure 5) are permissible.

- a. Corrosion measurements **Exceeds thresholds-Not OK: Carry out work procedure**
- b. Corrosion measurements **Does not exceed threshold-OK (Figures 5, 6 or 7): End measure.**

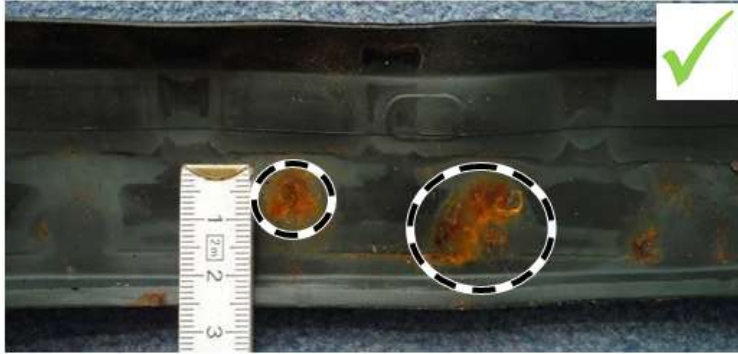
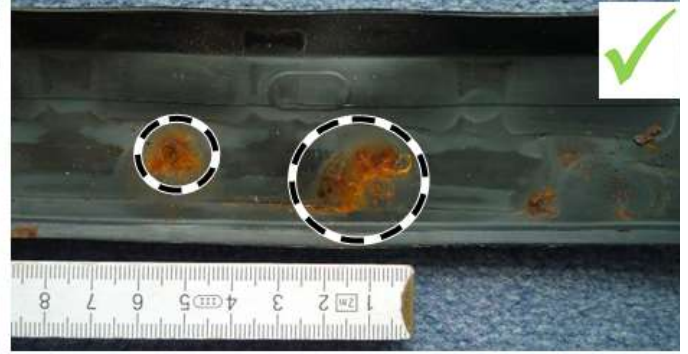
A maximum of **one point-shaped corrosion mark** with a diameter **greater than 15 mm** (Figures 6 and 7) is permitted.

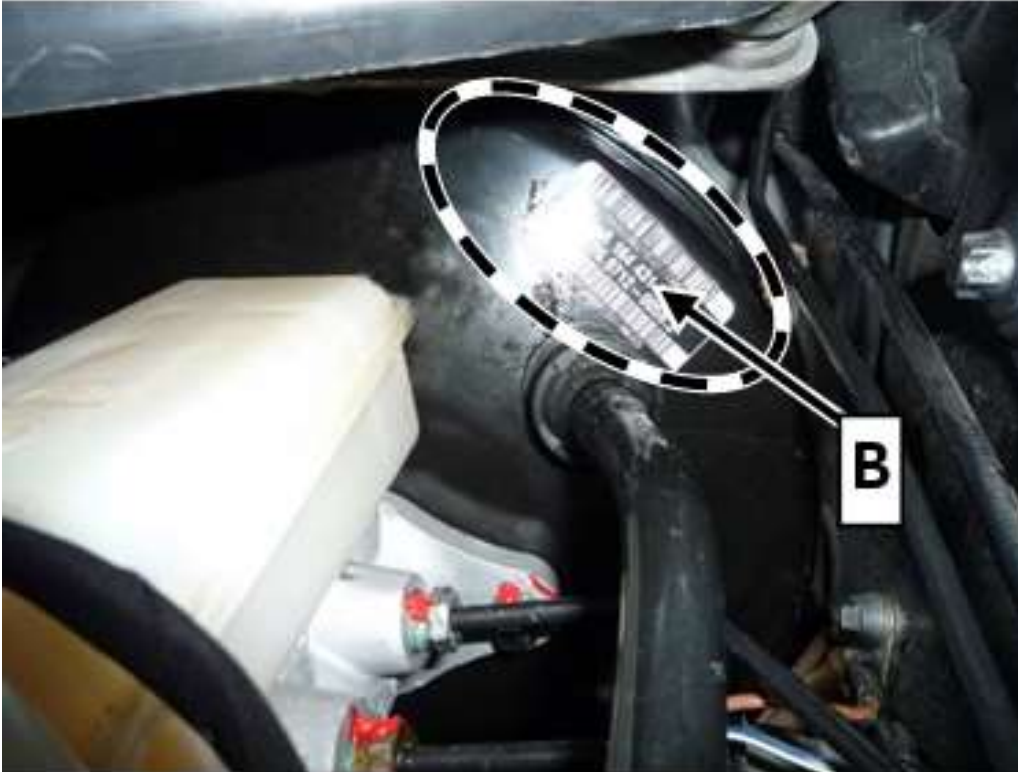
Figure 8

1. Take a photo of the barcode label (**B, Figure 8**) on the brake booster and store to a local HDD/computer storage location with the vehicle service file and attach to the warranty claim in EVA.

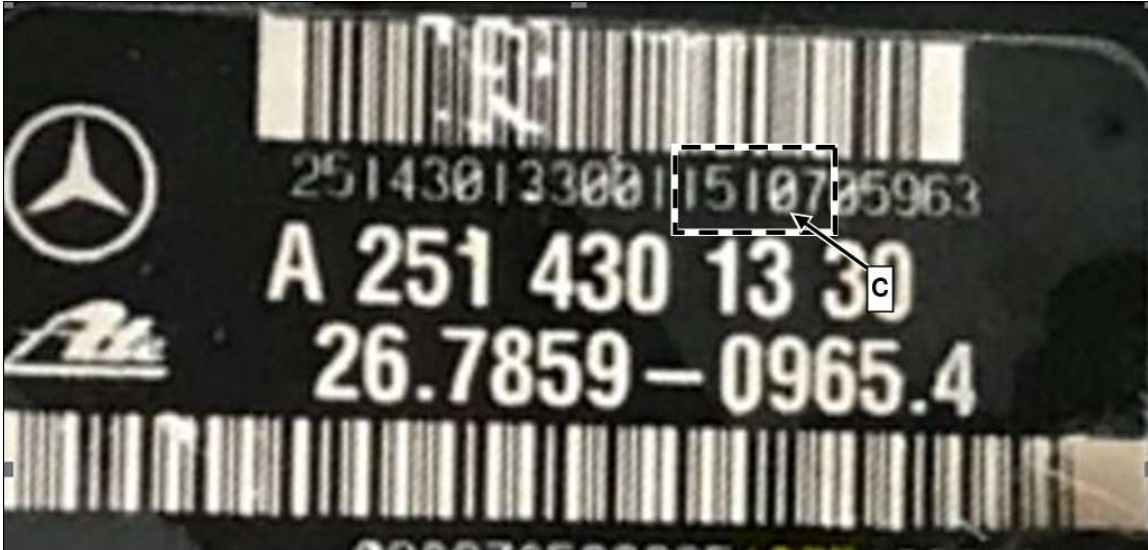
Figure 9

2. Check sequence of numbers on the barcode label (**C**, Figure 9).
 - a. If the numeric sequence between the 13th and 17th digits are **less than** "15126":
Carry out **Work Procedure below**.
 - b. If the numeric sequence between the 13th and 17th digits are **greater than or equal to** "15126":
End measure.

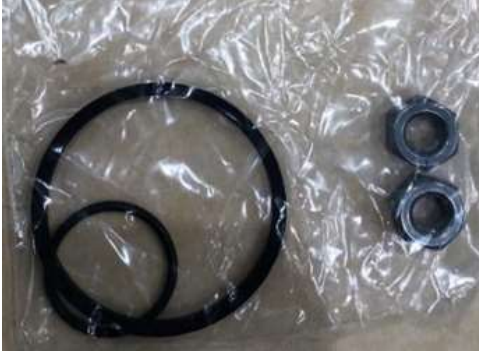
Figure 11

- i** The new brake booster contains a small parts kit (**Figure 11**).

1. Replace brake booster.
