Recall Campaign Bulletin

Campaign No. 2022050014, May 2022 Revision I: 05/23/2024

SUBJECT: Model GL-Class, ML-Class, and R-Class (X164, W164 and 251 platform) Model Year 2007-2008

Inspect Brake Booster – with Pedal Rework

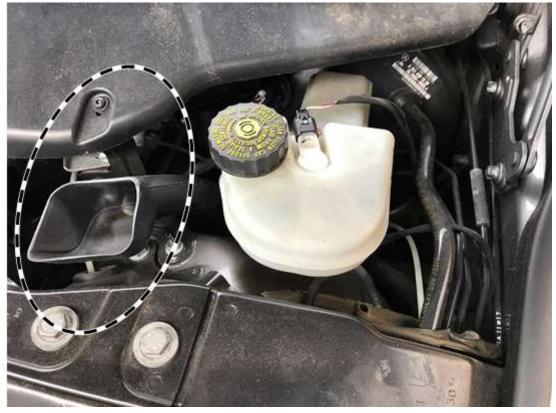
1. <u>Open the hood and check the water drains</u> (marking, Figure 1) for correct installation and ability to drain.

i Clean and correctly install water drains if necessary.

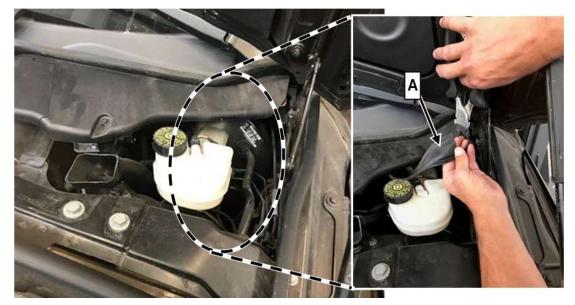
- 2. Remove the rubber sleeve wrapped around the brake booster (A, Figure 2) with a suitable tool (hook and side cutting pliers).
 - i If the rubber sleeve on the brake booster is missing or *not* present, then continue with **check/test procedure A1**.

i The rubber sleeve should be separated <u>above</u> the barcode label on the brake booster as seen in **(A, Figure 2)**.

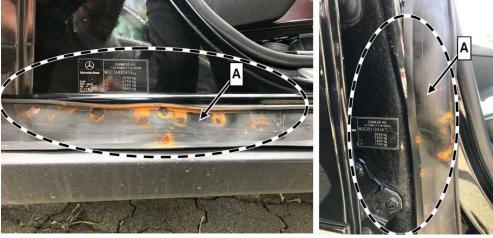
Figure 3

3. Take a photo of the rubber sleeve with the VIN label of the B-pillar (A, Figures 3 and 4) and store to a local HDD/computer storage location with the vehicle service file and attach it to the warranty claim in EVA.
 I These pictures serve as documentation of the current condition of the brake booster.

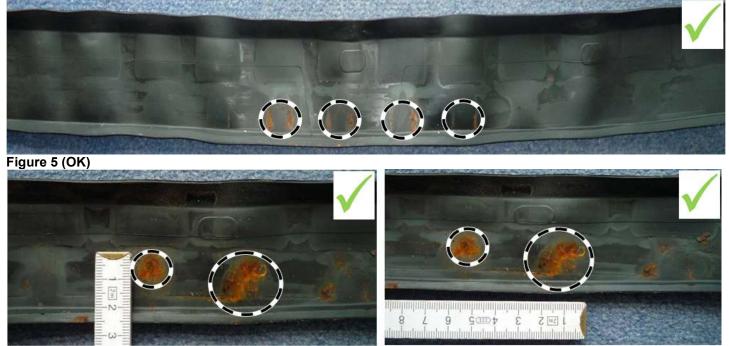
Multiple point-shaped corrosion marks (Figure 5) are permissible. A maximum of one point-shaped corrosion mark with a diameter greater than 15 mm (Figures 6 and 7) is permitted.

Figure 6 (OK)

Figure 7 (OK)

Widespread corrosion marks spanning the rubber sleeve are not permissible. More than one corrosion mark with a diameter greater than 15 mm is not permissible.

- a. Corrosion measurements Exceeds thresholds Not OK: Carry out work procedure
- b. Corrosion measurements Does not exceed threshold OK (Figures 5, 6 or 7): End measure.

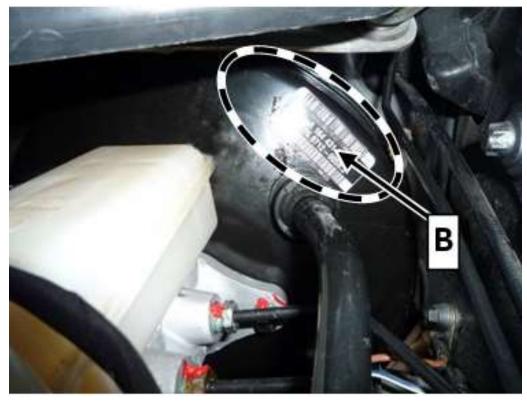
Figure 8

1. Take a photo of the barcode label (B, Figure 8) on the brake booster and store to a local HDD/computer storage location with the vehicle service file and attach to the warranty claim in EVA.

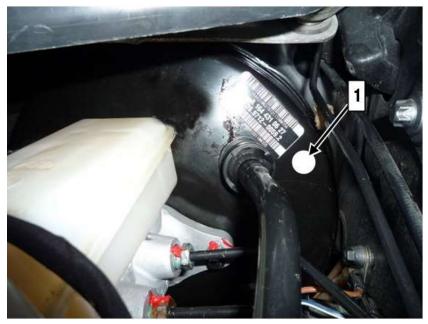
Figure 10

Apply marking with *white touch-up paint pen* (1, Figure 10) to the inspected brake booster.
 Under no circumstances should you treat the brake booster with anti-corrosion agent/paint.

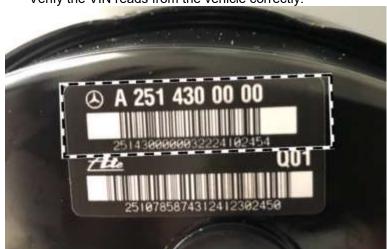
Figure 12

Read out serial number (Figure 12) using the *Mercedes-Benz PartScan* app.
