Recall Campaign Bulletin

Campaign No. 2022050014, May 2022

SUBJECT: **Model GL-Class, ML-Class, and R-Class (X164, W164 and 251 platform)
Model Year 2007-2008**

Inspect Brake Booster – with Pedal Rework

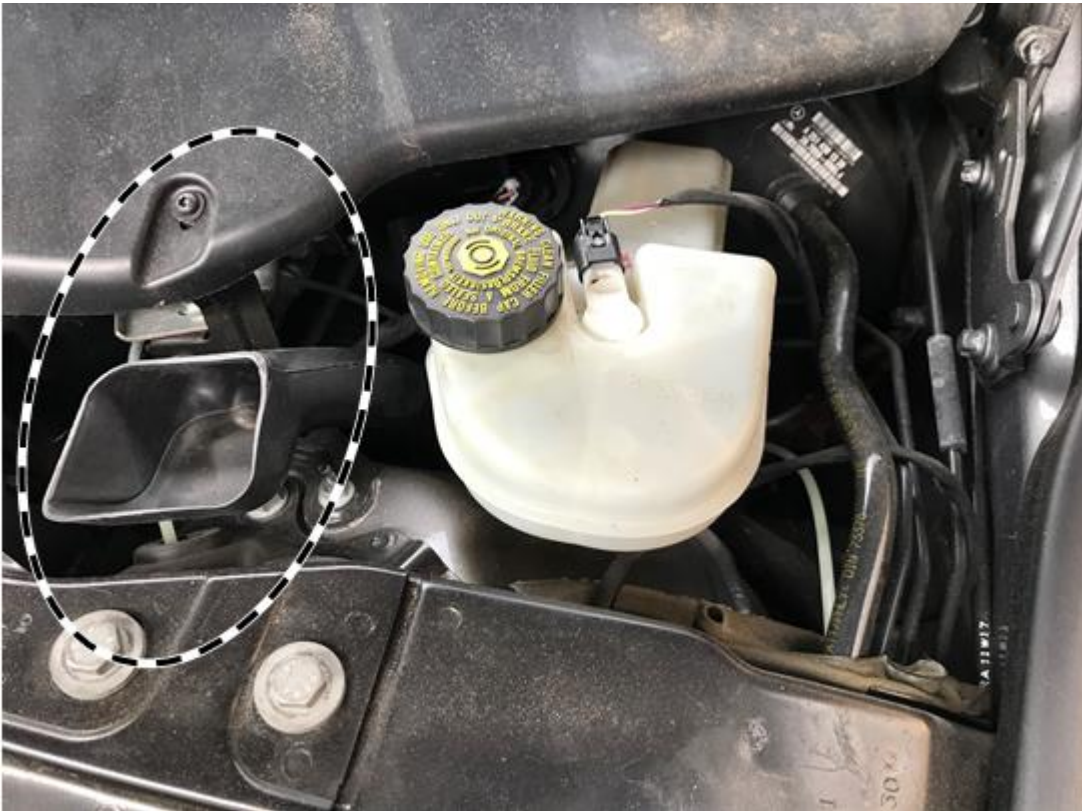
Figure 1

1. Open the hood and check the water drains (**marking, figure 1**) for correct installation and ability to drain.

i Only for model 251

i Clean and correctly install water drains if necessary.

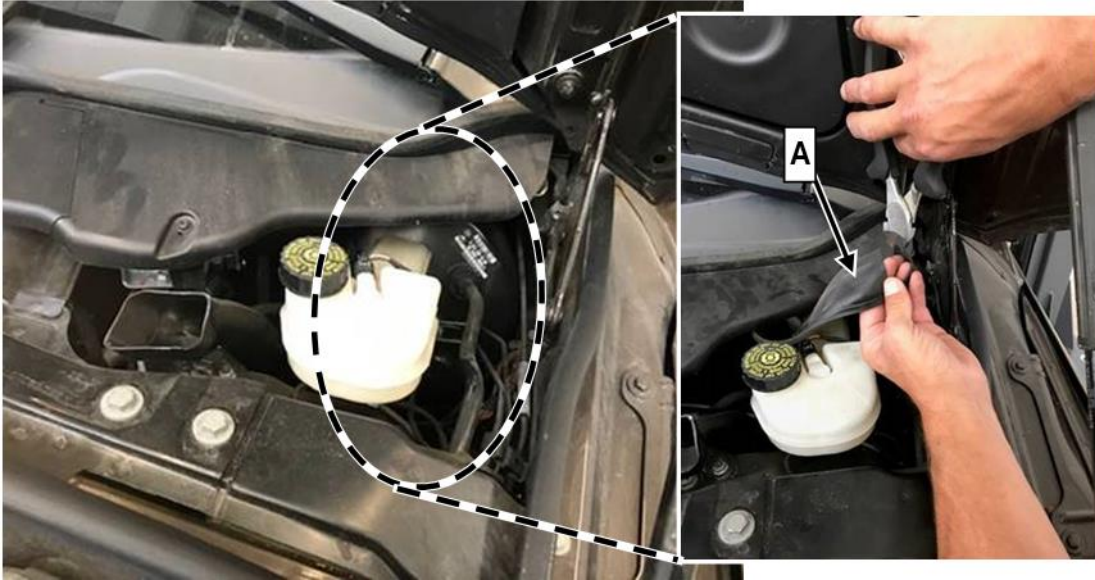
Figure 2

2. Remove the rubber sleeve wrapped around the brake booster (**A, figure 2**) with a suitable tool (hook and side cutting pliers). If the rubber sleeve is not present, please proceed to check/test procedure **A1**.

i The rubber sleeve should be separated above the barcode label on the brake booster as seen in (**A, figure 2** and **B, figure 4.1**).

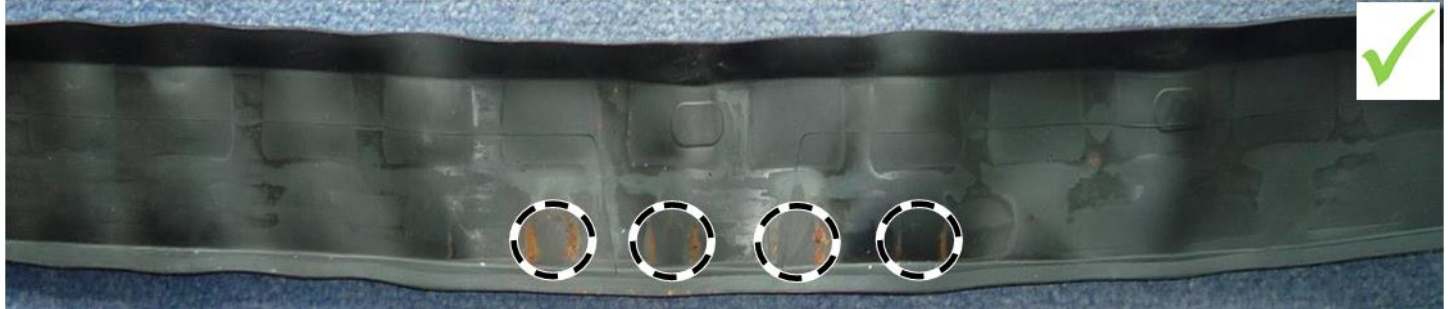
Figure 5 OK

Multiple point-shaped corrosion marks (**figure 5**) are permissible.

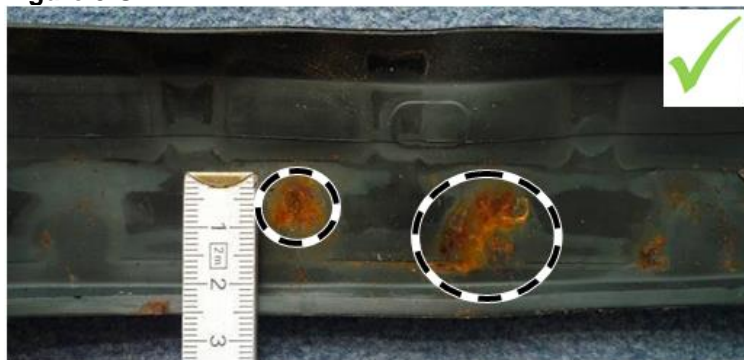
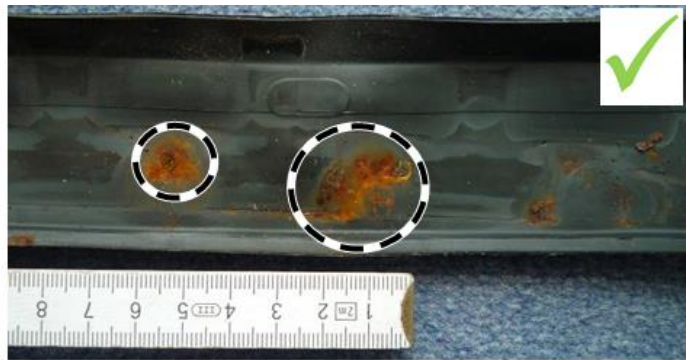
A maximum of **one point-shaped corrosion mark** with a diameter **greater than 15 mm** (**figures 6 and 7**) is permitted.

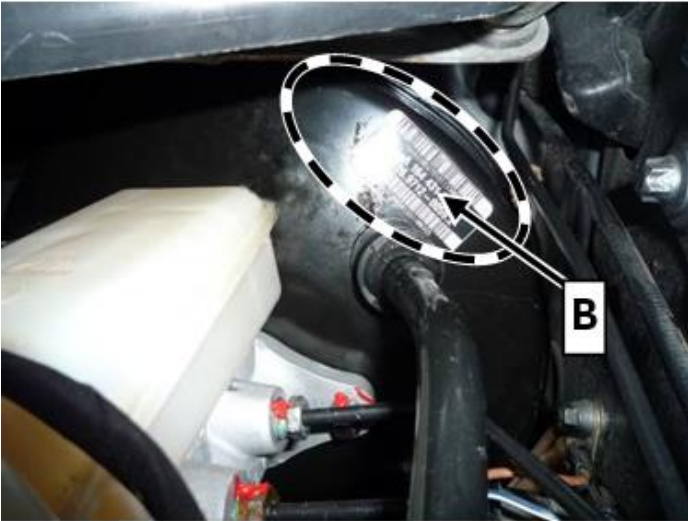
Figure 8

1. Take a photo of the barcode label (B, figure 8) on the brake booster and store to a local HDD/computer storage location with the vehicle service file and attach to the warranty claim in EVA.

i If the measure is ended, **do not** re-install a new rubber sleeve. Apply marking with **white touch-up paint pen** (1, figure 8) to the brake booster checked.

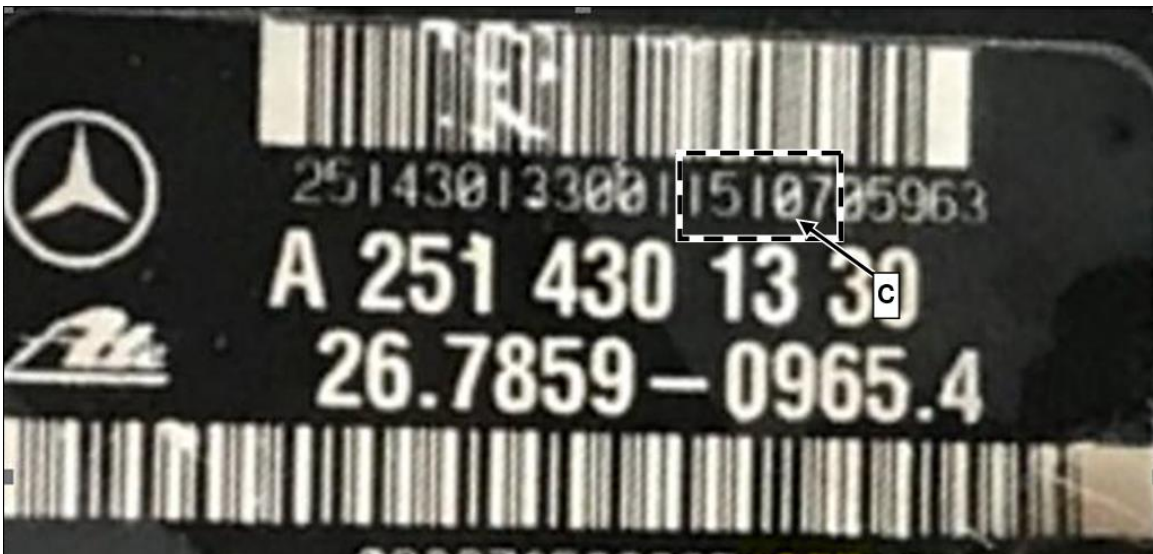
Figure 9

2. Check sequence of numbers on the barcode label (C, figure 9).
 - a. If the numeric sequence between numbers 13 and 17 is **less than** "15126": Carry out **scope of testing B - XENTRY/DAS**.
 - b. If the numeric sequence between numbers 13 and 17 is **greater than or equal to** "15126": **End measure**.
