Recall Campaign Bulletin

Campaign No. 2022050014, May 2022

SUBJECT: **Model GL-Class, ML-Class, and R-Class (X164, W164 and 251 platform)
Model Year 2007-2008**

Inspect Brake Booster – with Pedal Rework

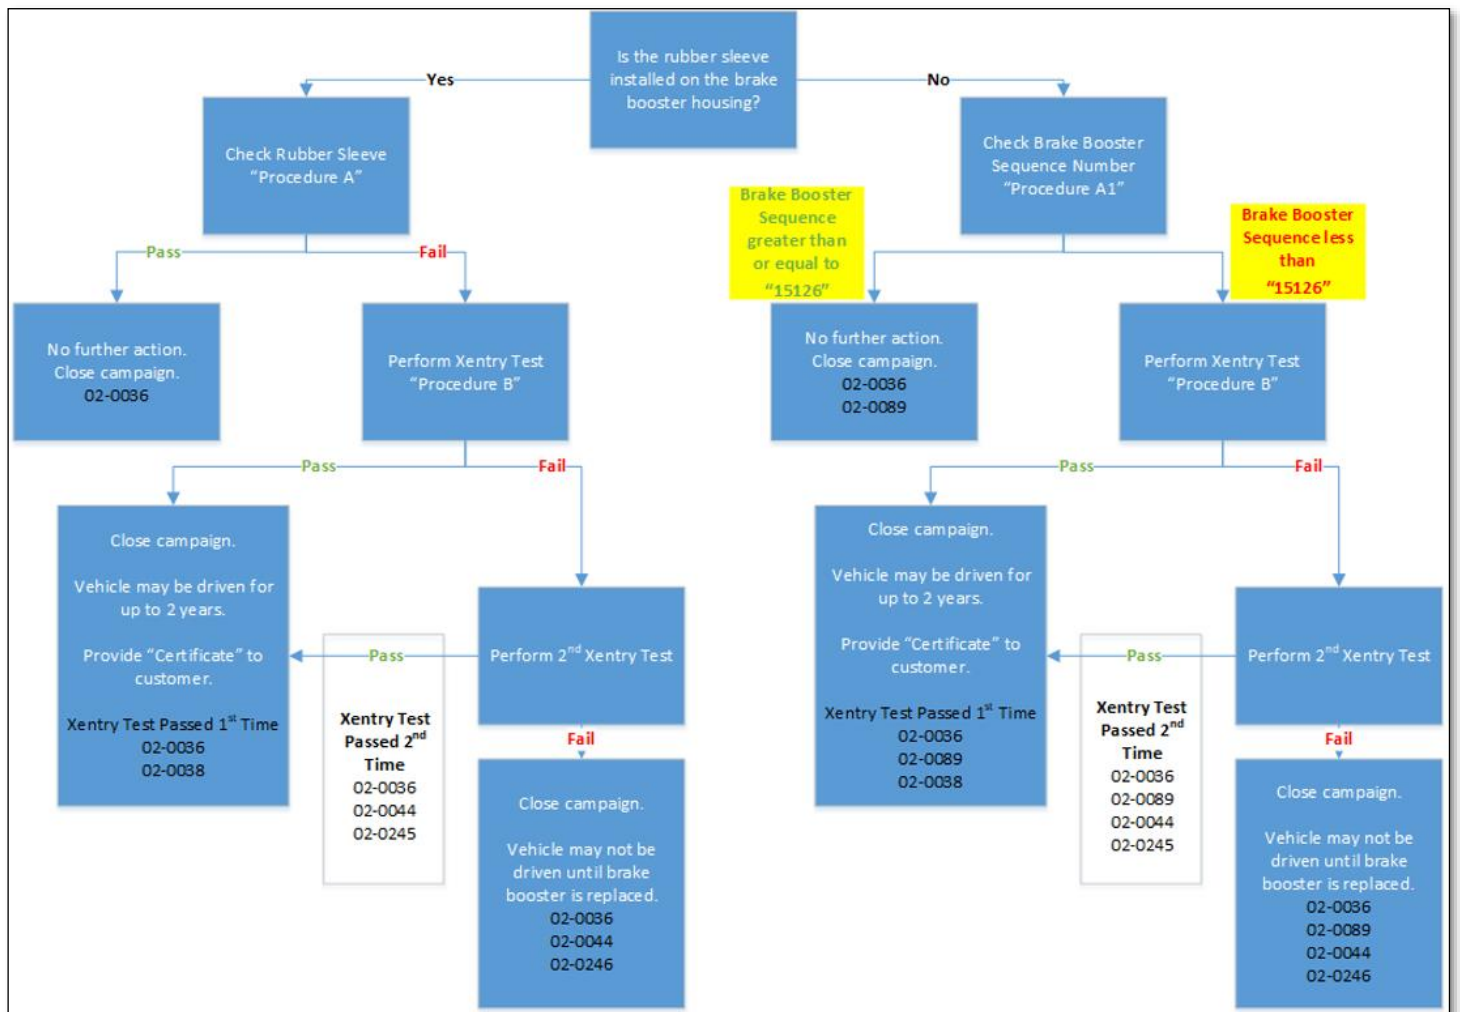
1. Flow chart with allowable labor operation codes when submitting a warranty claim.

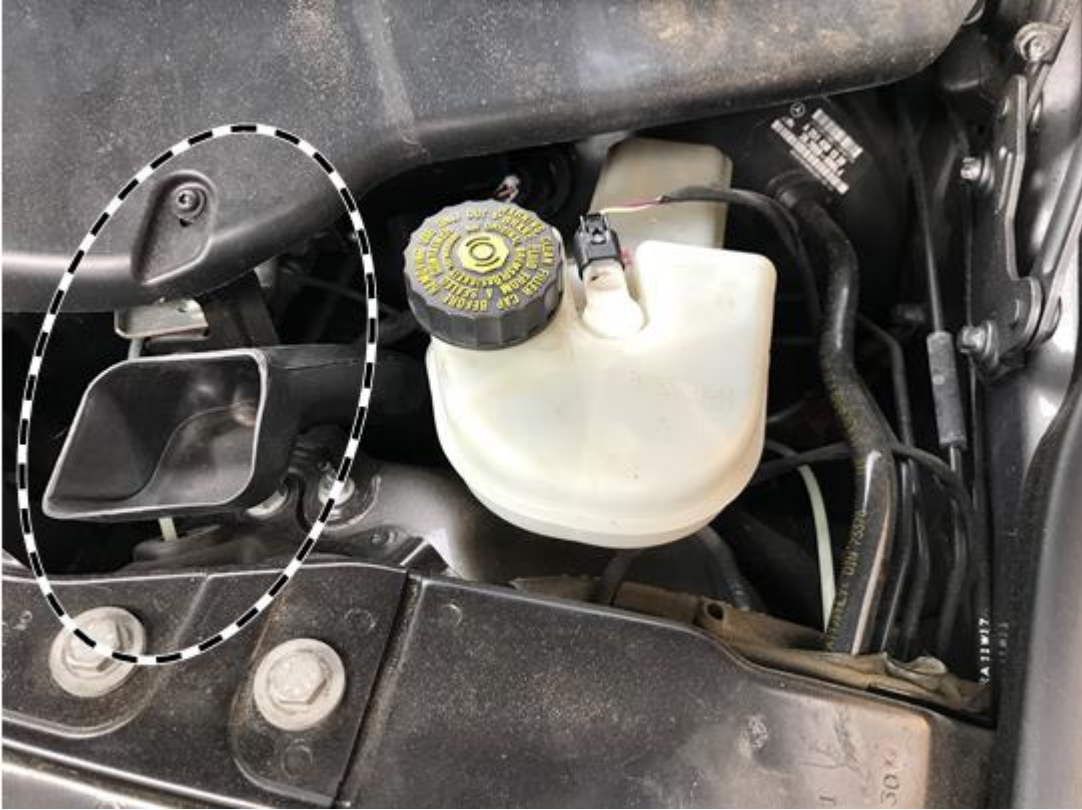
Figure 1

1. Open the hood and check the water drains (**marking, figure 1**) for correct installation and ability to drain.

i Only for model 251

i Clean and correctly install water drains if necessary.

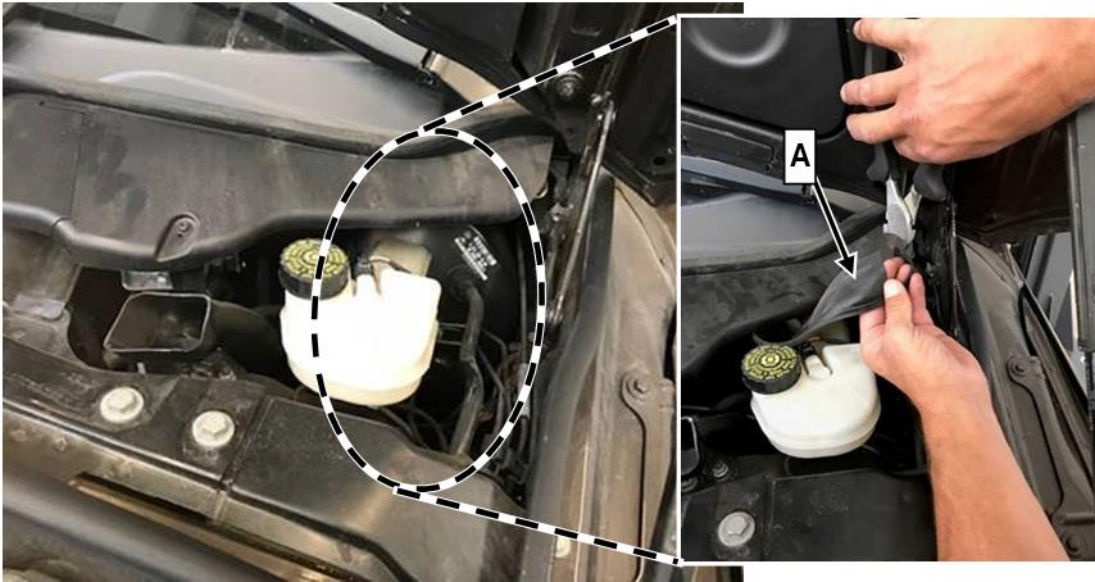
Figure 2

2. Remove the rubber sleeve wrapped around the brake booster (**A, figure 2**) with a suitable tool (hook and side cutting pliers). If the rubber sleeve is not present, please proceed to check/test procedure **A1**.
 - i** The rubber sleeve should be separated above the barcode label on the brake booster as seen in (**A, figure 2** and **B, figure 4.1**).

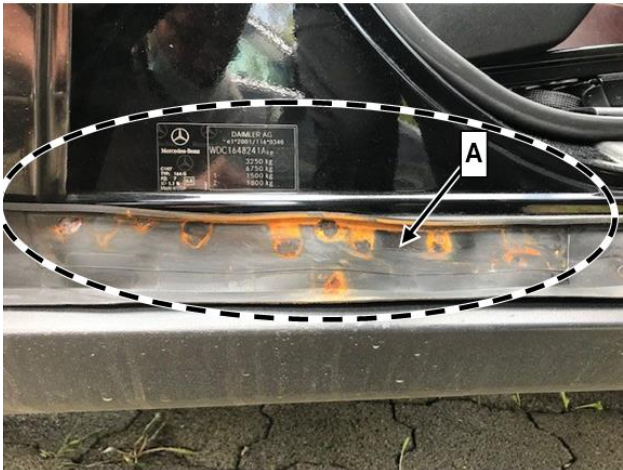
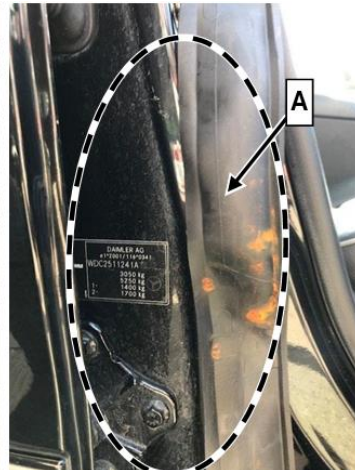
3. Take a photo of the rubber sleeve with the VIN label of the B-pillar (**A, figures 3 and 4**) and store to a local HDD/computer storage location with the vehicle service file and attach it to the warranty claim in EVA.
 - i** These pictures serve as documentation of the current condition of the brake booster.

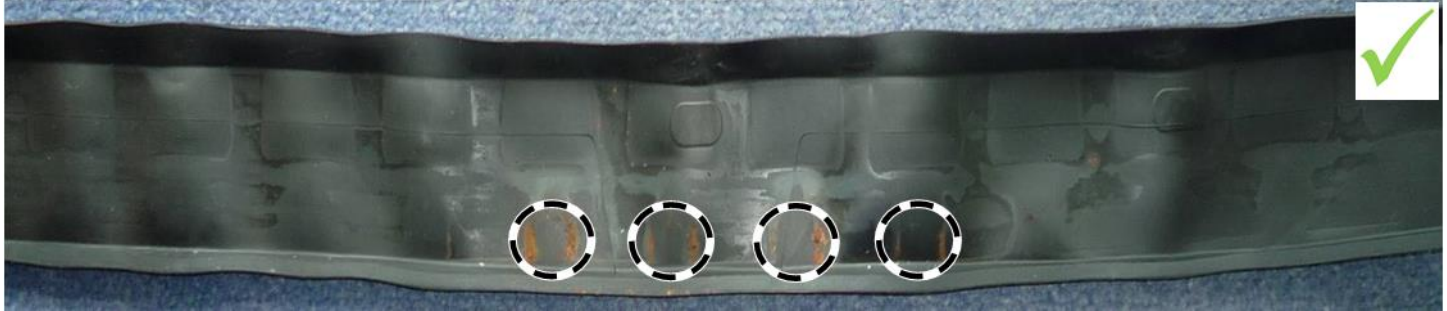
Figure 5 OK

Multiple point-shaped corrosion marks (**figure 5**) are permissible.

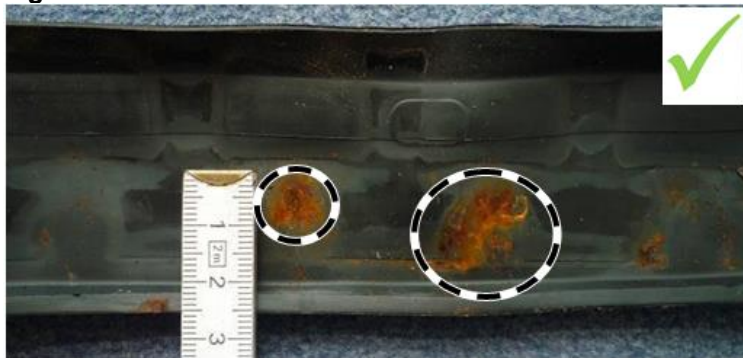
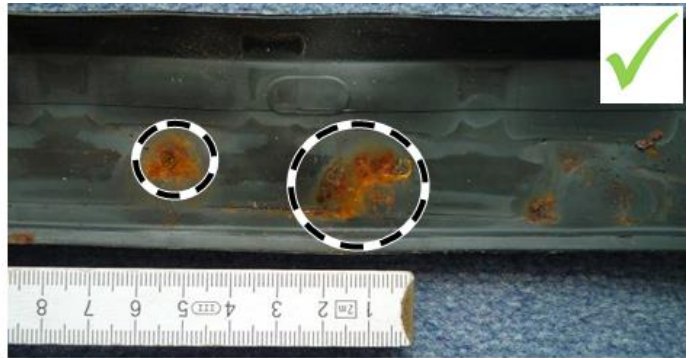
A maximum of **one point-shaped corrosion mark** with a diameter **greater than 15 mm** (**figures 6 and 7**) is permitted.
