Remedy available for
 2023 (JL) Jeep® Wrangler

SAFETY RECALL
NORTH AMERICA
Side Marker Lamp

Reference: 72A / NHTSA 22V-326

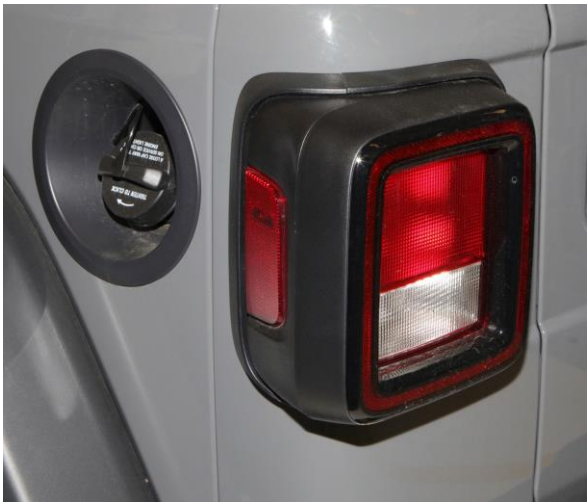
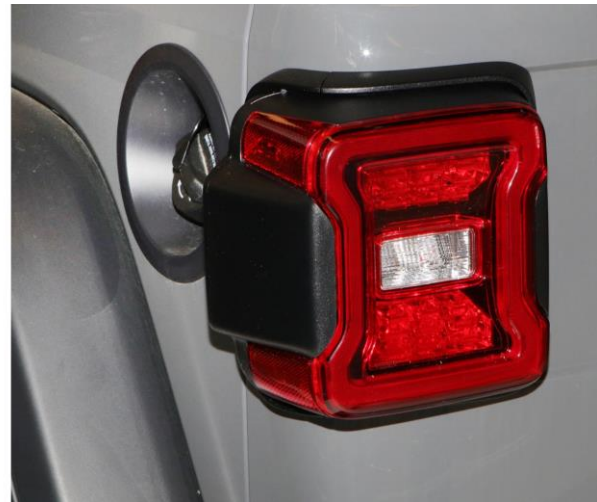
Figure 1 – Replace Incandescent Tail Lamps with LED Tail Lamps

Incandescent Tail Lamp

LED Tail Lamp

Replace incandescent tail lamps with Light Emitting Diode (LED) tail lamps and reconfigure the Body Control Module (BCM) to add LAY sales code, to allow the LED lamps to work.

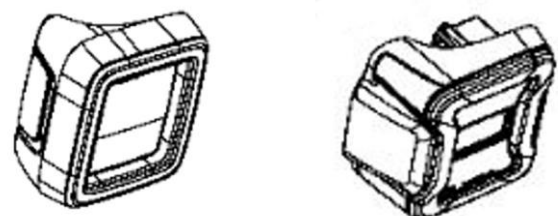
Figure 5 – Tail Lamps

Incandescent

LED

7. Remove the tail lamp assembly from the vehicle.
8. **DISCARD** the incandescent tail lamp assembly (Figure 5).
9. Obtain the **NEW** LED tail lamp assembly (Figure 5).
