FMVSS Noncompliance
Recall Campaign2022MY
Telluride (ON)

SC237

July 2022

INSTRUMENT CLUSTER ASSEMBLY
REPLACEMENT (SC237)

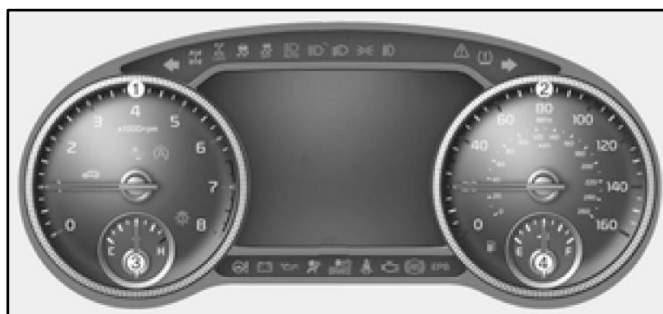
This bulletin provides the procedure to replace the instrument cluster assembly on certain 2022MY Telluride (ON) vehicles equipped with the 3.5-inch Mono TFT LCD or Supervision 7-inch TFT LCD cluster, produced from September 9, 2021 through March 30, 2022. Due to an incorrect die applicator setting at the supplier, excess adhesive was applied to a circuit board within the instrument cluster. Excess adhesive may lead to a poor electrical connection and cause the LCD information display screen to go blank resulting in the driver's inability to see the odometer. As a result, the subject vehicles fail to comply with the visibility requirements of Federal Motor Vehicle Safety Standard (FMVSS) 101, "Controls and Displays". This condition does not affect the functionality of the vehicle's underlying systems or dedicated telltale/warning lamps. Follow the procedure outlined in this publication to replace the instrument cluster. Before conducting the procedure, verify that the vehicle is included in the list of affected VINs.
