Recall Campaign Bulletin

Mercedes-Benz

CAMPAIGN NO.	2023110006
CAMPAIGN DESC.	23P5497319
NHTSA ID	22V365
SUBJECT	SIM Card Communication Module – Wave 6
MODEL(S)	A-Class, C-Class, CLA, CLS, E-Class, G-Class, GLA, GLB, GLC, GLE/GLS, AMG GT 4-door, S-Class, and SLC vehicles (177, 205, 117, 118, 257, 213, 238, 463, 247, 156, 253, 166, 292, 167, 290, 217, 222 and 172 platform)
MODEL YEAR(S)	2017 – 2022
CAMPAIGN POPULATION	19,980

Campaign Technical Instructions

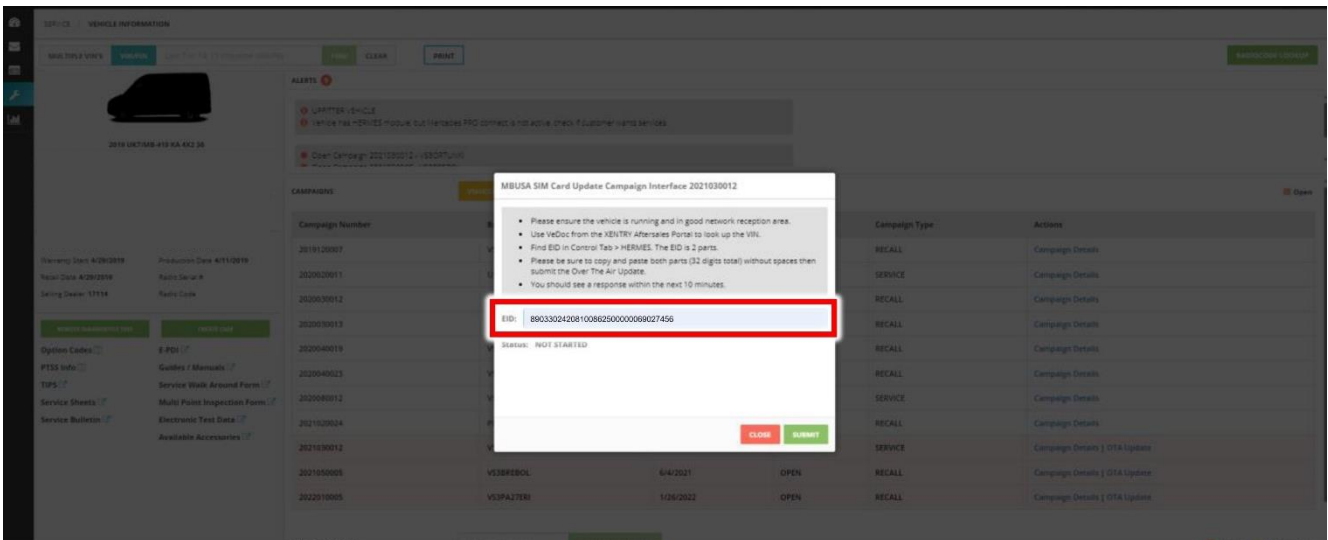
Figure 7 – EID1 + EID2 input

5. Enter the valid EID number and click on “Submit” (Figure 7).

i To do this, enter the **EID1 + EID2** numbers from VeDoc **without spaces or special characters** as shown. (e.g.: 8903302420810086250000069027456 – **EXAMPLE ONLY**).

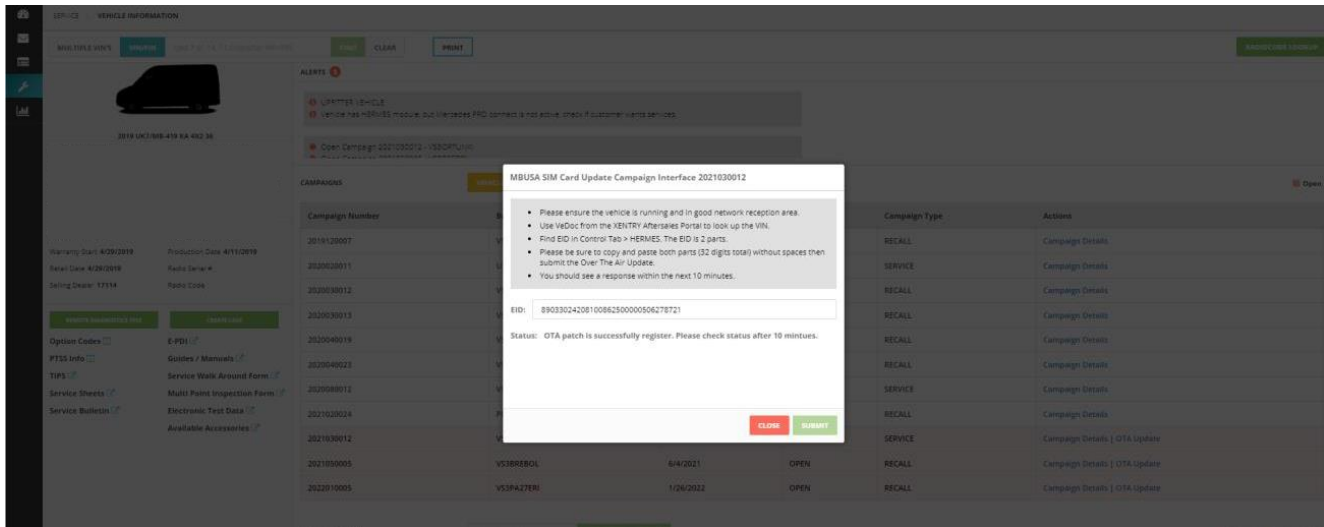
Figure 8 (screen on “NetStar” after the OTA update has been registered successfully)
Status: OTA patch is successfully registered. Please check status after 10 minutes

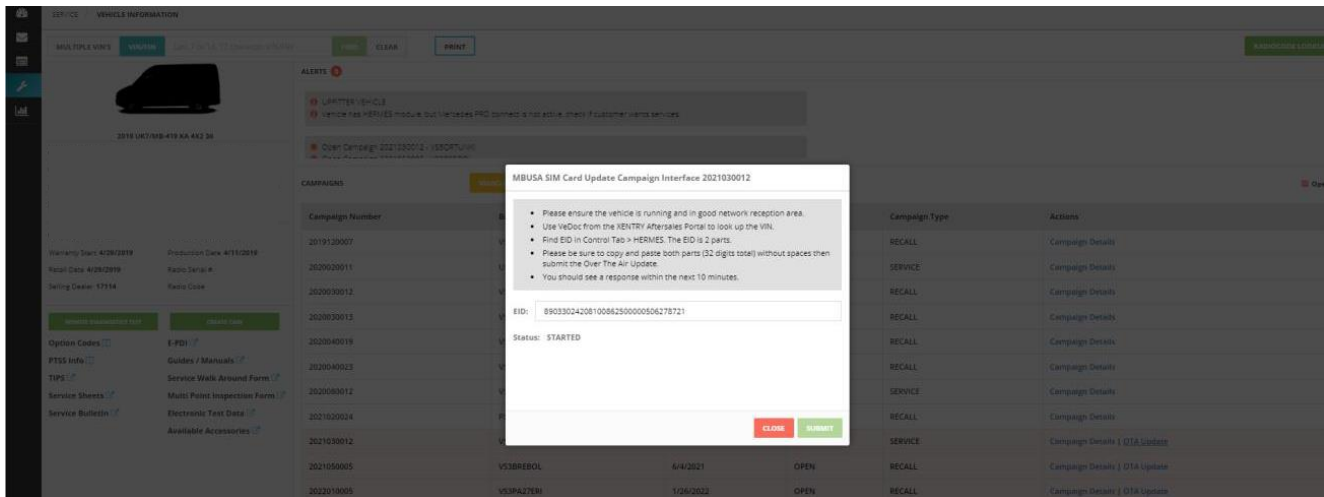
Figure 9 (screen on “NetStar” if “OTA update” is clicked again during the OTA update process)
Status: Started

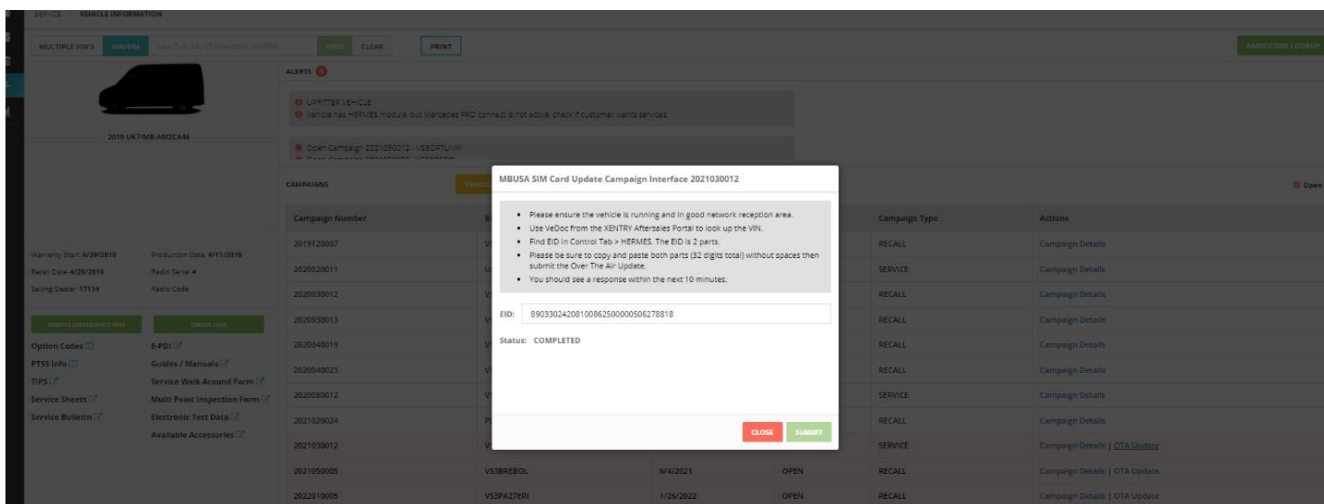
Figure 10 (screen on “NetStar” if the OTA update was successful)
Status: Completed

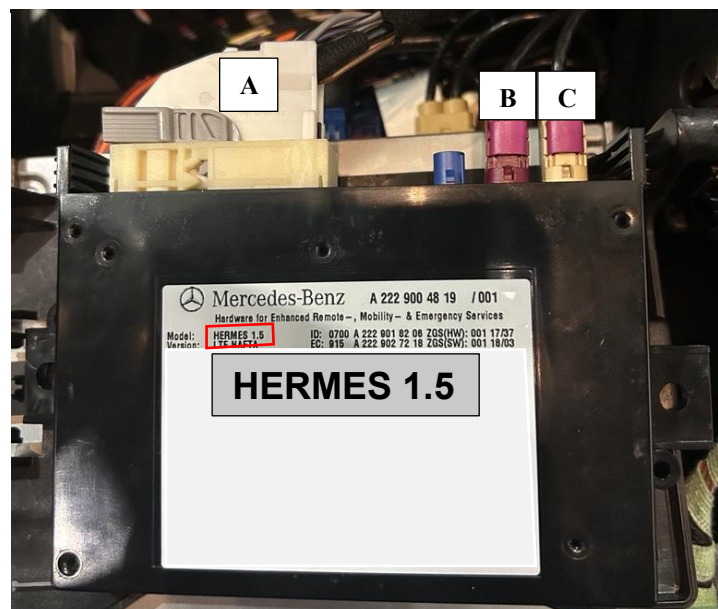
Figure 13 – HERMES 1.5 installed on 205 chassis

- 2.** Modify electrical connectors (**Figure 13, B & C**) to retrofit **HERMES v3.0 control unit (N112/9)**:

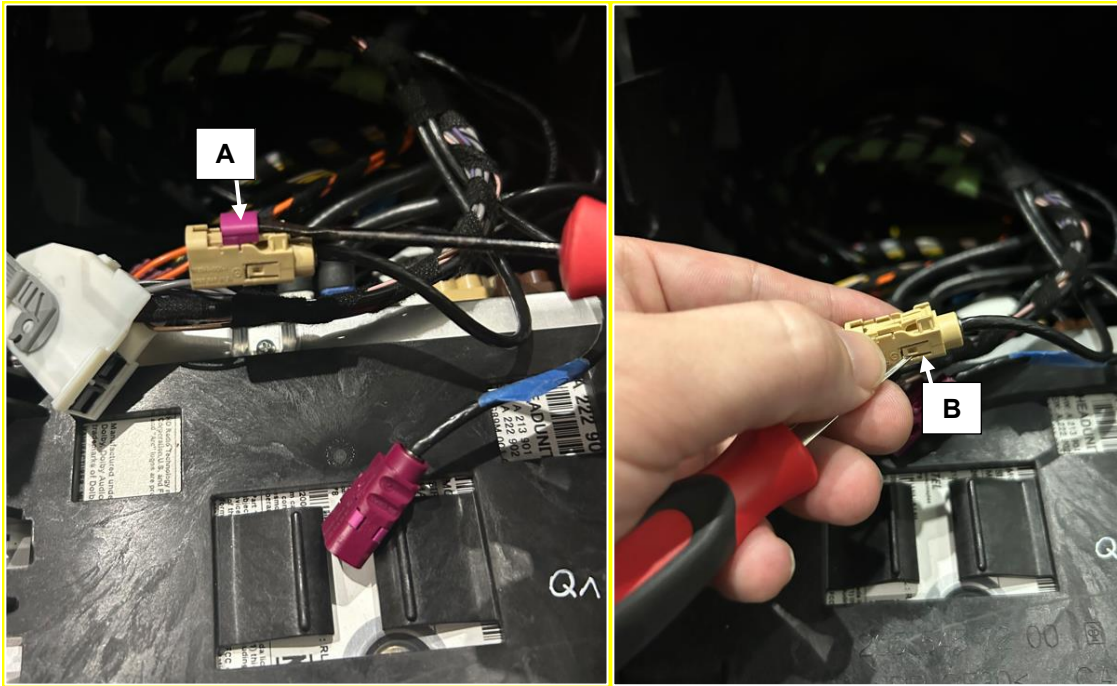
Figure 14 – shown on 205 chassis with original GSM connector housings

- 2.1** Remove antenna pins from existing GSM connector housings (**Figure 13, B & C**):
- Use a small flathead screwdriver to remove **Secondary Lock (Figure 14, A)**.
 - Use a small pick to remove the **Primary Lock (Figure 14, B)**.
- 2.2** Install both antenna pins into a single GSM connector housing (**Figure 15**).

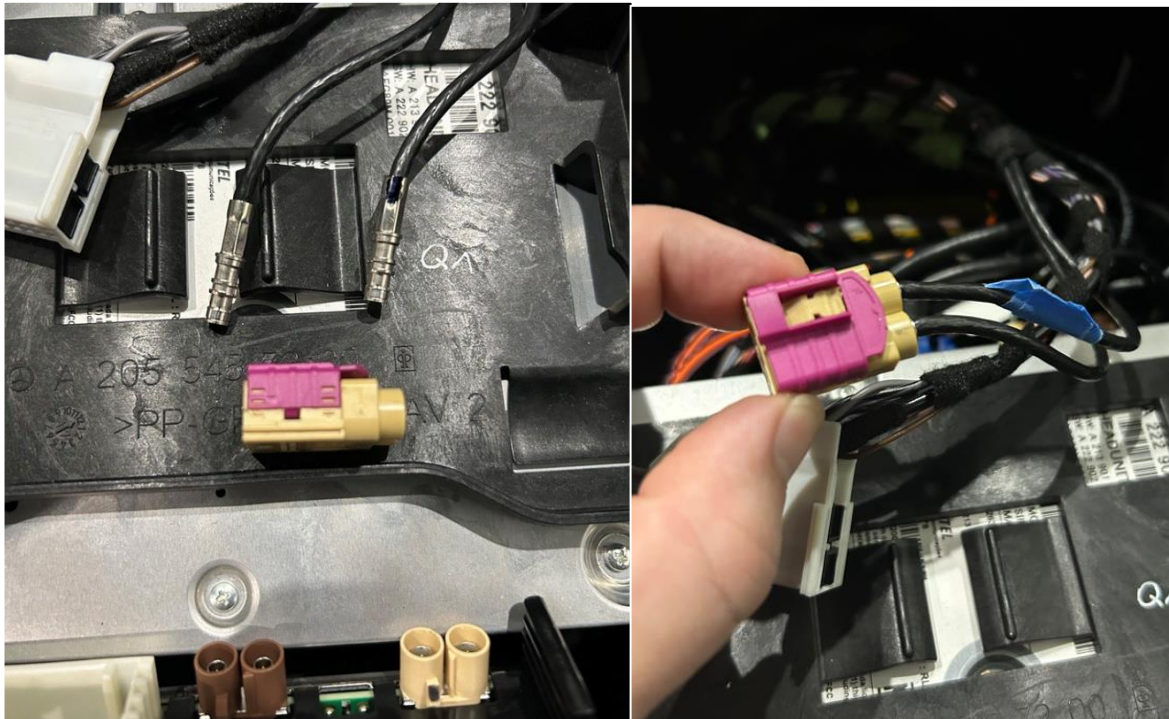
Figure 15 – shown on 205 chassis with new GSM connector housing (A 029 545 95 26)

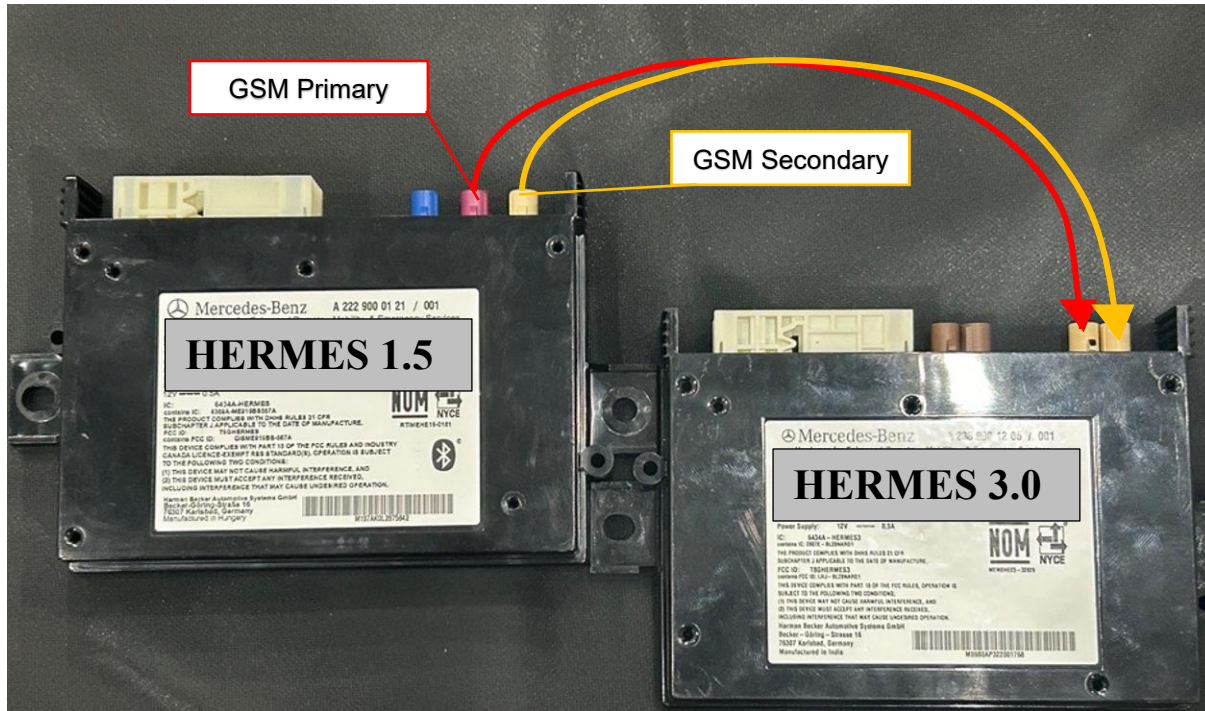
**Figure 16 – Electrical connector reference for HERMES 1.5 → HERMES 3.0**

See **Figure 16** for pin location reference guide.
