Recall Campaign Bulletin

Campaign No. 2023110006, May 2024

SUBJECT: **Various Models**
Model Year 2019 – 2022

SIM Card Communication Module – Wave 1

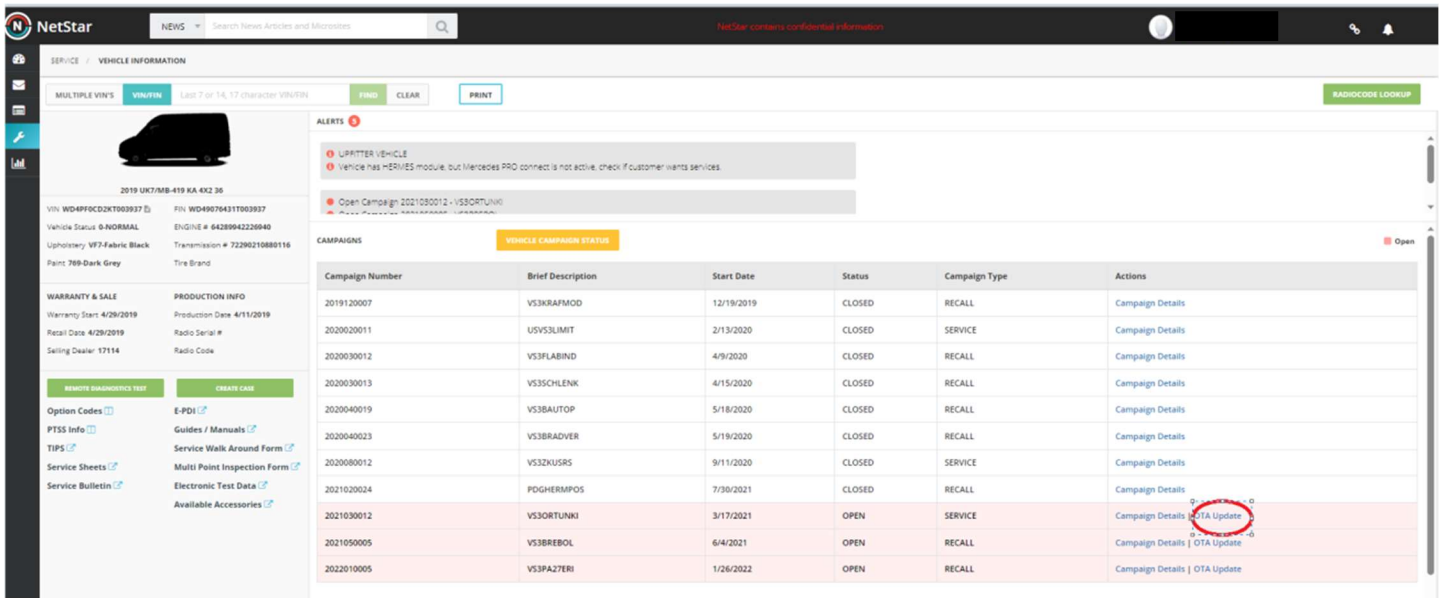
i The "OTA Update" link becomes visible in the campaign table (next to Campaign Number 2023110006) in the VMI screen when the campaign is open for the selected vehicle.

Figure 4 – In the "Actions" column, "OTA Update" is available, listed next to Campaign Number 2023110006

3. Click on the "OTA update" link (Figure 4).

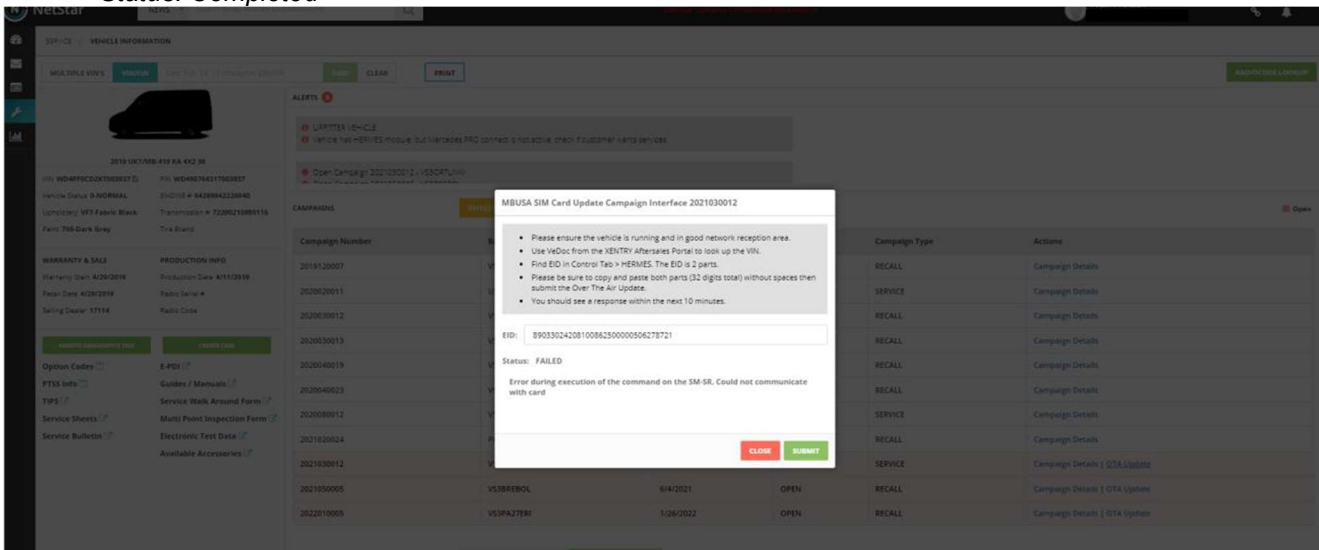
Figure 11 (screen on "NetStar" if the OTA update was not successful)
 Status: Failed – Error during execution of the command on the SM-SR. Could not communicate with card.

- If the data of the SIM card in the HERMES control unit (N112/9) is **not** updated OTA successfully after approx. 7 minutes: Carry out **Work Procedures 3 and 4**.
- If the data of the SIM card in the HERMES control unit (N112/9) is updated OTA successfully: Carry out only **Work Procedure 4**.
