# Recall Campaign Bulletin

Rev. E: February 27, 2026

CAMPAIGN NO.	2023110006
CAMPAIGN DESC.	23P5497319
NHTSA ID	22V365
SUBJECT	<b>SIM Card Communication Module – Wave 7</b>
MODEL(S)	A-Class, C-Class, CLA, CLS, E-Class, G-Class, GLA, GLB, GLC, GLE/GLS, AMG GT 4-door, S-Class, and SLC vehicles (177, 205, 117, 118, 257, 213, 238, 463, 247, 156, 253, 166, 292, 167, 290, 217, 222 and 172 platform)
MODEL YEAR(S)	2017 – 2022
CAMPAIGN POPULATION	<b>23,699</b>

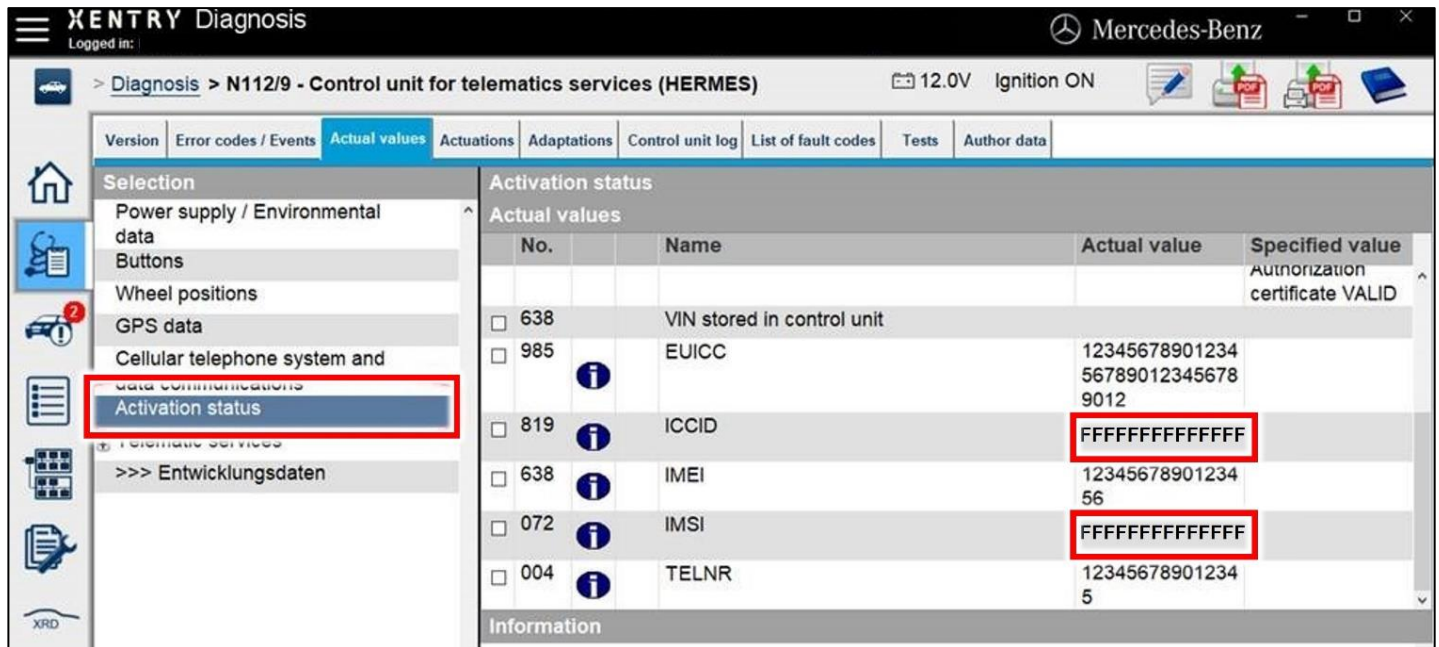
Figure 1

- If XENTRY Diagnosis displays “FFFFFFFFFFFFFF” for the “ICCID” and “IMSI” actual values (Figure 1): Carry out only **Work Procedures 3 and 4**.  
**NOTE: This must be documented in the Repair Order text!**
- If XENTRY Diagnosis “IMSI” actual value starts with “90140...” (Figure 2): **End Measure**.  
**NOTE: This must be documented in the Repair Order text!**
- If XENTRY Diagnosis “IMSI” actual value starts with “310170...”: Carry out **Work Procedures 1, 2, 3** (Work Procedure 3 is dependent on results of Work Procedure 2), **and 4**.

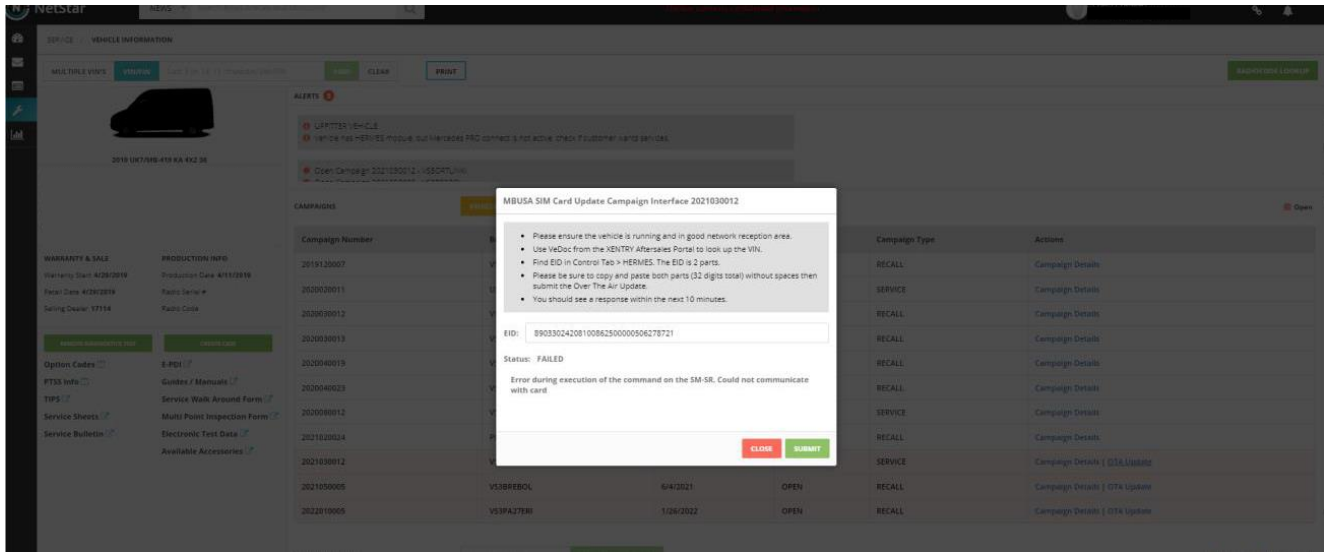
**Figure 11** (screen on “NetStar” if the OTA update was not successful)  
 Status: Failed – Error during execution of the command on the SM-SR. Could not communicate with card.

- a. The OTA procedure must be attempted a **second time if the first attempt fails**.  
 Wait at least 7 minutes after the first attempt before retrying. If the SIM Card data in HERMES control unit (N112/9) **does not update** successfully OTA after the second attempt: Perform Work Procedures 3 and 4.
- b. If the SIM Card data in HERMES control unit (N112/9) **updates** successfully OTA: Perform Work Procedure 4 only.
