# Recall Campaign Bulletin

Campaign No. 2023110006, July 2024

SUBJECT: **Various Models**  
**Model Year 2019 – 2022**

### **SIM Card Communication Module – Wave 3**

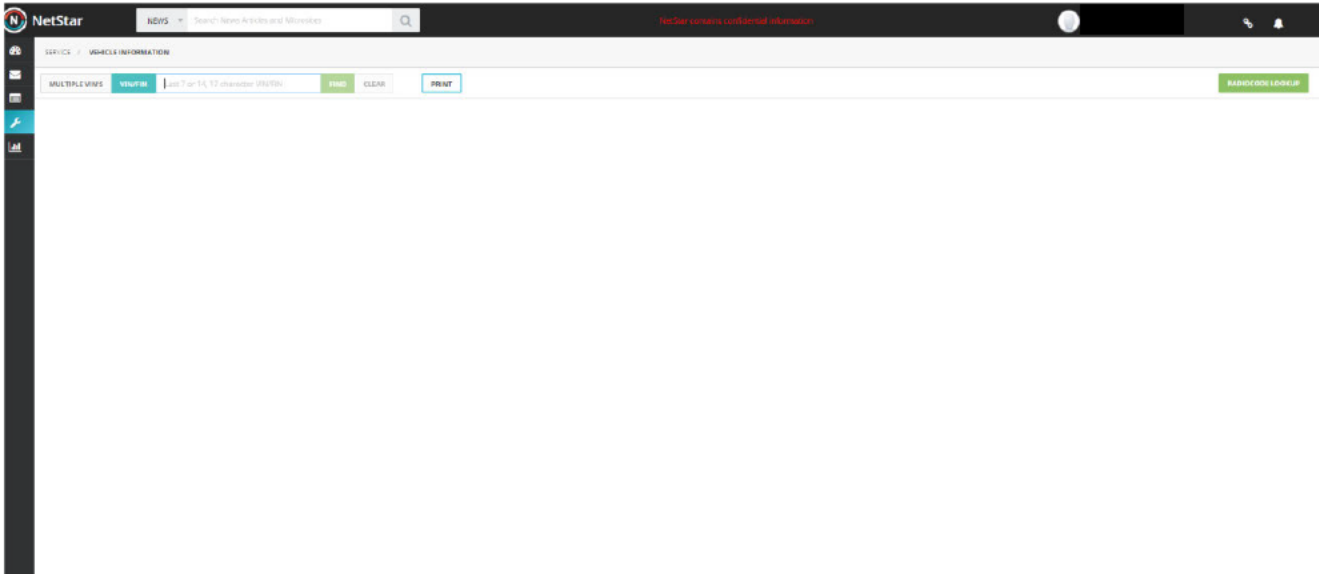
Figure 3

1. Log in to "NetStar" and call up the Vehicle Master Inquiry (VMI) screen (Figure 3).

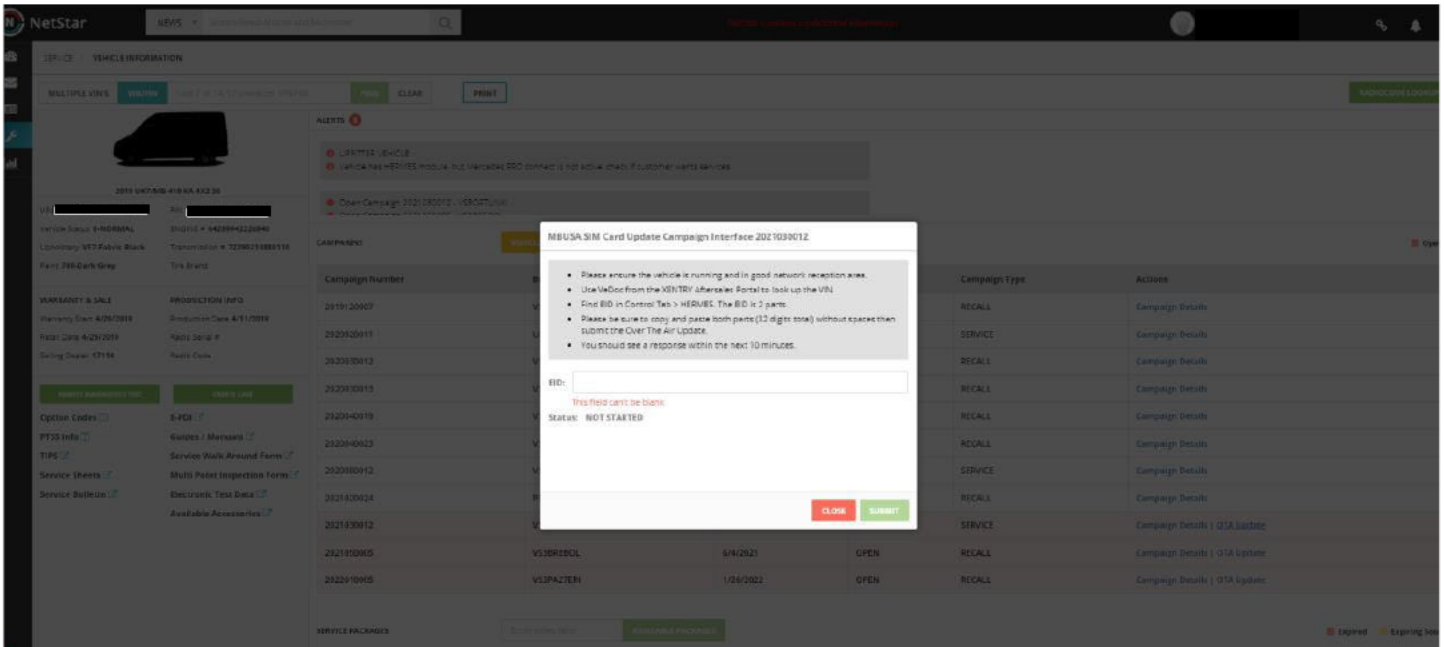
Figure 5

**i** A pop-up window requesting an EID number for the OTA update will appear (Figure 5).

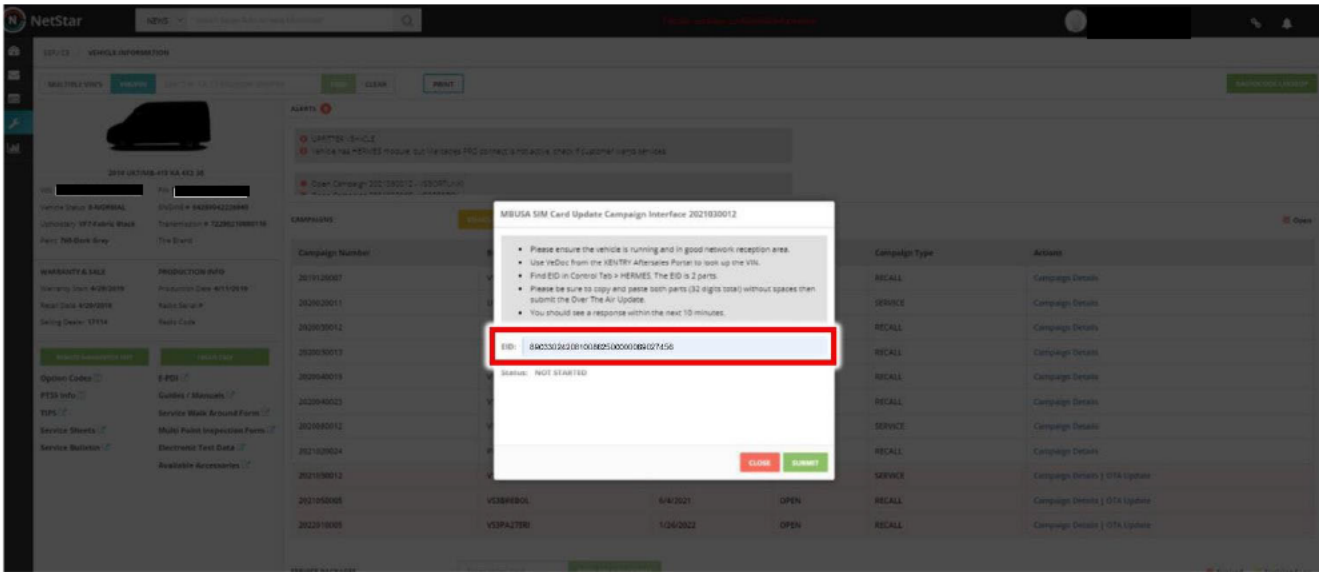
Figure 7 – EID1 + EID2 input

5. Enter the valid EID number and click on "Submit" (Figure 7).

**i** To do this, enter the **EID1 + EID2** numbers from VeDoc without spaces or special characters as shown. (e.g.: 89033024208100862500000069027456 – EXAMPLE ONLY).

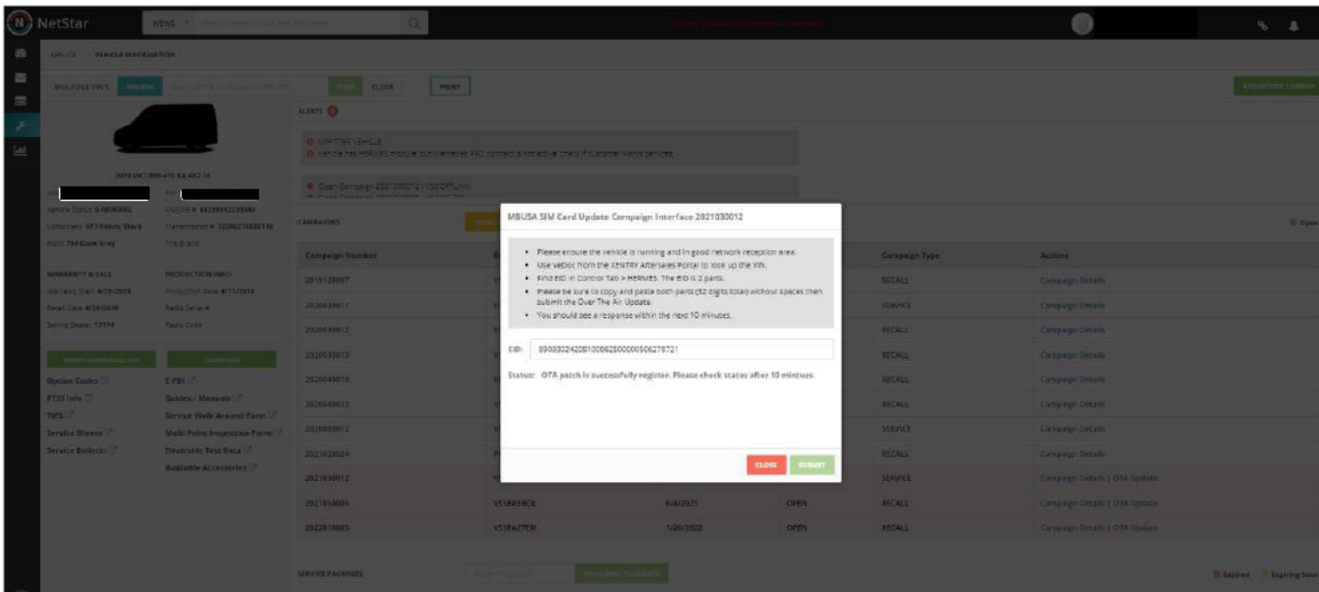
Figure 8 (screen on "NetStar" after the OTA update has been registered successfully)  
 Status: OTA patch is successfully registered. Please check status after 10 minutes

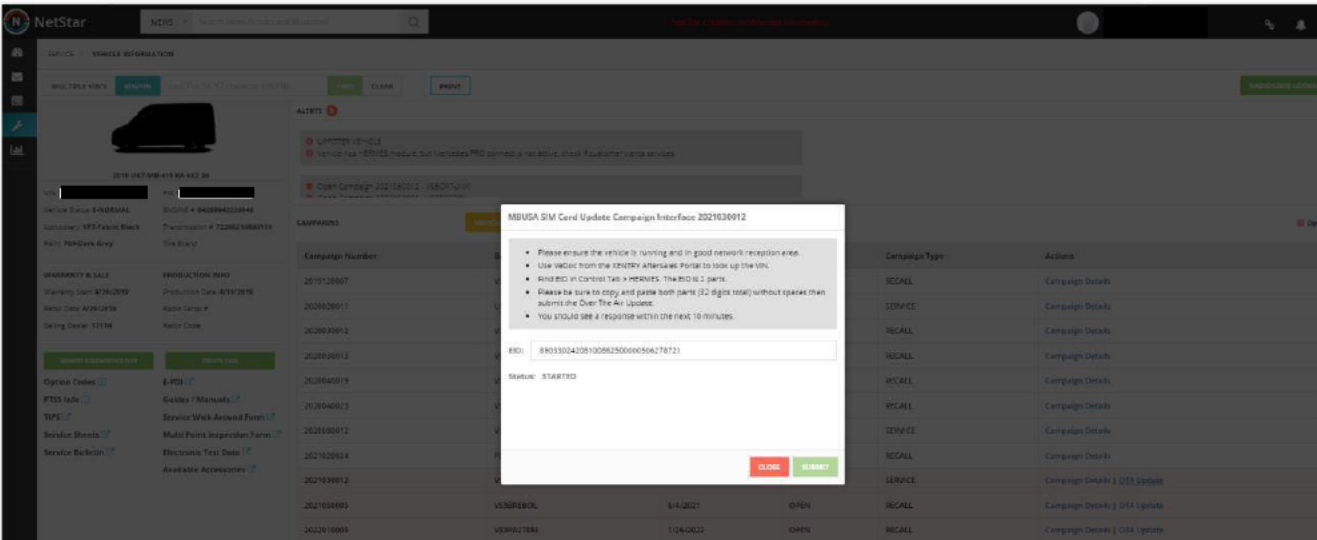
Figure 9 (screen on "NetStar" if "OTA update" is clicked again during the OTA update process)  
 Status: Started

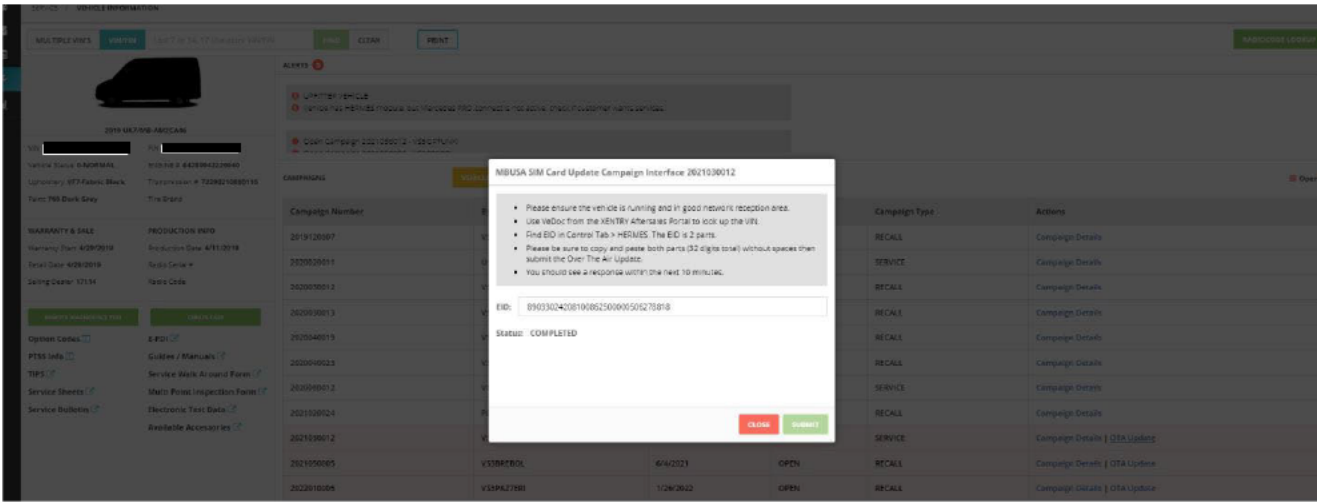
Figure 10 (screen on "NetStar" if the OTA update was successful)  
 Status: Completed

- If the data of the SIM card in the HERMES control unit (N112/9) is *not* updated OTA successfully after approx. 7 minutes: Carry out **Work Procedures 3 and 4**.
- If the data of the SIM card in the HERMES control unit (N112/9) is updated OTA successfully: Carry out only **Work Procedure 4**.

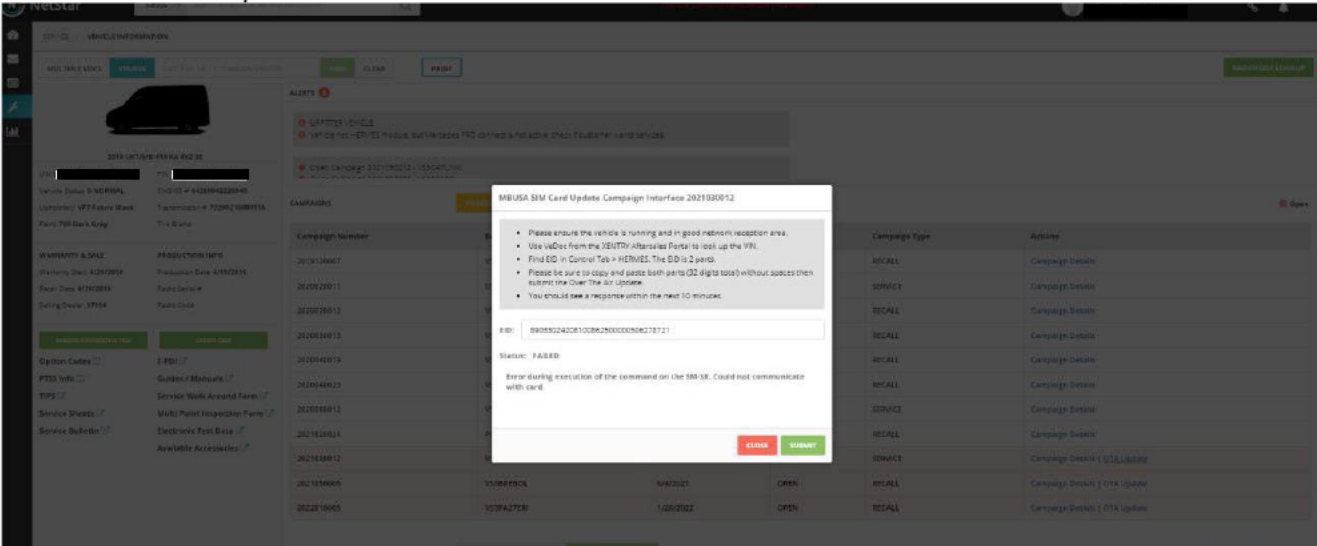
Figure 11 (screen on "NetStar" if the OTA update was not successful)  
 Status: Failed – Error during execution of the command on the SM-SR. Could not communicate with card.
