Recall Campaign Bulletin

Campaign No. 2023110006, July 2024

SUBJECT: **Various Models**
Model Year 2019 – 2022

SIM Card Communication Module – Wave 2

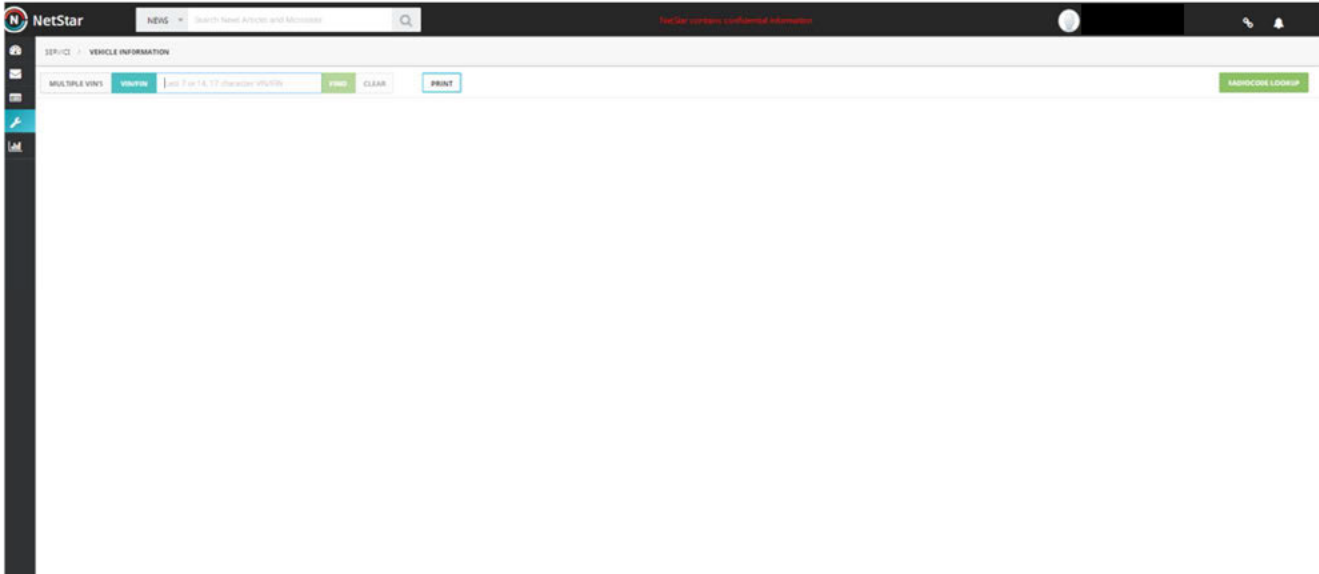
Figure 3

1. Log in to "NetStar" and call up the Vehicle Master Inquiry (VMI) screen (Figure 3).

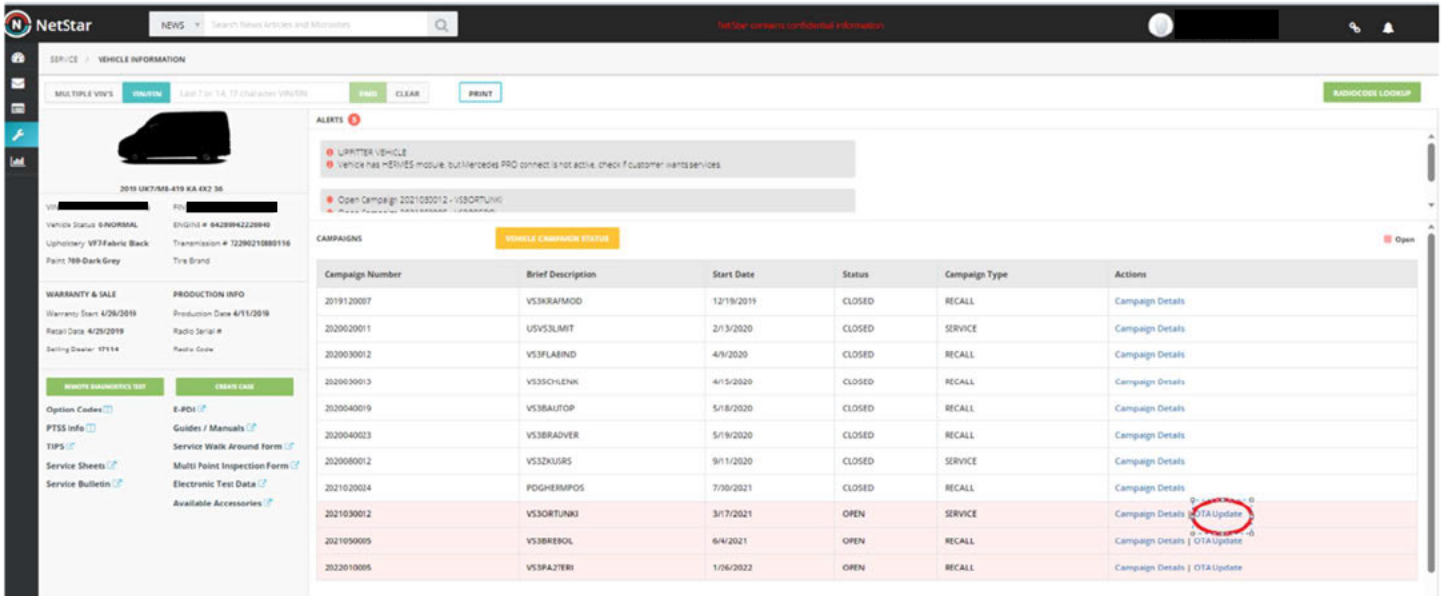
Figure 4 – In the "Actions" column, "OTA Update" is available, listed next to Campaign Number 2023110006

i The "OTA Update" link becomes visible in the campaign table (next to Campaign Number 2023110006) in the VMI screen when the campaign is open for the selected vehicle.

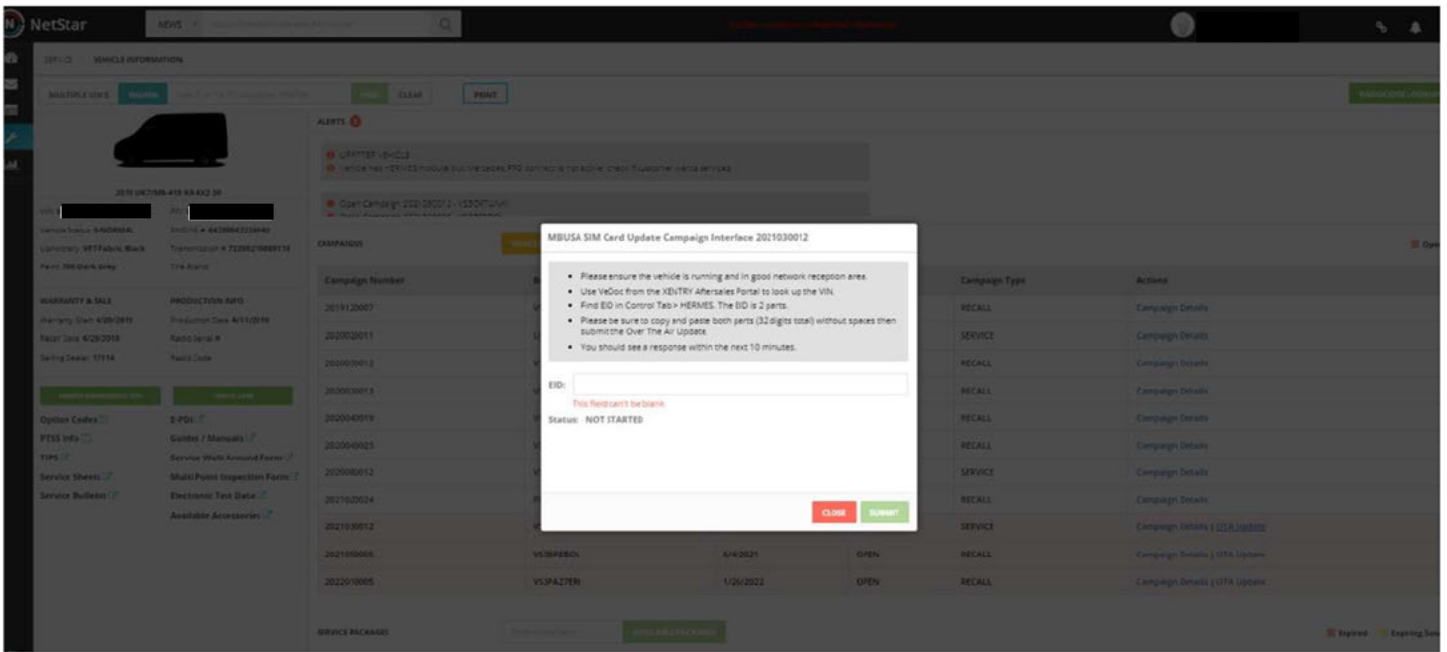
Figure 5

i A pop-up window requesting an EID number for the OTA update will appear (Figure 5).

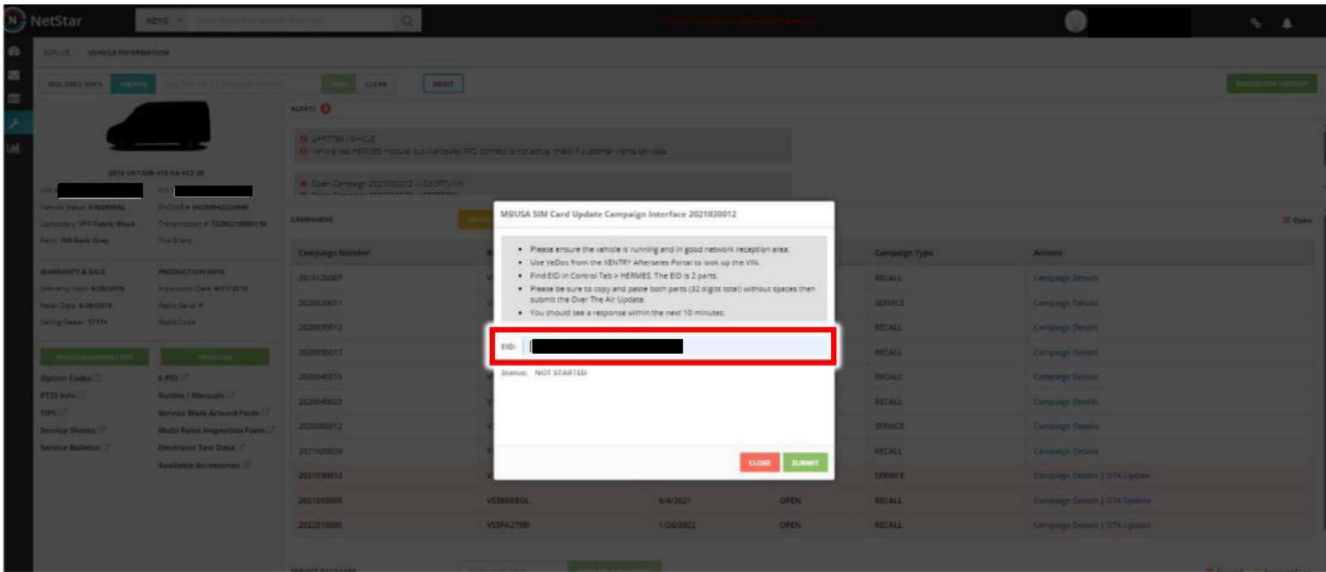
Figure 7 – EID1 + EID2 input

i To do this, enter the **EID1 + EID2** numbers from VeDoc without spaces or special characters as shown. (e.g.: 89033024208100862500000069027456 – EXAMPLE ONLY).

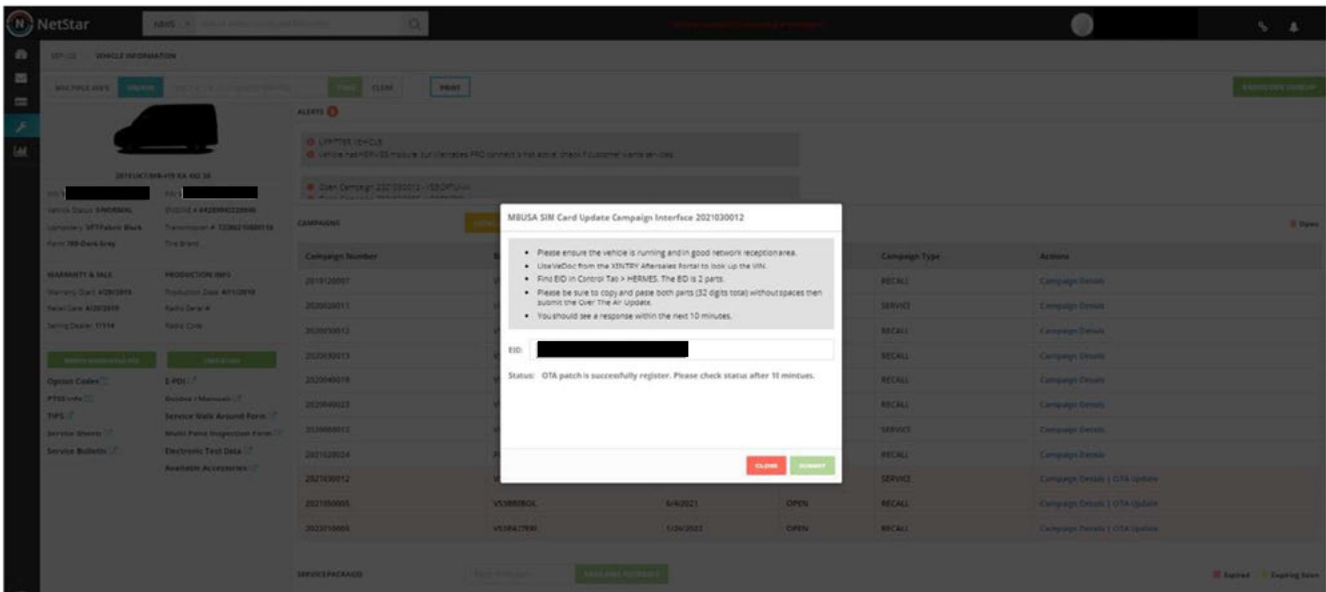
Figure 8 (screen on "NetStar" after the OTA update has been registered successfully)
Status: OTA patch is successfully registered. Please check status after 10 minutes

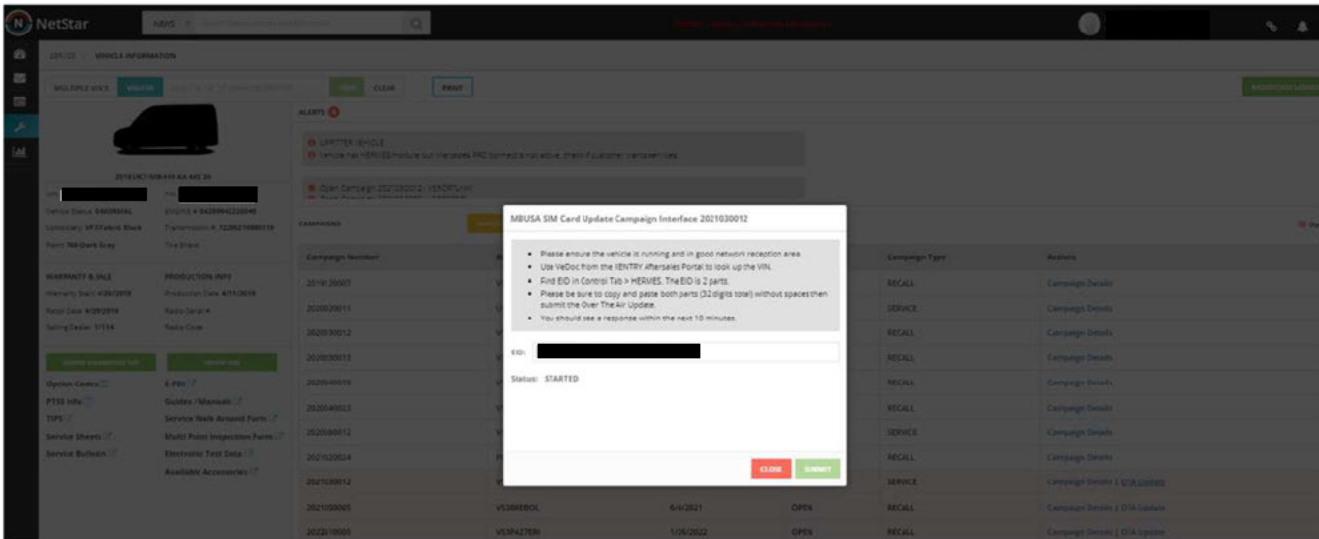
Figure 9 (screen on "NetStar" if "OTA update" is clicked again during the OTA update process)
 Status: Started

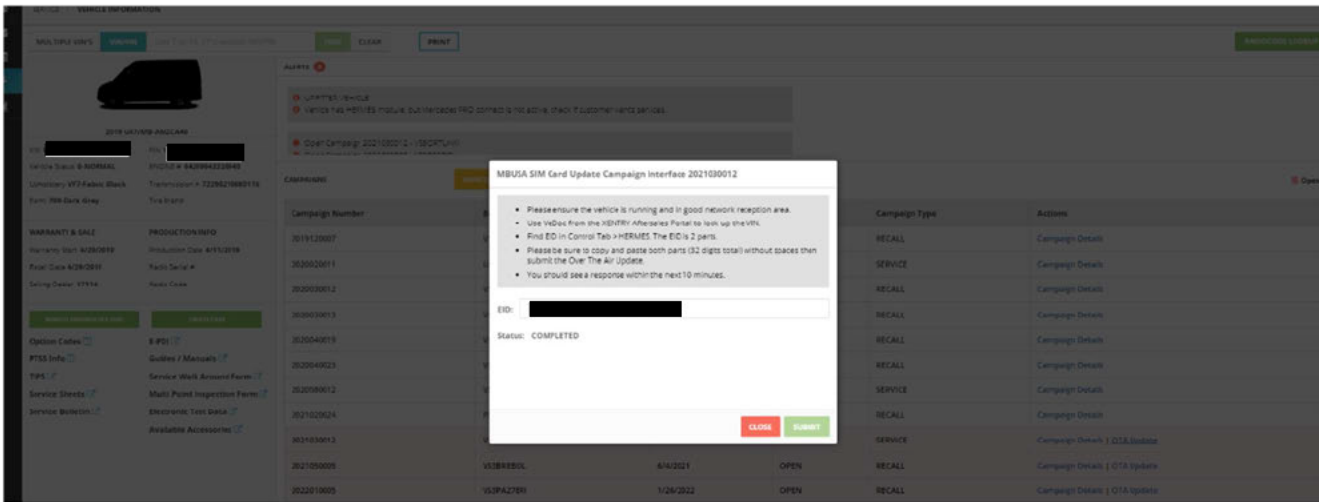
Figure 10 (screen on "NetStar" if the OTA update was successful)
 Status: Completed

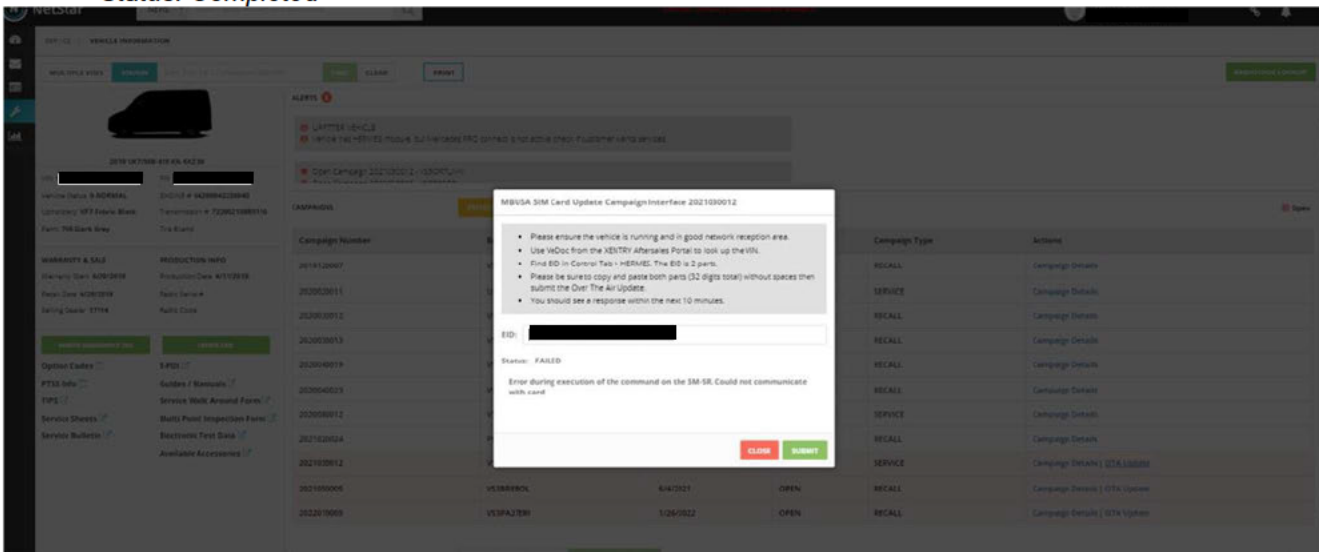
Figure 11 (screen on "NetStar" if the OTA update was not successful)
 Status: Failed – Error during execution of the command on the SM-SR. Could not communicate with card.

- If the data of the SIM card in the HERMES control unit (N112/9) is *not* updated OTA successfully after approx. 7 minutes: Carry out **Work Procedures 3 and 4**.
- If the data of the SIM card in the HERMES control unit (N112/9) is updated OTA successfully: Carry out only **Work Procedure 4**.
