RECALL 22V381. 2022-277 REMEDY INSTRUCTIONS

Make(s): BERKSHIRE
Model(s): MANY, SEE LIST
Model Year(s): 2021 - 2022

Concern:

An incorrect circuit breaker may have been installed in the vehicles' house distribution subpanel which does not allow the internal spring retention mechanism to properly contact the subpanel.

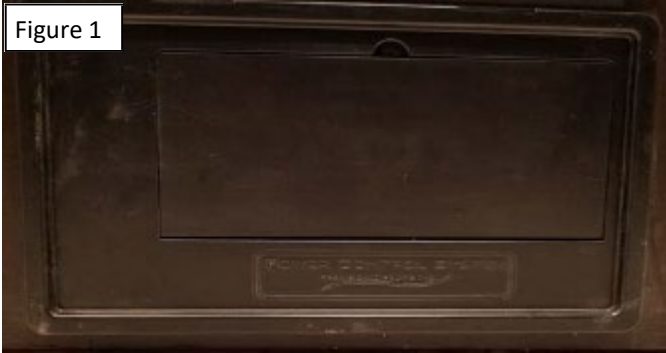
Figure 1

STEP 1: LOCATE THE SERVICE PANEL (FIGURE 1);

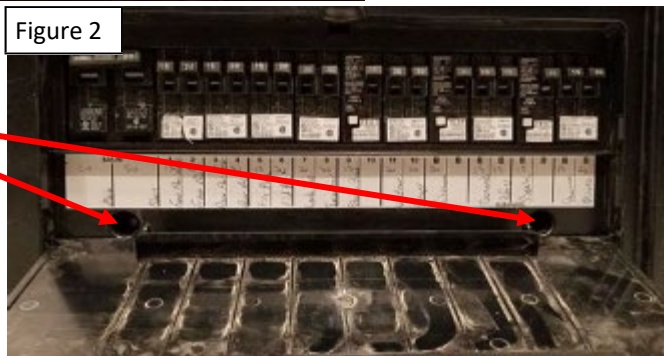
Figure 2

STEP 2: REMOVE THE COVER AND PULL DOWN THE LID AND REMOVE THE TWO (2) SCREWS (FIGURE 2);

PULL DOWN LID
AND REMOVE
TWO SCREWS.

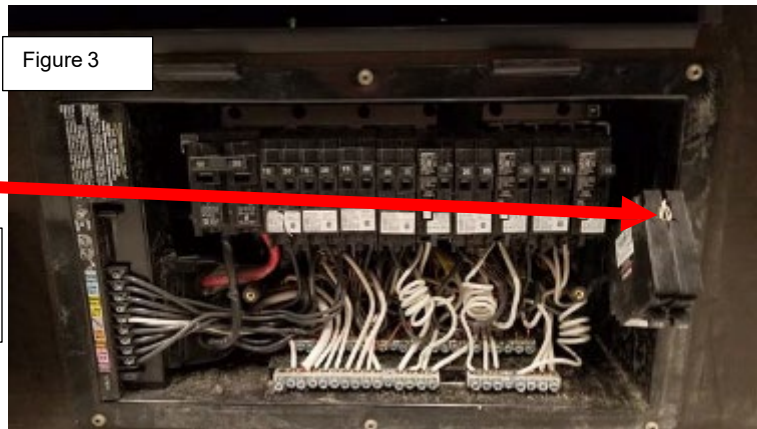
Figure 3

STEP 3: LOCATE THE BREAKER ON THE FAR RIGHT OF THE SERVICE PANEL (FIGURE 3);

PULL BREAKER
ON FAR RIGHT
OF THE PANEL.

STEP 5: DISCONNECT THE BLACK WIRE(S) FROM THE BREAKER:

- NOTE WHICH WIRE IS ON THE 15AMP SIDE OF THE BREAKER;
- WRAP A TWO INCH (2") LENGTH OF TAPE AROUND THE WIRE FEEDING THE 15AMP SIDE OF THE BREAKER;
- DISCONNECT BOTH WIRES FROM THE BREAKER;
- PULL THE BREAKER OUT OF THE SUB-PANEL BOX AND DISCARD;

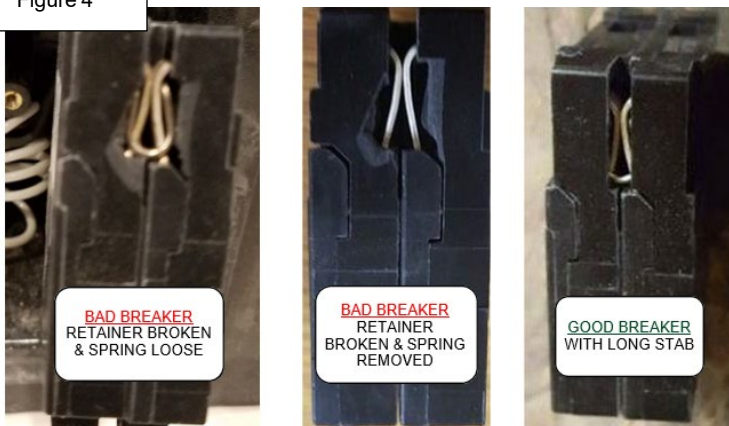
Figure 4

STEP 4: INSPECT THE BREAKER PER FIGURE 4, IF IT IS BROKE OR BAD, PROCEED WITH REMEDY. IF BREAK IS GOOD, CLAIM INSPECTION CODE.

BAD BREAKER
RETAINER BROKEN
& SPRING LOOSE

BAD BREAKER
RETAINER
BROKEN & SPRING
REMOVED

GOOD BREAKER
WITH LONG STAB

STEP 6: INSTALL REPLACEMENT BREAKER – Q1520NC INTO THE SUB-PANEL BOX:

- INSTALL THE WIRE WITH THE COLORED TAPE INTO THE 15AMP SIDE OF THE BREAKER LUG;
- INSTALL THE OTHER WIRE TO THE 20AMP SIDE OF THE BREAKER LUG;
- ENSURE BOTH 15AMP AND 20AMP LUGS ARE TIGHTLY SECURED AND DO NOT ALLOW WIRE MOVEMENT;
- TAKE A PHOTO OF NEWLY INSTALLED BREAKER;
