SUBJECT: RM Fan Housing Bolt Torque

DATE: 08/23/2022

NUMBER: SB-0243a

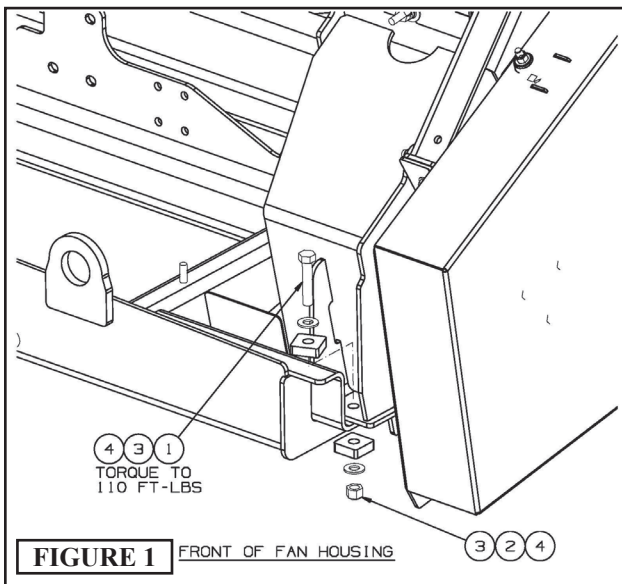
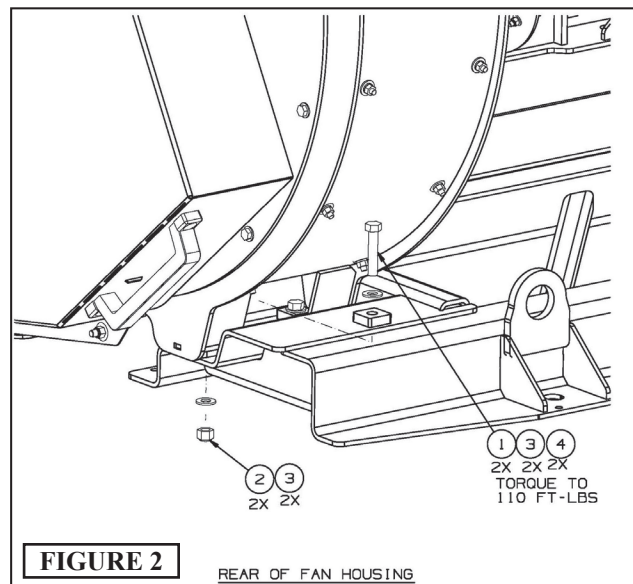
Certain RM (RegenX) sweepers may have Fan Housing Bolts that are improperly tensioned. FSO 1140232 must be installed on all affected sweepers.

FSO 1140232 provides parts and instructions to update the Fan Housing Assembly Retention. Grade 5 hardware is replaced with new Grade 8 hardware and new spacers must be installed. Bolts must be tightened to 110 lb-ft.

1. Order FSO 1140232 for all affected units.
2. Install FSO 1140232 as instructed in the drawing supplied with the kit. (reference FIGURES 1&2)

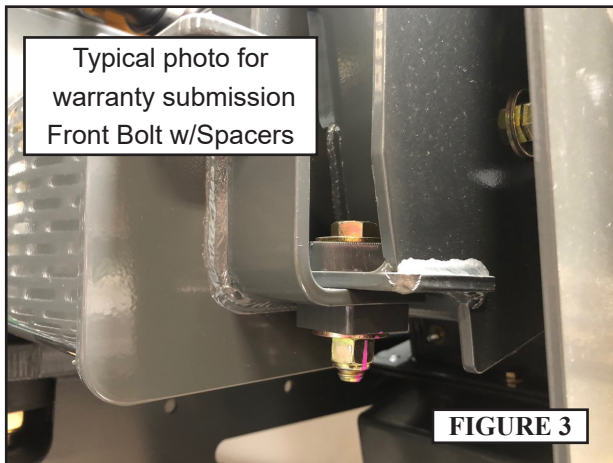
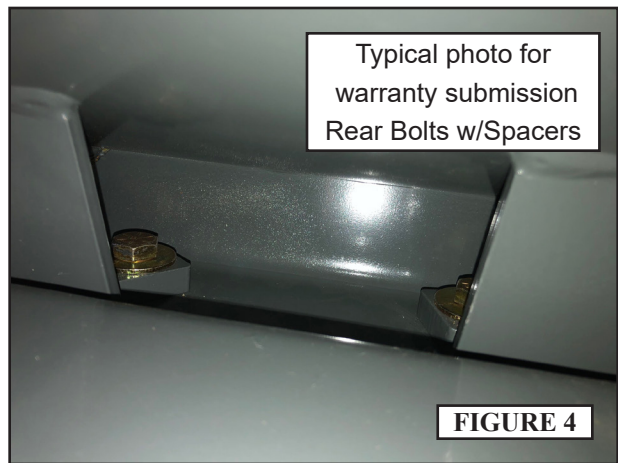
Submission must include photo of the completed installation for each unit. See typical photos (FIGURES 3 and 4).
