SUBJECT: RM Fan Housing Bolt Torque

DATE: 06/08/2022

NUMBER: SB-0243

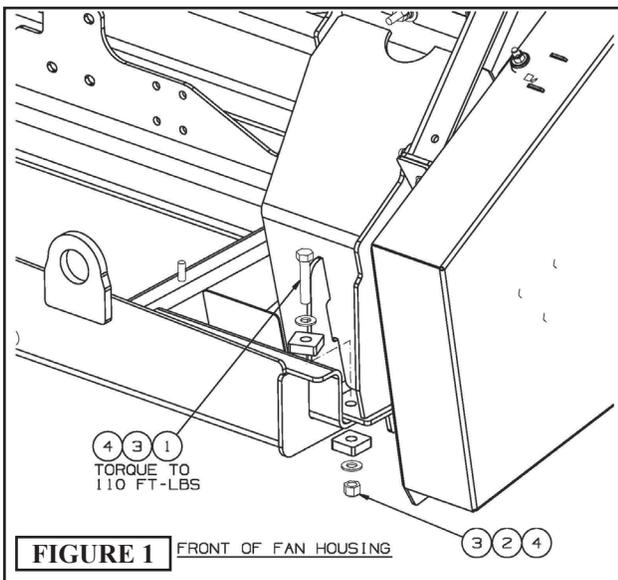
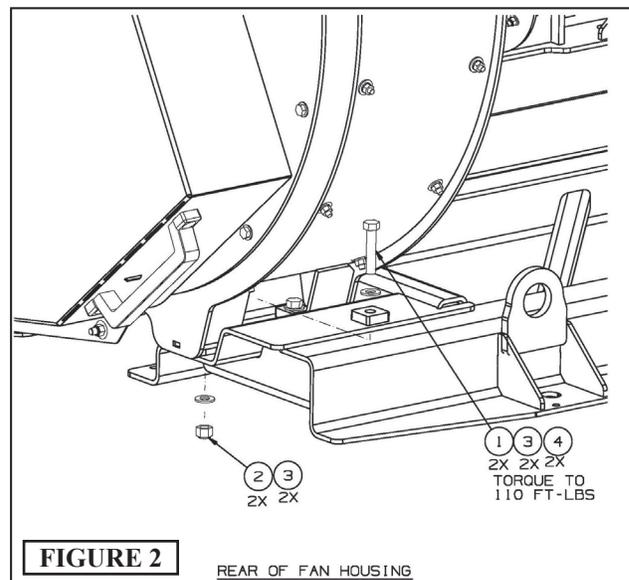
Certain RM (RegenX) sweepers may have Fan Housing Bolts that are improperly tensioned. FSO 1140232 must be installed on all affected sweepers.

FSO 1140232 provides parts and instructions to update the Fan Housing Assembly Retention. Grade 5 hardware is replaced with new Grade 8 hardware and new spacers must be installed. Bolts must be tightened to 110 lb-ft.

1. Order FSO 1140232 for all affected units.
2. Install FSO 1140232 as instructed in the drawing supplied with the kit. (reference FIGURES 1&2)
