L62X-R.03.22

Campaign name:Incorrect bowden cable assembly**Model:**Huracan EVO, Huracan STO**Model Year:**2022**Limited or special editions:**All**Markets:**Australia, Austria, Belgium, Canada, Germany, Italy, Portugal, Romania, Singapore, UK, USA.**VIN Identification:**From 20090 to 20306

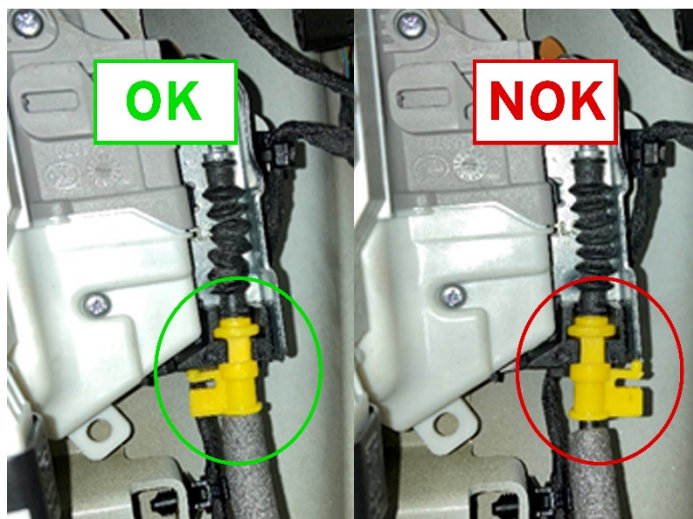
I. Left door bowden cable clip check

- Check if the yellow clip securing the bowden cable on the door opening mechanism is rotated toward the inside of the panel and clicked in its housing (green OK on figure).
 - If the yellow bowden cable fixing clip on the door opening mechanism is facing the inside of the door panel and correctly clicked in its housing (**green OK** on figure) → this campaign is not necessary for this vehicle, please execute the steps indicated by the **OPTION A**.
 - If the yellow bowden cable fixing clip on the door opening mechanism is facing the outside of the door panel and it is not clicked in its housing (**red NOK** on figure) → please execute the steps indicated by the **OPTION B**.
