# Campaign Service

**BULLETIN NUMBER:**  
CB22-N-001

## IMPORTANT SAFETY RECALL

### MIS-WIRED ENGINE OIL PRESSURE SENSOR (V2202) – 22V-TBD Transport Canada 2022-TBD

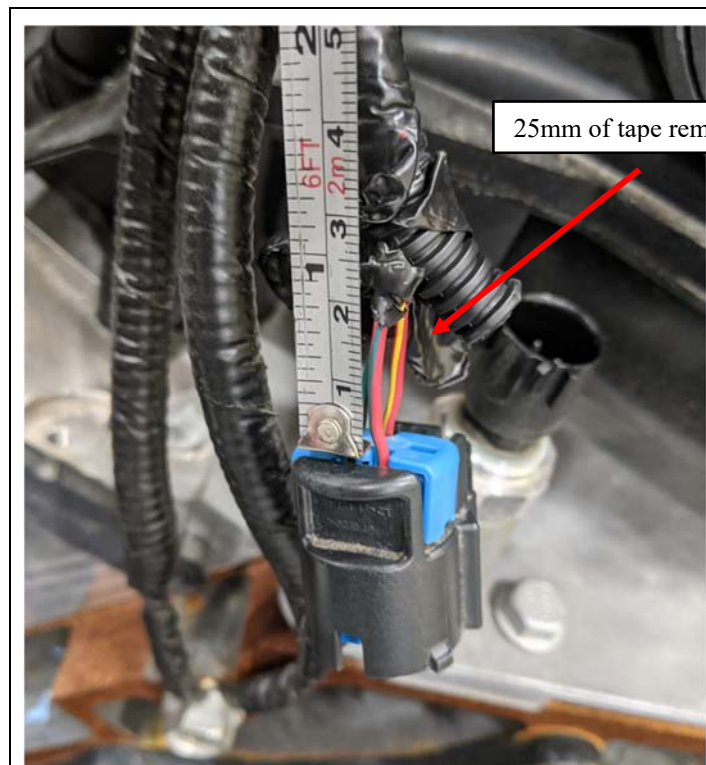
**Figure 3**

25mm of tape removed

4. Remove the connector E-104 from the oil pressure sensor by squeezing the lock tab and pulling upwards.
5. Remove the tape from the plastic conduit around the wires to the E-104 connector about 30mm up from the connector. Remove the wires from the conduit.
6. Remove the tape from the wires about 25mm up from the E-104 connector. (See Figure 3.)

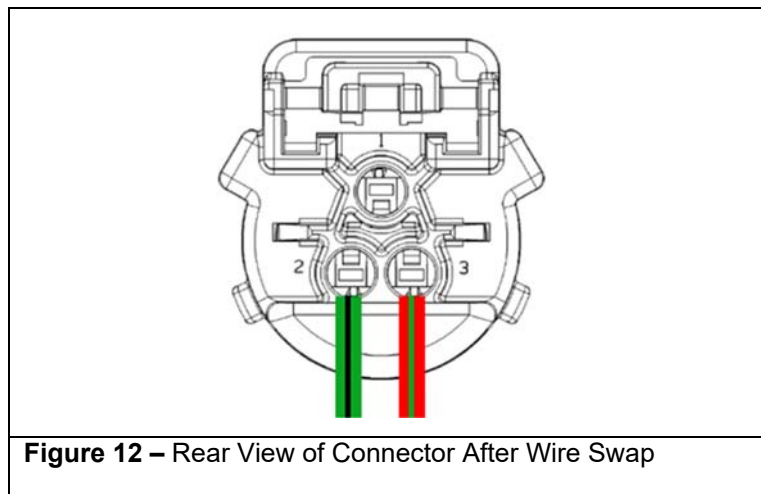
**Figure 12 – Rear View of Connector After Wire Swap**

Isuzu Motors Limited has decided that a defect exists in certain 2022 model year Isuzu NQR and NRR trucks (equipped with 6.0L gasoline engines) built before November 3, 2021. In the affected vehicles, the engine wiring harness assembly was incorrectly wired at the pinout connector for the oil pressure sensor. The ECM (and a technician's scan tool) will not detect the condition for low oil pressure and will always perceive the pressure to be at 126 PSI. If the oil pressure drops below a certain level, the engine oil pressure telltale will not illuminate to indicate low pressure. If the engine oil pressure is low, the defect will mask the warning to the driver or consumer, who may continue to operate the vehicles with a low engine oil pressure. If the engine continues to operate at a low engine oil pressure, it could damage the engine or its components and could cause the engine to seize and stall without prior warning. A seized engine can result in vehicle stalling and increase the risk of a crash.

11. Swap the wires of Terminals 2 and 3. Insert each wire into the proper hole with the metal terminal orientated the same way as it came out in Step 10. (See Figure 12.) Ensure that each metal terminal fully engages under each lock arm and that the rubber seal is completely seated into the connector.
12. Inspect the rear of the connector to ensure that the wires of Terminals 2 and 3 are now in the correct locations as shown in Figure 12.
