VOLUNTARY RECALL CAMPAIGN

Classification: AT22-007A	Reference: NTB22-064A	Date: February 9, 2023
------------------------------	--------------------------	---------------------------

VOLUNTARY SAFETY RECALL CAMPAIGN 2020-2022 FRONTIER, TITAN/TITAN XD 4WD; TRANSMISSION PARKING PAWL PIN

CAMPAIGN ID #: R22A1
APPLIED VEHICLES: 2020-2021 Frontier (D40) 4WD
2022 Frontier (D41) 4WD
2020-2022 Titan and Titan XD (A61) 4WD

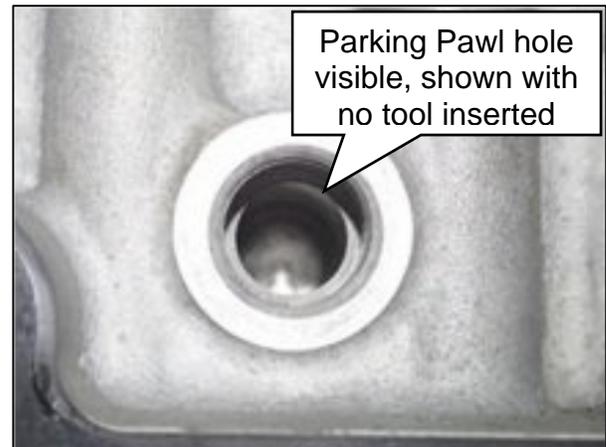
Figure 12

- If the Parking Pawl hole is fully visible as shown in Figure 12, skip to step 21 on page 12 for **Parking Pawl Pin Installation**.

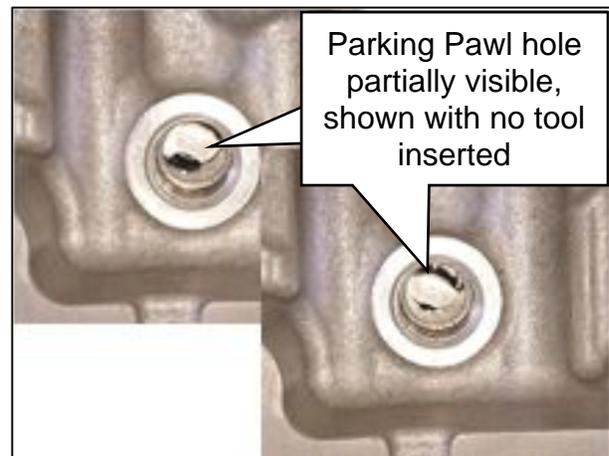
Figure 13

- If the Parking Pawl hole is partially visible as shown in Figure 13, the Parking Pawl may have moved out of position. Continue to step 16 on page 9 for **Parking Pawl Position Alignment**.

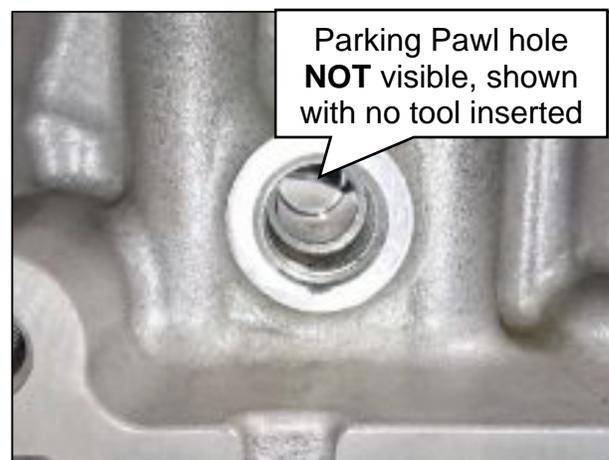
Figure 14

- If the Parking Pawl hole is **NOT** visible as shown in Figure 14, the Parking Pawl may have moved out of position. Continue to step 15 on page 9 for **Parking Pawl Position Alignment**.

15. Use a small magnetic rod to raise the Parking Pawl until the Parking Pawl hole is visible.
 - If the Parking Pawl hole is visible after raising it with a magnetic rod, continue to step 16.
 - If the Parking Pawl hole is NOT visible after multiple attempts, skip to 17 on page 10 for **Parking Pawl Position Recovery**.

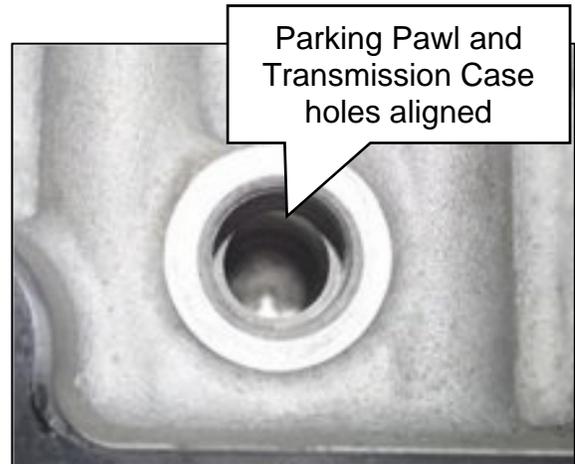
Figure 17

- Remove the Phillips head screwdriver and verify the Parking Pawl and the Transmission Case holes are aligned, as shown in Figure 17.
- If the Parking Pawl and the Transmission Case holes are aligned, as shown in Figure 17, skip to step 21 on page 12 for **Parking Pawl Pin Installation**.
- If the Parking Pawl and the Transmission Case holes are NOT aligned, as shown in Figure 13 and Figure 14 on page 8, continue to step 17 for **Parking Pawl Position Recovery**.
