HYUNDAI Technical Service Bulletin	GROUP RECALL	NUMBER 23-01-024H
	DATE MARCH 2023	MODEL(S) IONIQ HYBRID (AE HEV) IONIQ PLUG-IN (AE PHEV)
SUBJECT: IONIQ HEV/PHEV MAIN RELAY / POWER RELAY ASSY INSPECTION / REPLACEMENT (RECALL CAMPAIGN 232)

Description: The subject vehicles may not have received the proper remedy components under Recall 178, a safety recall addressing an electrical pin fit condition on the main relays within the PRA that, if continually operated in this condition, could increase electrical resistance thereby generating heat and increasing the risk of a fire.

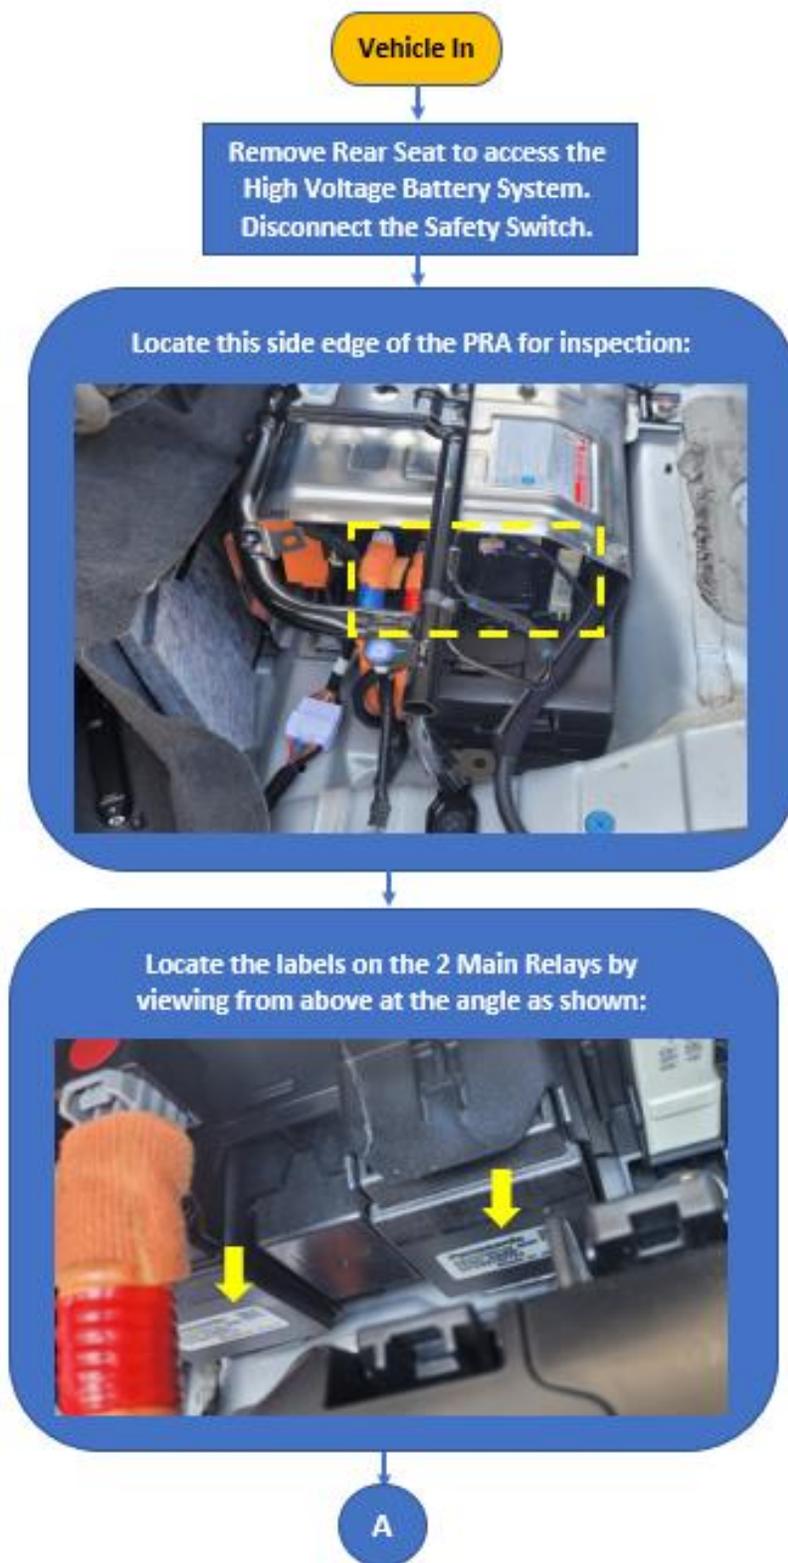
Some vehicles may not have their main relay labels visible due to a more recently installed battery pack, resulting in the PRA cover that is not removable. A PRA where the cover is not removable has the latest labels enclosed with 'Panasonic'.
