SAFETY RECALL BULLETIN

SUBJECT:			No: SR-22-003
IMPROPER OPERATION OF AUDIO UNIT – SAFETY RECALL CAMPAIGN			DATE: July 2022
			MODEL: 2022 Outlander
CIRCULATE TO:	<input checked="" type="checkbox"/> GENERAL MANAGER	<input checked="" type="checkbox"/> PARTS MANAGER	<input checked="" type="checkbox"/> TECHNICIAN
<input checked="" type="checkbox"/> SERVICE ADVISOR	<input checked="" type="checkbox"/> SERVICE MANAGER	<input checked="" type="checkbox"/> WARRANTY PROCESSOR	<input checked="" type="checkbox"/> SALES MANAGER

This Campaign Bulletin provides instructions to reprogram the In Vehicle Infotainment (IVI) system with modified software.

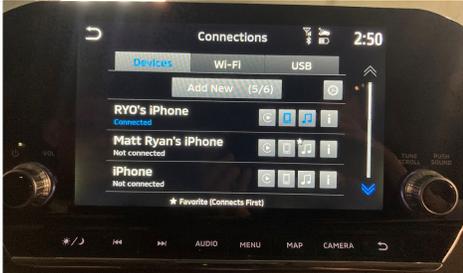
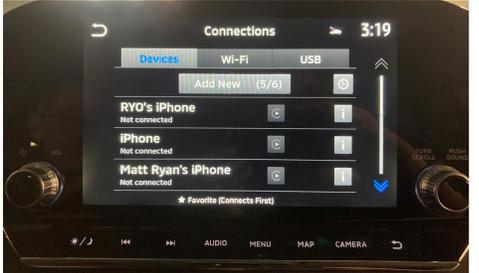
Impacted pre-sets item	Before IVI update	After IVI update
<p>#1 Bluetooth devices stored, Wi-Fi stored</p>

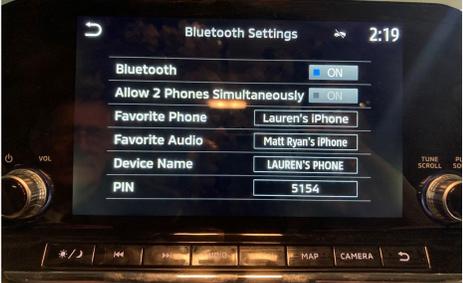
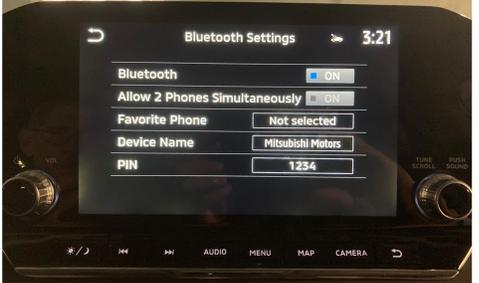
<p>#2 Favorite Phone, Favorite Audio, Device Name and PIN in the Bluetooth Settings</p>

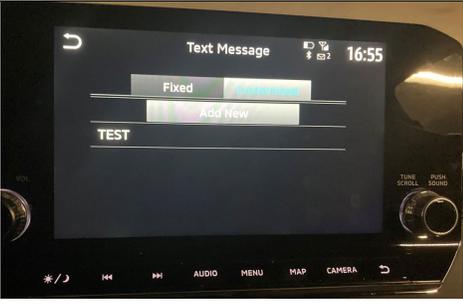
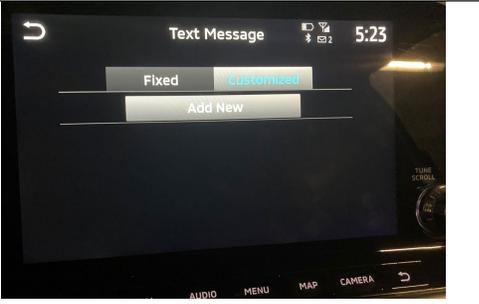
<p>#3 Quick dial and Customize text message</p>

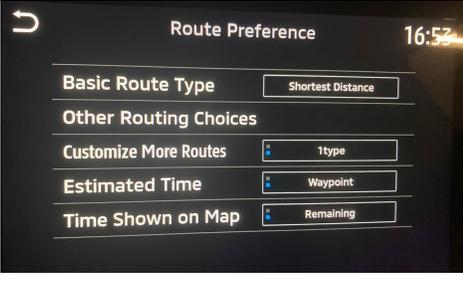
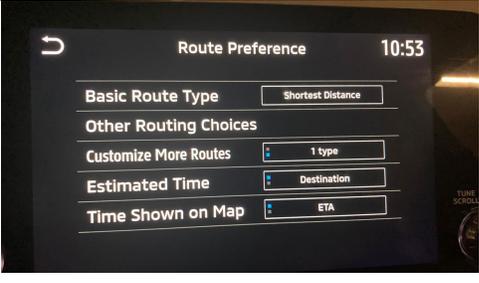
<p><Note> Registered Quick dial will be lost.</p>
<p>#4 Estimated Time and Time Shown on Map settings in Navigation Route Preference (returns to default)</p>

<p><Note> Registered route is retained. No impact to 8' screen without map data.</p>
