PRODUCT CAMPAIGN BULLETIN

APPLICABILITY: 2019-20MY Ascent
 2021MY Legacy 2.4L (turbo models)
 2021MY Outback 2.4L (turbo models)
SUBJECT: CVT Chain Guide Breakage

NUMBER: WRK-21/22R

DATE: 07/05/22

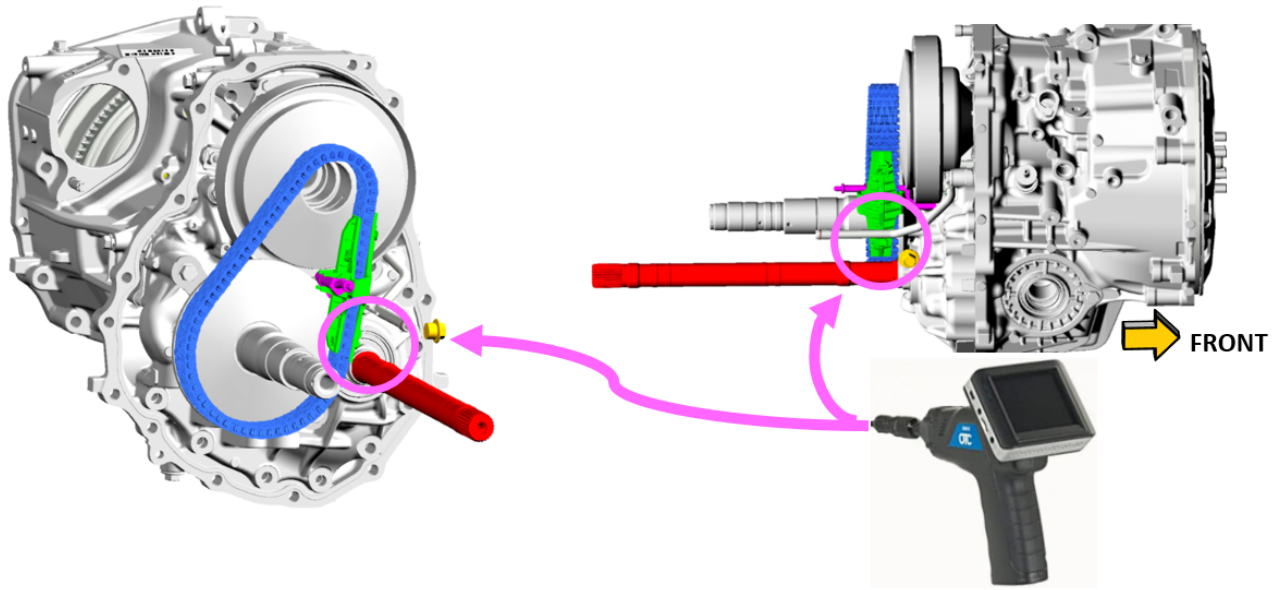
STEP 3E: Inspect the position of the lower end of the chain guide rail and the drive pinion shaft.
