TECHNICAL INSTRUCTIONS
FOR
SAFETY (NONCOMPLIANCE) RECALL 22TA07

**Panoramic View Monitor System – Potential Failure to Display Rearview
Image**

Certain 2022 Model Year Tundra + Tundra HV

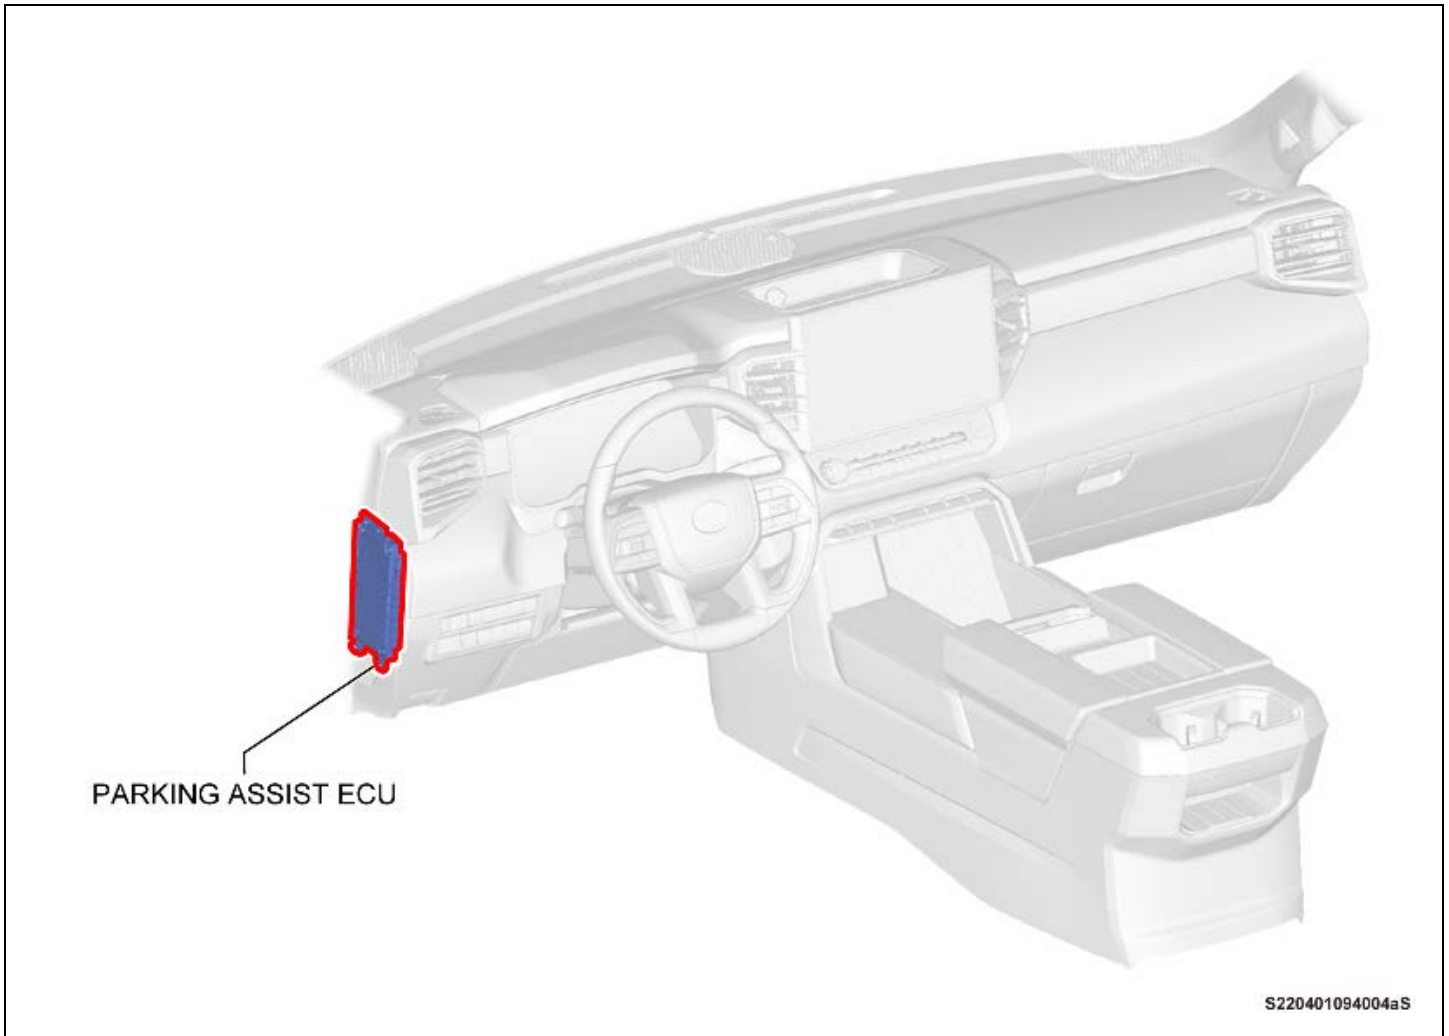
- b. In the affected vehicles, a software programming issue can cause the front camera image of the Panoramic View Monitoring (PVM) system to display instead of the rear camera image when the vehicle is placed into reverse position. If the rear camera image does not display after the vehicle is placed into reverse position, the vehicle will not comply with certain U.S. safety requirements and may increase the risk of a crash during a backing event.
