PRODUCT CAMPAIGN BULLETIN

APPLICABILITY: 2015-2021 MY WRX STI

NUMBER: WRE-22

SUBJECT: Safety Recall – Back-Up Lamp Switch Failure

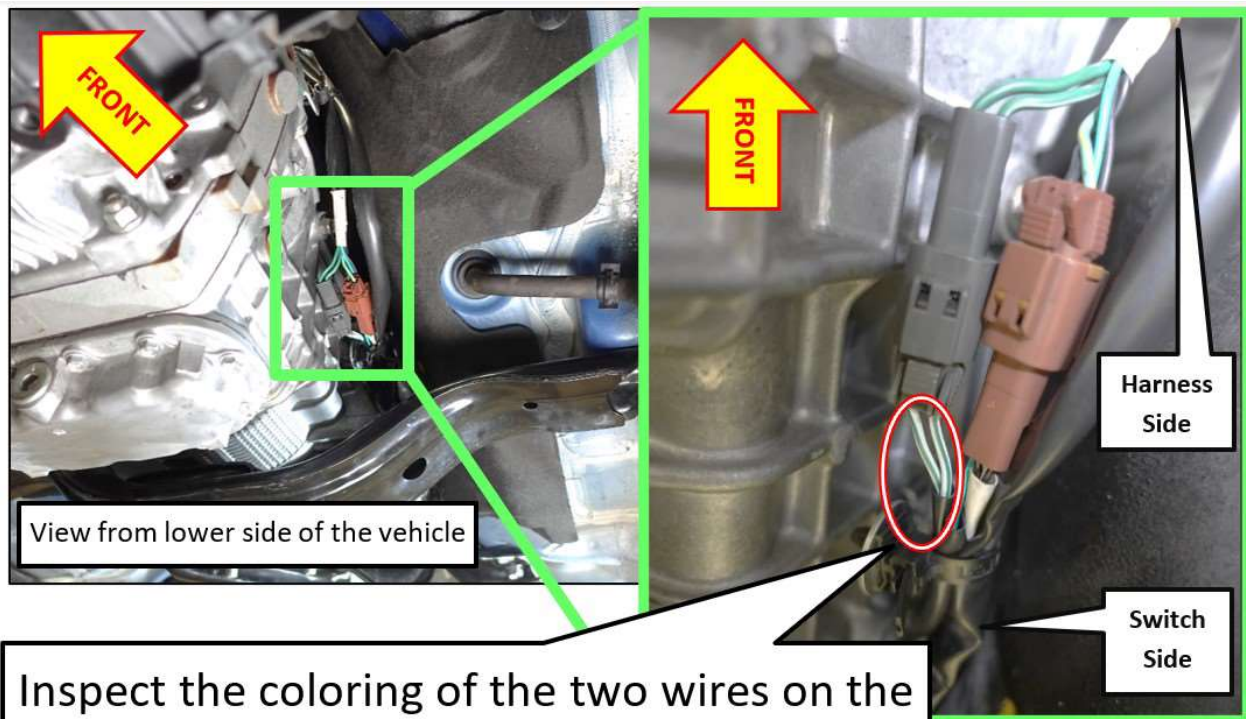
STEP 4: Perform a visual inspection of the wiring harness colors on the back-up lamp switch.

Inspect the coloring of the two wires on the switch side of the gray connector
The black protection tube can be pulled back for inspection

STEP 5: Apply the visual inspection results from **STEP 4** to the table below to verify the next course of action.

Back-Up Lamp Switch Version	OLD	NEW
Back-Up Lamp Switch Replacement	REQUIRED	<u>NOT</u> REQUIRED
Next Step	Proceed to STEP 6	No further action is required. Reinstall the removed parts in the reverse order of disassembly.
