Recall Campaign Bulletin

Campaign No. 2022080010, September 2022

SUBJECT: **Various Models**
Model Year 2019-2022

Check Transmission Wiring Harness Connector

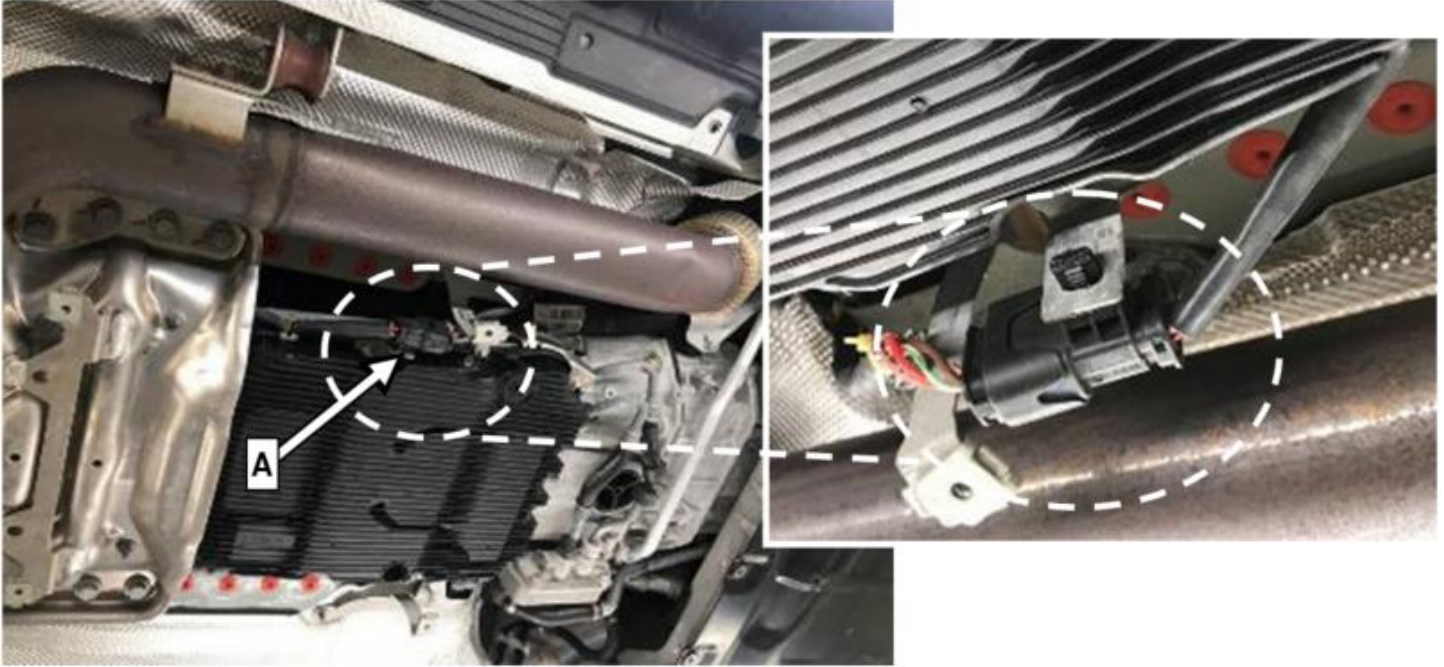
Figure 1

1. Remove rear underfloor paneling under transmission.
2. Disconnect electrical connector **X279** (A, figure 1) from the oil pan on the right side.

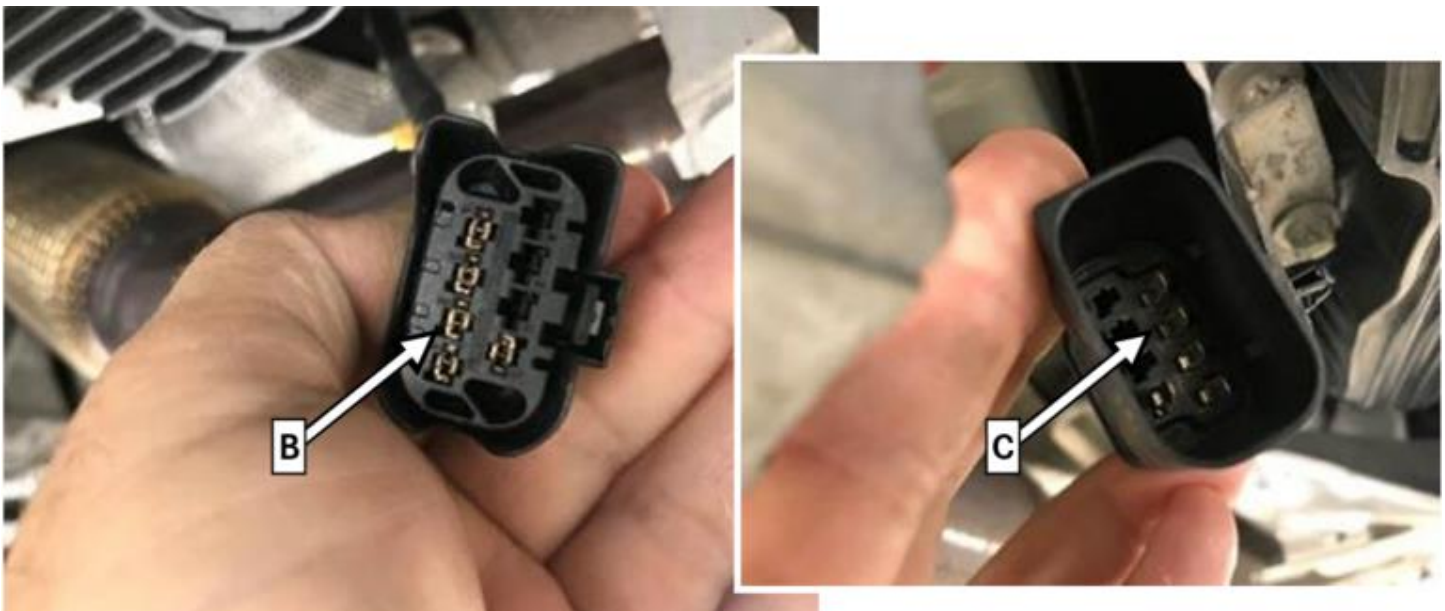
Figure 2

3. Check insides of the connector (B, figure 2 – vehicle side) and (C, figure 2 – transfer case side) for corrosion and other damage or noticeable problems.

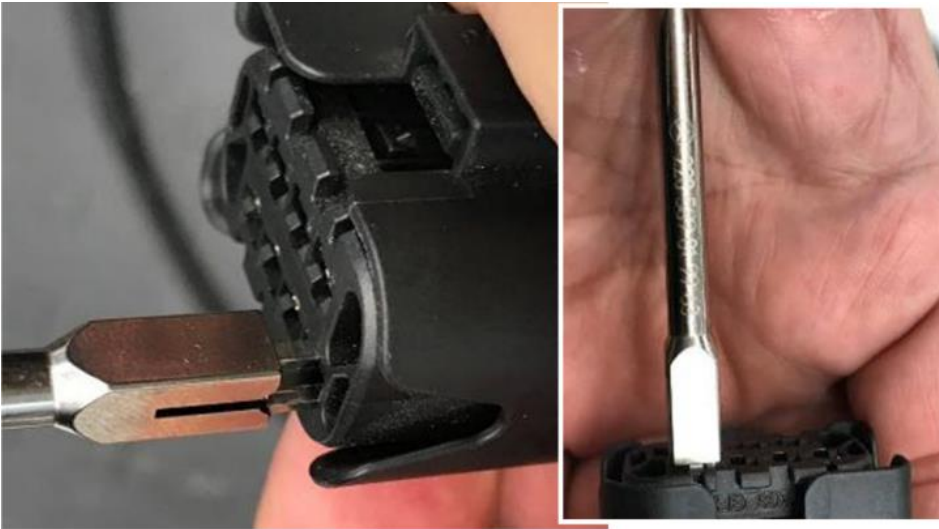
Figure 3

4. Check pins from the **vehicle side** wiring harness (B, figure 2) with the special tool **W 220 589 01 99 63** (figure 3). **Unpin** each individually, check for corrosion and damage such as wire melting or wire sealing lips (figure 4), **and then pin back in**. DO NOT remove all pins at once.

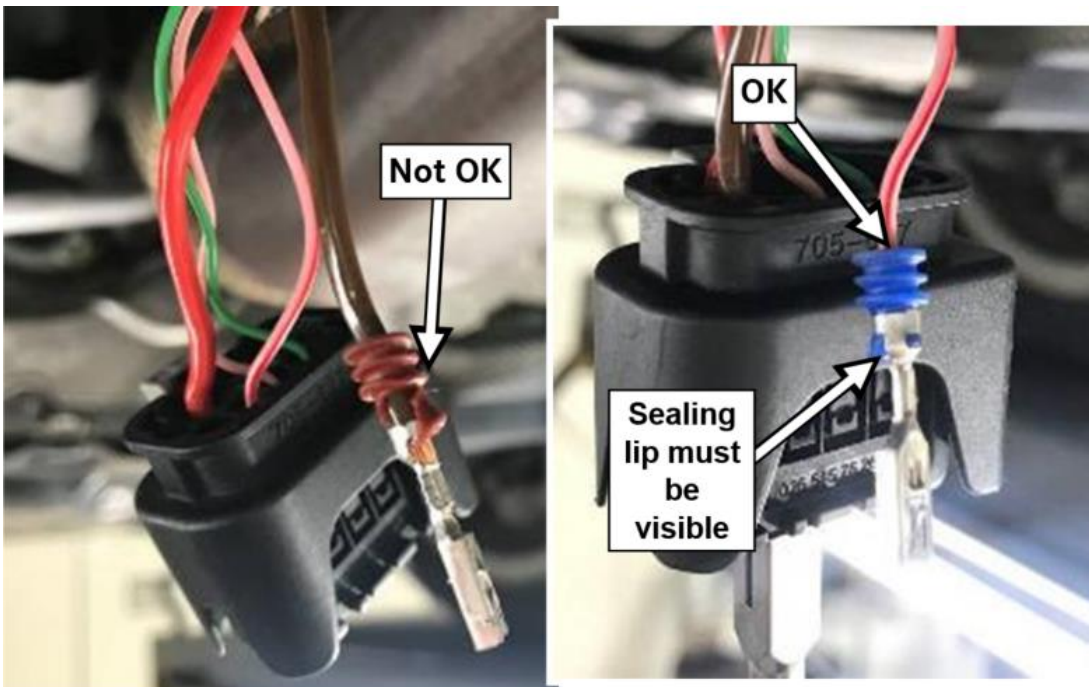
Figure 4 (*not OK* and OK sealing element)

- i** Equivalent commercially available unpinning tools can be used.
- i** **All pins may not** be unpinned from the plug housing **simultaneously**.
- i** The **pins must audibly engage** when reinserted.
- i** No damage or noticeable problems may be visible.
- i** No sealing elements may be damaged or melted at the cables.
- i** Sealing elements must be properly crimped in the cable lug.
- i** See OK figure. Sealing lip must be visible.
- i** Figure 4 shows a *not OK* and OK sealing element!

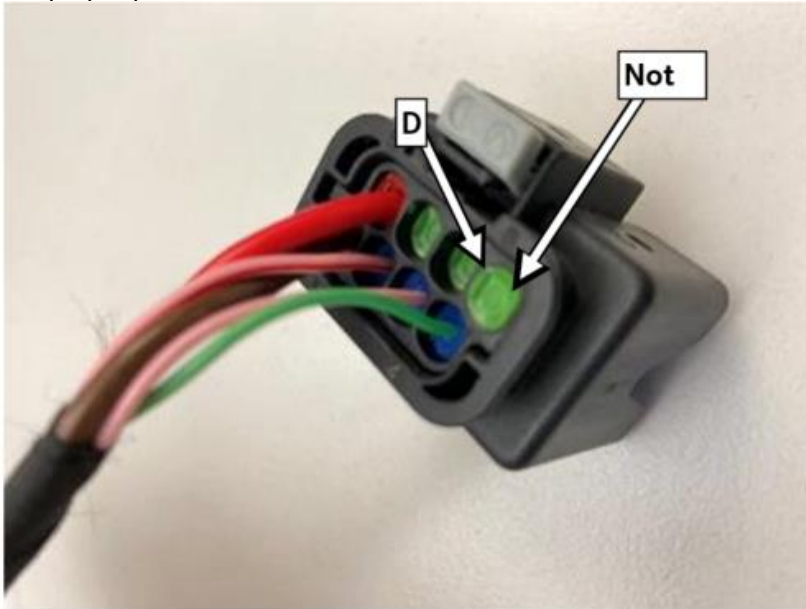
Figure 5

5. Check green blind plugs (D, figure 5) on the rear side of the connector for proper seating, rework if necessary.

i If the connector and the blind plug has no damage and are out of place, the blind plugs need to be pressed into its proper position.

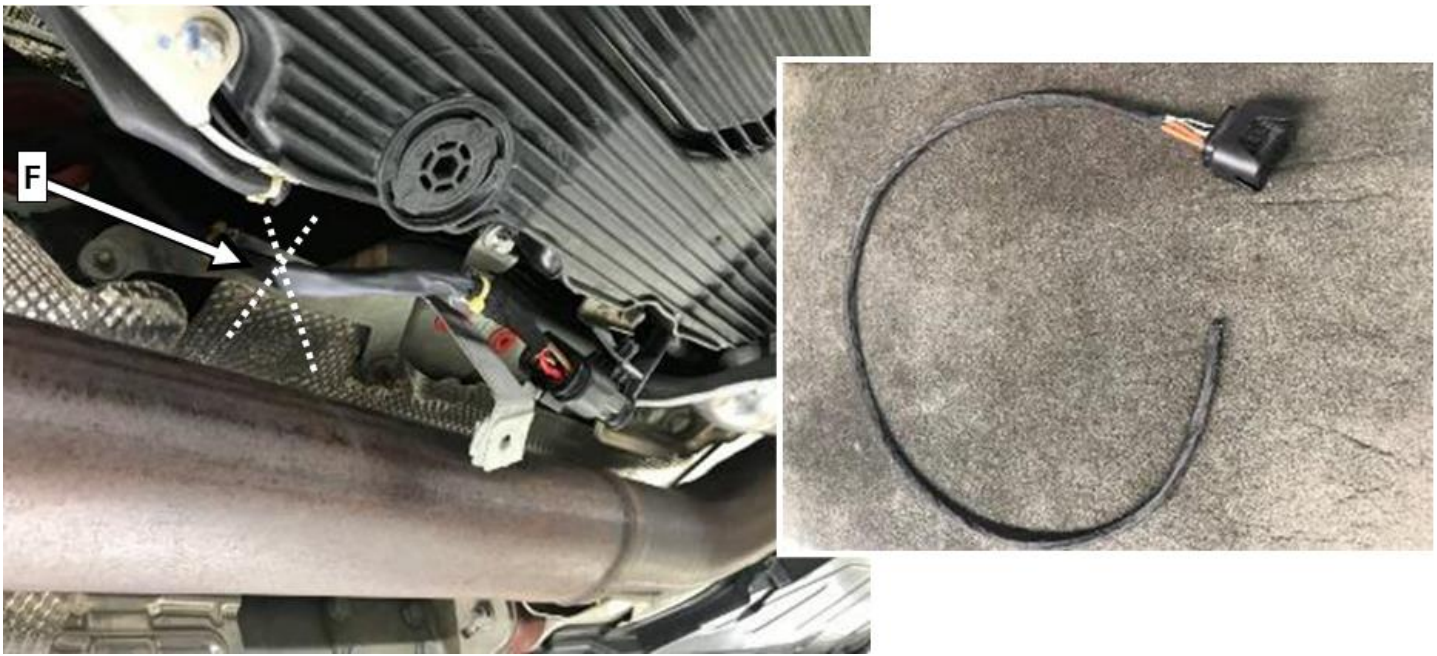
Figure 9

i If **damage** to the pins, cables, sealing, or plug housing is present, the vehicle-side wiring harness must be always repaired with the **repair wiring harness**.

2. Disconnect the vehicle-side wiring harness in the denoted area (F, figure 9), strip and connect it with the repair wiring harness using a line connector.

i **Repair wiring harness by means of a line connector, see AR00.19-P-0100-09A.**

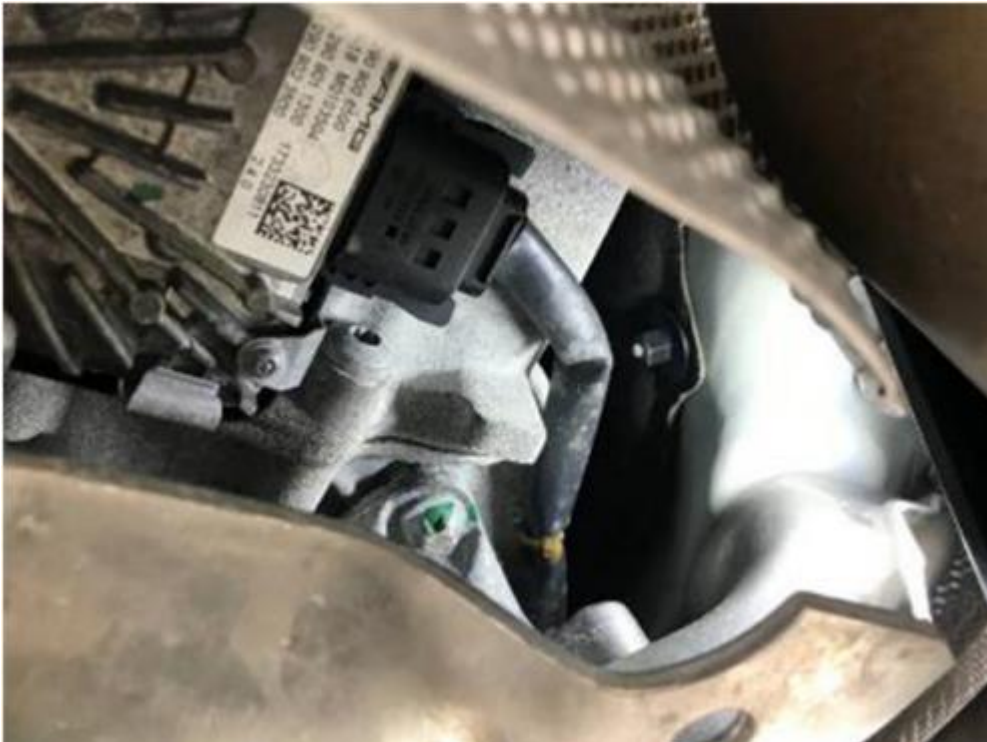
Figure 10

i If the **transfer case wiring harness** is damaged, it must be completely replaced.

1. Remove rear crossbar transmission.
i Secure transmission against tilting.
2. Unclip the transfer case-side wiring harness on the bracket of the automatic oil pan, unclip the transfer case and disconnect it from the variable transfer case control unit.
i To disconnect the control unit the heat shield must be gently pushed down.

3. Replace transfer case-side wiring harness.
 4. Assemble in reverse order.
 5. Attach additional bracket as described in work procedure A and fasten wiring harness.
-
