Recall Campaign Bulletin

Campaign No. 2022080010, September 2022

SUBJECT: **Various Models**
Model Year 2019-2022

Check Transmission Wiring Harness Connector

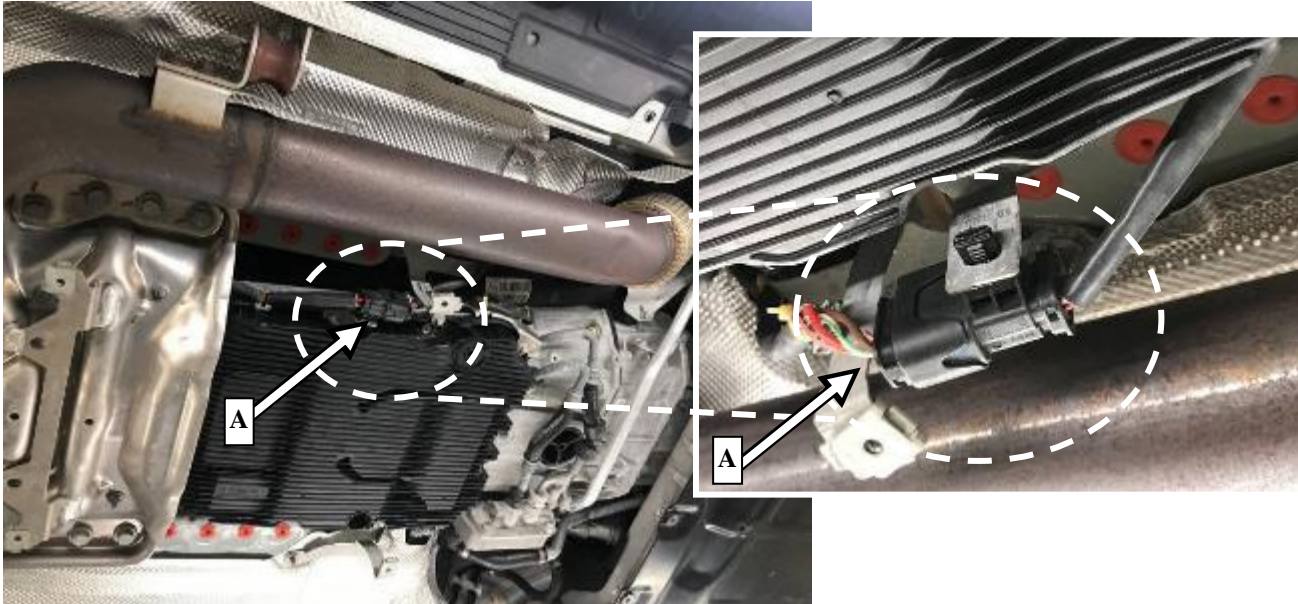
Figure 1

2. Disconnect electrical connector **X279** (A, Figure 1) from right oil pan.
