Recall Campaign Bulletin

Campaign No. 2022080010, September 2022

SUBJECT: **Various Models**
Model Year 2019-2022

Check Transmission Wiring Harness Connector

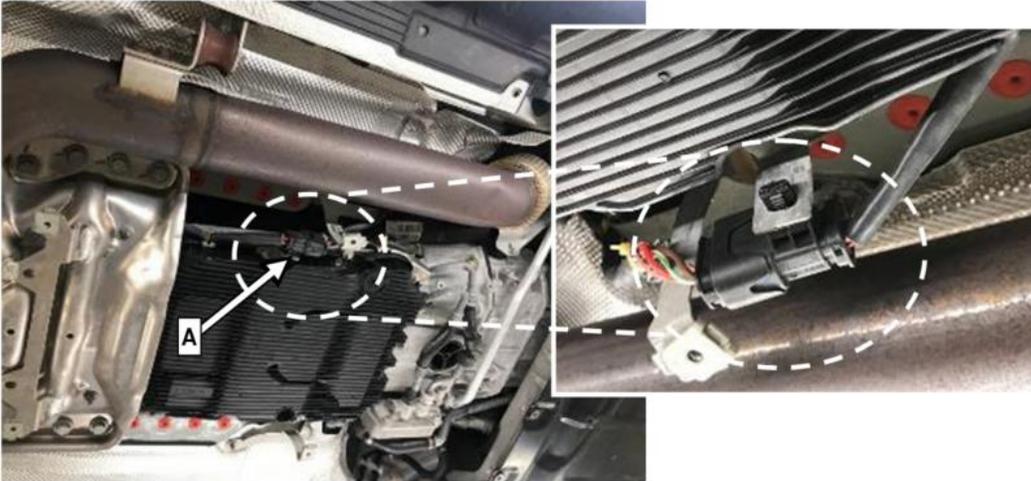
**Figure 1**

1. Remove rear underfloor paneling under transmission.
2. Disconnect electrical connector X279 (A, figure 1) from the oil pan on the right side.

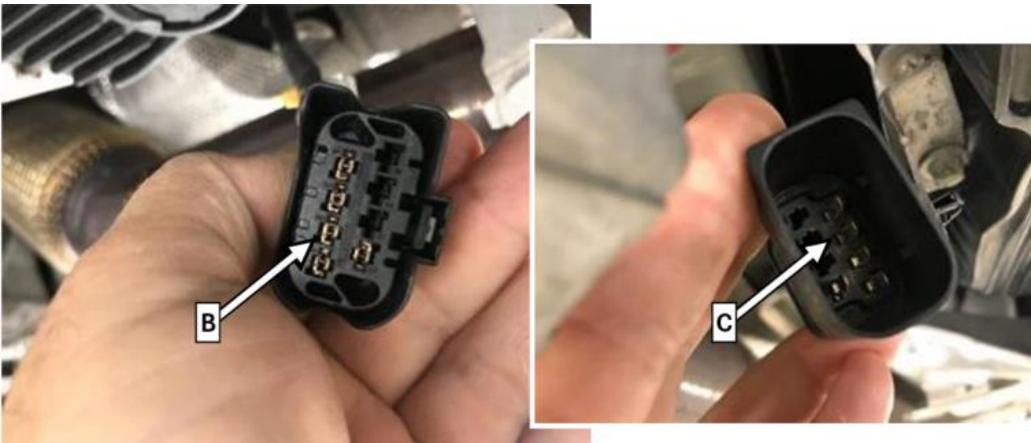
**Figure 2**

3. Check insides of the connector (B, figure 2 – vehicle side) and (C, figure 2 – transfer case side) for corrosion and other damage or noticeable problems.

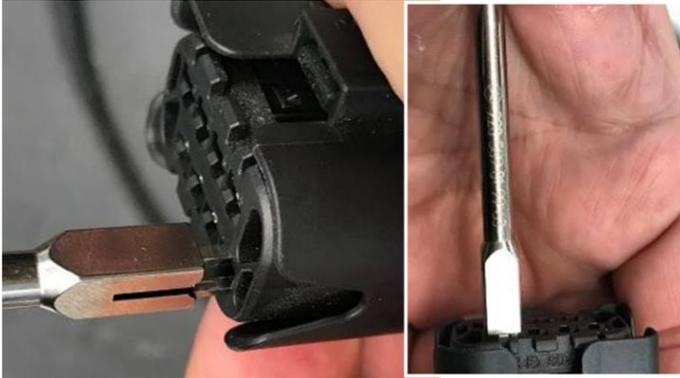
Figure 3

4. Check pins from the **vehicle side** wiring harness (B, figure 2) with the special tool **W 220 589 01 99 63** (figure 3). **Unpin** each individually, check for corrosion and damage such as wire melting or wire sealing lips (figure 4), **and then pin back in**. DO NOT remove all pins at once.

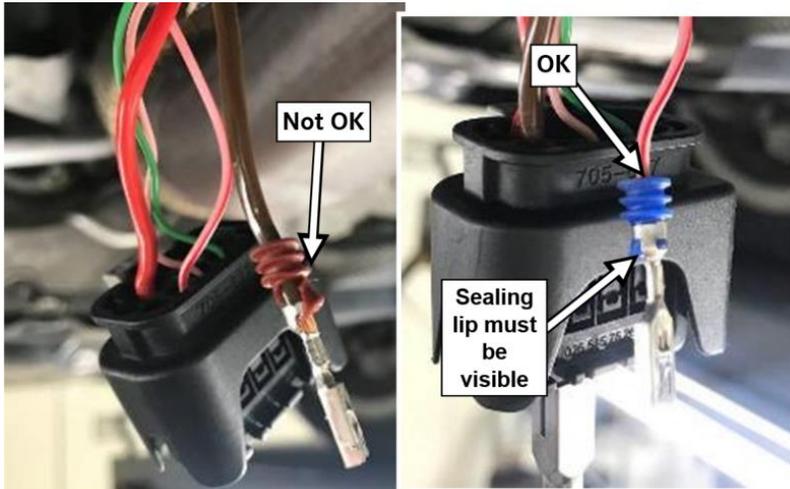
Figure 4 (*not OK* and OK sealing element)

No sealing elements may be damaged or melted at the cables.
-

Sealing elements must be properly crimped in the cable lug.
-

See OK figure. Sealing lip must be visible.
-

Figure 4 shows a *not OK* and OK sealing element!

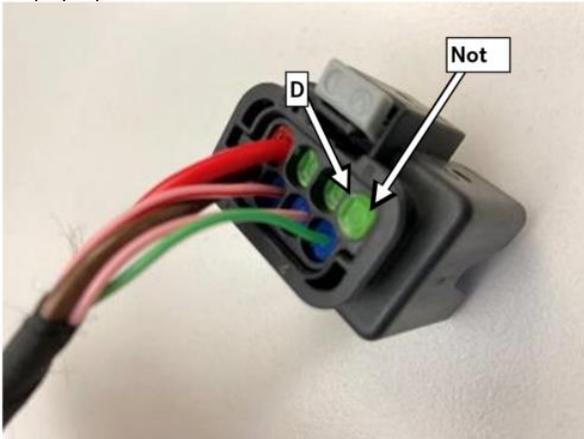
Figure 5

5. Check green blind plugs (D, figure 5) on the rear side of the connector for proper seating, rework if necessary.

i If the connector and the blind plug has no damage and are out of place, the blind plugs need to be pressed into its proper position.

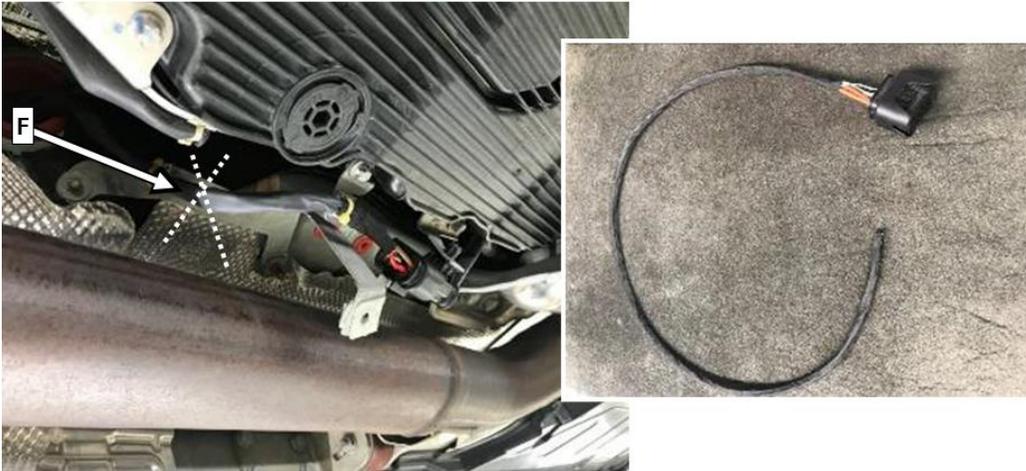
Figure 9

i If **damage** to the pins, cables, sealing, or plug housing is present, the vehicle-side wiring harness must be always repaired with the **repair wiring harness**.

2. Disconnect the vehicle-side wiring harness in the denoted area (F, figure 9), strip and connect it with the repair wiring harness using a line connector.

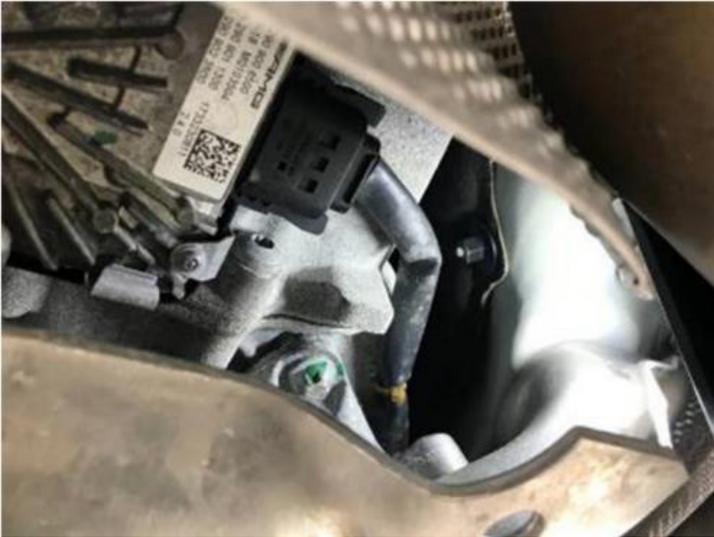
Figure 10

i If the **transfer case wiring harness** is damaged, it must be completely replaced.

2. Unclip the transfer case-side wiring harness on the bracket of the automatic oil pan, unclip the transfer case and disconnect it from the variable transfer case control unit.

3. Replace transfer case-side wiring harness.
