SIB 61 14 22

RECALL 22V-541: HIGH-VOLTAGE BATTERY

E-Series	Model Description Production Date	
G26 BEV	i4 Gran Coupe	November 10, 2021 – October
		21, 2022

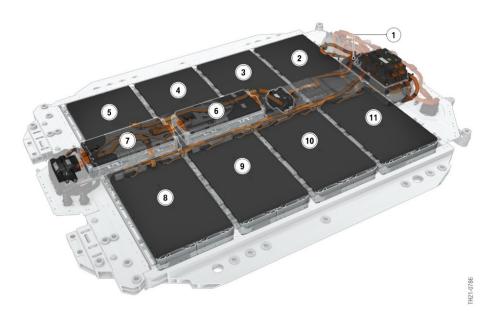
G26 BEV SE27 HB Battery module locations shown below-

During supplier production, the high-voltage battery may not have been produced to specifications. A short-circuit could occur which could lead to a thermal event. The affected high-voltage battery cell module will be replaced.

Some high-voltage battery modules may not have been produced to specifications.

3. Replace the defective high-voltage cell modules using repair instructions **61 27 703** to **61 27 877** depending on the affected cell module location.
