SIB 61 14 22

2023-01-20

RECALL 22V-541: HIGH-VOLTAGE BATTERY

E-Series	Model Description	Production Date
G26 BEV	i4 Gran Coupe	November 10, 2021 – October 21, 2022

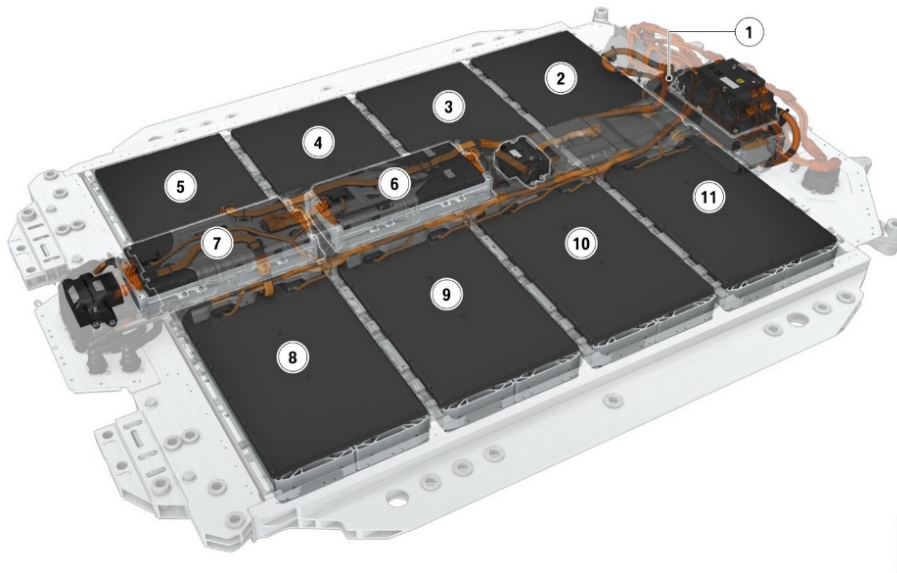
G26 BEV SE27 HB Battery module locations shown below-

During supplier production, the high-voltage battery may not have been produced to specifications. A short-circuit could occur which could lead to a thermal event. The affected high-voltage battery cell module will be replaced.

Some high-voltage battery modules may not have been produced to specifications.

3. Replace the defective high-voltage cell modules using repair instructions **61 27 703** to **61 27 877** depending on the affected cell module location.
