# AWNING INSPECTION AND WELD/SEAM REPAIR

<b>Recall Number:</b>	22E-055		
<b>Product:</b>	Awnings		
<b>Date:</b>	July 15, 2022	<b>Labor Rate:</b>	.20 hours inspection only    .30 hours repair only 1.5 hours fabric replacement only

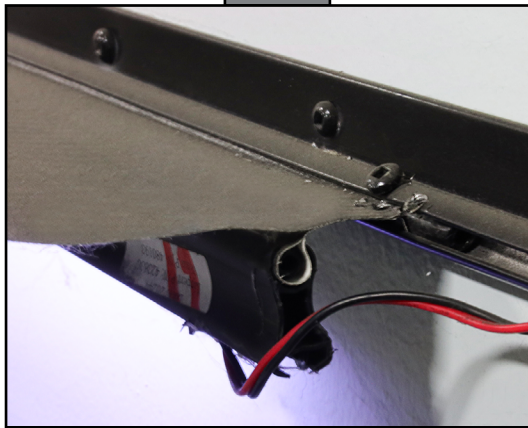
**Fig. 1**

The purpose of this document is to provide guidance, as well as visual aides, to dealers performing inspection on units that may have insufficient awning weld(s). The inspection point is at the awning fabric seam at the awning rail at the wall of the unit (Fig. 1). This only affects awnings manufactured January 17, 2022 – June 14, 2022. The date of manufacture can be located on the variant code label (Fig. 2) located on the awning.

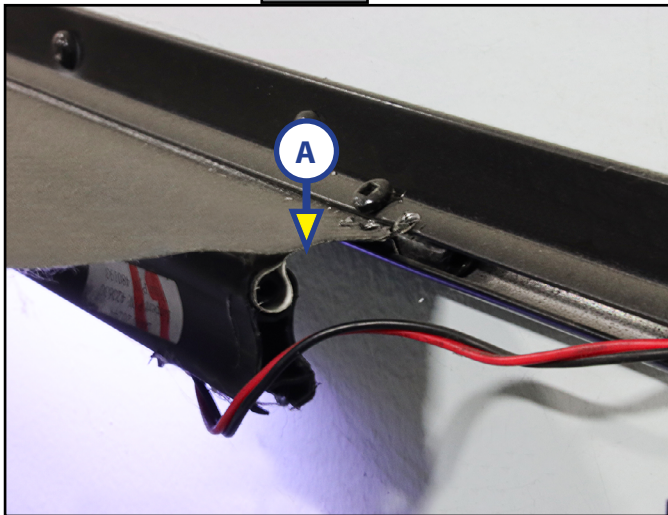
**Fig. 3**

1. Position stepladder next to the unit to view the topside of the awning at the unit wall from either end (drive/idler side).
2. Inspect the weld near the awning rail (Fig. 3A).
  - A. Fig. 3 shows no separation at the seam. It does not require repair or replacement.
  - B. Fig. 3 shows separation at the seam (Fig. 4A).
    - I. If the separation is less than 6 inches, repair can be accomplished using the procedure described in [TI-434](#).
    - II. If the separation is over 6 inches it will require awning fabric replacement using the procedure described in [TI-166](#).
