AWNING INSPECTION AND WELD/SEAM REPAIR

Recall Number:	22E-055		
Product:	Awnings		
Date:	July 15, 2022	Labor Rate:	.20 hours inspection only .30 hours repair only 1.5 hours fabric replacement only

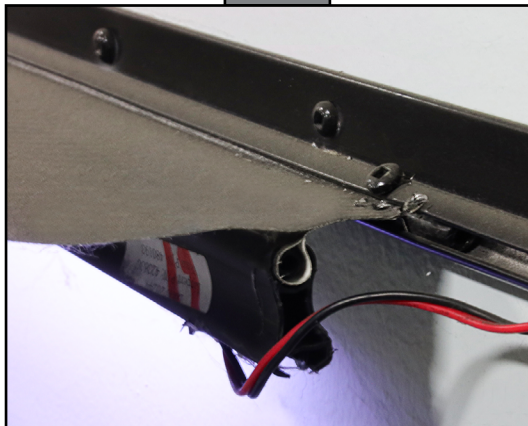
Fig. 1

The purpose of this document is to provide guidance, as well as visual aides, to dealers performing inspection on units that may have insufficient awning weld(s). The inspection point is at the awning fabric seam at the awning rail at the wall of the unit (Fig. 1). This only affects awnings manufactured January 17, 2022 – June 14, 2022. The date of manufacture can be located on the variant code label (Fig. 2) located on the awning.
