GROUP	MODEL		
	Safety Recall Campaign	2012-2013MY		
		Optima (QF)		
	NUMBER	DATE		
	SC245	September 2022		
SAFETY RECALL CAMPAIGN				
ADHESIVE TAPE APPLICATION				
SUBJECT: ON HEADLINER	PLATES (SC245)

ADHESIVE TAPE APPLICATION ON HEADLINER PLATES (SC245)

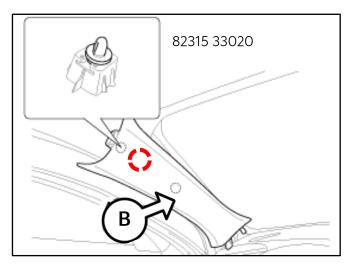
When the front pillar trim is pulled away from pillar, the clip/tether may be cut in the area shown so it may be removed. The remaining clip in the trim can be twisted off once the trim is removed from the vehicle.

Note: Fasteners/Clip replacement:

- Replace 85815 3S100 Clip/Tether.
 (May not be re-used)
- Replace 82315 33020 Fastener (Only if broken or damaged).

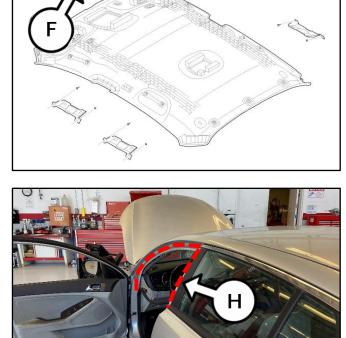
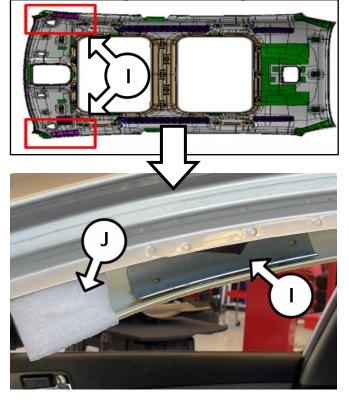
5a. Carefully and gently pull down the headliner from the (LH and RH) front door openings to expose the metal plates (I) in the front areas shown.

5b. <u>Note</u>: Insert a pair of 1.5" (40mm) thick foam blocks (J) to prevent damage to headliner and provide working space between the headliner and vehicle roof.
