## Awning Fabric Weld Repair Instructions

<b>Bulletin Type:</b>	Recall	<b>Publication Date:</b>	August 2022
<b>Bulletin #(s):</b>	22V-571 US 2022-424 Canada	<b>Revision Date:</b>	September 2022
<b>Job Code(s):</b>	9901578	<b>Revision Date:</b>	December 2022
<b>Flat Rate(s):</b>	9901578A - 0.30 Inspection only 9901578B - 0.60 Inspection and Repair 9901578C - 1.8 Inspection and Replace	<b>Make(s):</b>	Jayco
		<b>Model(s):</b>	Eagle, Jay Flight, North Point, Pinnacle, Seismic
		<b>Model Year(s):</b>	2022-2023
<b>Incident:</b>	Insufficient Fabric Awning Weld		
<b>Affected Units:</b>	2022-2023 Jayco Eagle, Jay Flight, North Point, Pinnacle, Seismic		
<b>Parts Kit: 22V-571</b>	Parts Kit #: 22V-571		
	Part Kit Contents: Adhesive, RPR Seam Awning (Jayco Part #2040196)		
<b>Misc. Tools &amp; Supplies: N/A</b>	<b>Stepladder</b>

<b>Incident:</b>	Insufficient Fabric Awning Weld
<b>Affected Units:</b>	2022 Jayco Greyhawk, Melbourne, Redhawk & Entegra Coach Odyssey
<b>Parts Kit: 22V-571</b>	Parts Kit #: 22V-571
	Part Kit Contents: Adhesive, RPR Seam Awning (Jayco Part #2040196)
<b>Misc. Tools &amp; Supplies:</b>	Stepladder

## INSUFFICIENT AWNING WELD(S) INSPECTION

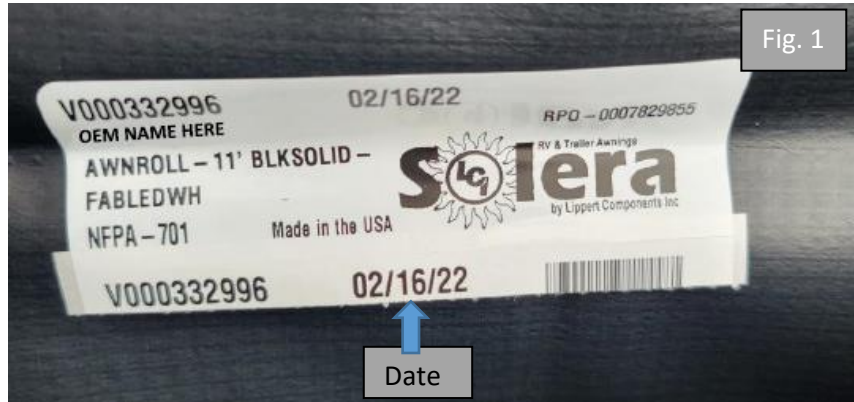
- b. Clear photo of the awning tag.
    - c. Photos documenting any weld separation concerns.
  2. This recall only affects awnings manufactured between January 17, 2022 - June 14, 2022. The date of manufacture can be located on the variant code label located on the awning fabric. (Figure 1) File for inspection only if the date range is outside January 17, 2022 - June 14, 2022. Proceed with inspection instructions of awning fabric weld if date range is between January 17, 2022 - June 14, 2022.

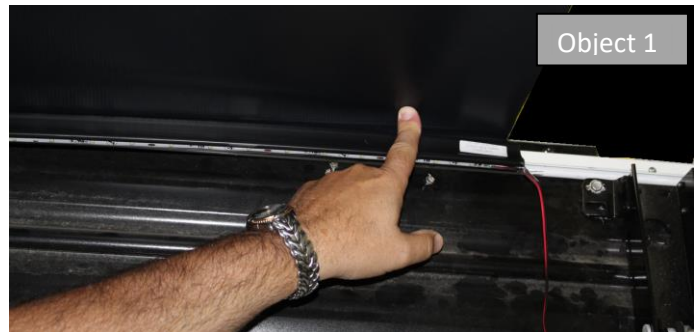
3. Perform push test:
    - a. Extend the awning.
    - b. From underneath the awning, about 1" to 1.5" from the fabric edge push up on the fabric with one finger (Object 1) until the awning fabric is flush with the top of the awning rail. Look for any separation or visible daylight at the seam. Perform push test at both ends of the awning.

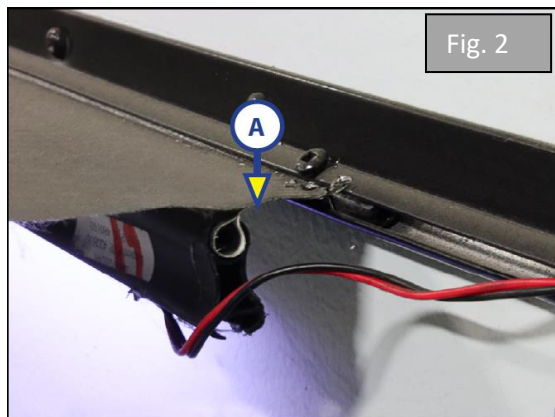
4. Figure 2 shows no separation at the seam. File a claim for inspection only.
  5. Figure 3 shows separation at the seam:
    - a. If the separation is less than 6 inches, repair can be accomplished using the procedures described in the INSUFFICIENT AWNING FABRIC WELD REPAIR INSTRUCTIONS.

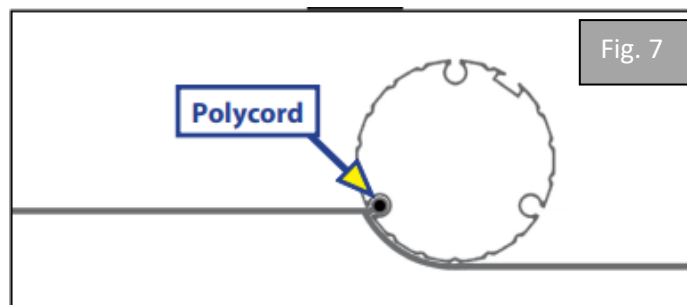
Fig. 7

- **CAUTION: Moving parts can pinch, crush or cut. Keep clear and use caution.**
- **Note: Previous awning versions had two (2) polycords and fabric stitching along the hem. The current awning model has one (1) polycord (see Figure 7) and no fabric stitching. This should not be mistaken as defective.**
- **Manual Awning Fabric Replacement**
  1. Order the Awning Fabric using the Compliance Order Form. You must include with order form:
    - a. Clear photo of the awning tag.
    - b. Photos documenting any weld separation concerns.
  2. Remove the drip cap (if equipped) from the end of the awning from which the fabric will be removed.
  3. Extend the awning out approximately 12" and insert cotter pins through both end caps into the shafts on the head assemblies. (Figure 8)
