Awning Fabric Weld Repair Instructions

Bulletin Type:	Recall		Publication Date: Revision Date:	August 2022 <mark>September 2022</mark>
Bulletin #(s):	22V-571 US 2022-424 Canada		Make(s):	Јаусо
Job Code(s):	9901578			
	9901578A - 0.30 Inspection only 9901578B - 0.60 Inspection and Repair 9901578C - 1.8 Inspection and Replace		Model(s):	Eagle, Jay Flight, North Point, Pinnacle, Seismic
Flat Rate(s):			Model Year(s):	2022-2023
Incident:		Insufficient Fabric Awning Weld		
Affected Units:		2022-2023 Jayco Eagle, Jay Flight, North Point, Pinnacle, Seismic		
Parts Kit: 22V-571		Parts Kit #: 22V-571		
		Part Kit Contents: Adhesive, RPR Seam Awning (Jayco Part #2040196)		
Misc. Tools & Supplies: N/A		Stepladder

Incident:	Insufficient Fabric Awning Weld	
Affected Units:	2022 Jayco Greyhawk, Melbourne, Redhawk & Entegra Coach Odyssey	
	Parts Kit #: 22V-571	
Parts Kit: 22V-571	Part Kit Contents: Adhesive, RPR Seam Awning (Jayco Part #2040196)	
Misc. Tools & Supplies:	Stepladder

INSUFFICIENT AWNING WELD(S) INSPECTION

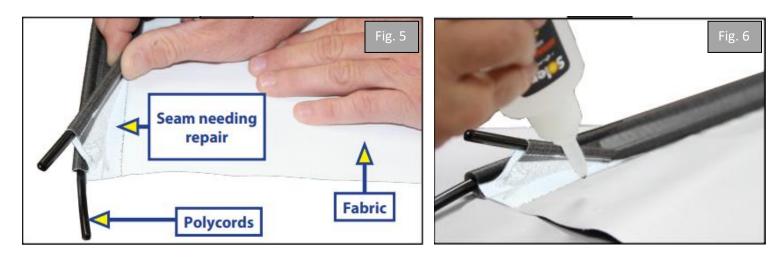
- a. Note: Figure 5 shows fabric off awning for clarity and upside down. The repair can be completed with the awning fabric installed.
- 5. Use Awning Seam Repair Adhesive Parts Kit #: 22V-571 (Figure 4) along the entire separation (Figure 6).
- 6. Press down firmly and hold for several minutes.
- 7. Allow to dry for at least four hours.

- Seam Separation Repair Procedure is below
- Note: The repair procedure is optimal for seam separation less than 6".
- Resources Required: Awning Seam Repair Adhesive Parts Kit #: 22V-571 (Figure 4)
 - 1. Begin by extending the awning:
 - a. For a seam fix at the awning rail, extend the awning a few feet.
 - 2. Tie both awning arms slightly back to gain some slack at the fabric.
 - 3. Clean the area to be repaired with mild soap and water. Allow to dry completely.
 - 4. Spread open the seam area needing repair (Figure 5) and apply a continuous bead of Awning Seam Repair Adhesive. (Figure 6)
