<b>Recall Number:</b>	NHTSA 22v591 - TC 2022-437	HEARTLAND WCC: 99.01.69
<b>Product:</b>	Awnings	
<b>Date:</b>	July 15, 2022	<b>Labor Rate:</b> .20 hours inspection only      .30 hours repair only 1.5 hours fabric replacement only

## Purpose

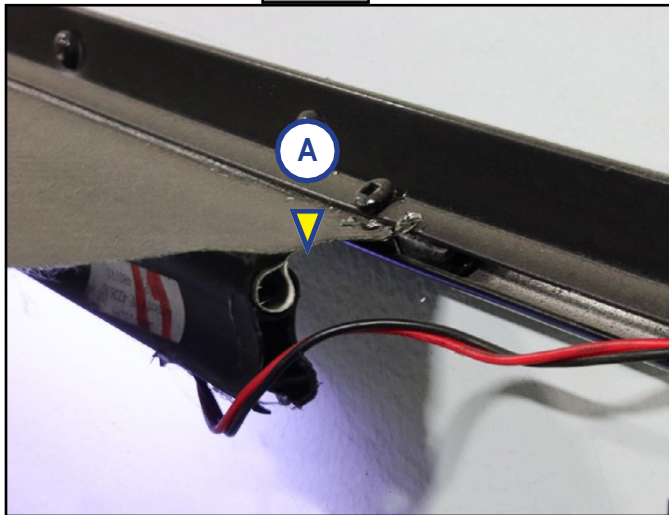
1. Position stepladder next to the unit to view the topside of the awning at the unit wall from either end (drive/idler side).
2. Inspect the weld near the awning rail (Fig. 3A).
  - A. Fig. 3 shows no separation at the seam. It does not require repair or replacement.
  - B. Fig. 3 shows separation at the seam (Fig. 4A).
    - I. If the separation is less than 6 inches, repair can be accomplished using the procedure described in [TI-434](#).
    - II. If the separation is over 6 inches it will require awning fabric replacement using the procedure described in [TI-166](#).
