AWNING INSPECTION AND WELD/SEAM REPAIR

Recall Number:	22E-055		
Product:	Awnings		
Date:	July 15, 2022	Labor Rate:	.20 hours inspection only .30 hours repair only 1.5 hours fabric replacement only

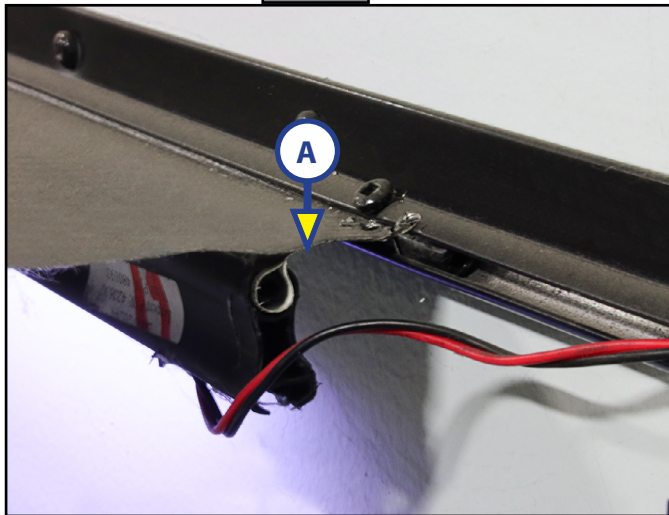
1. Position stepladder next to the unit to view the topside of the awning at the unit wall from either end (drive/idler side).
2. Inspect the weld near the awning rail (Fig. 3A).
 - A. Fig. 3 shows no separation at the seam. It does not require repair or replacement.
 - B. Fig. 3 shows separation at the seam (Fig. 4A).
 - I. If the separation is less than 6 inches, repair can be accomplished using the procedure described in [TI-434](#).
 - II. If the separation is over 6 inches it will require awning fabric replacement using the procedure described in [TI-166](#).
