APPLICABILITY: 2017-19MY Impreza / Halogen Head Lamps

NUMBER: WRG-22

SUBJECT: Halogen Headlamp Low Beam & Side Reflector

DATE: 2/17/2022

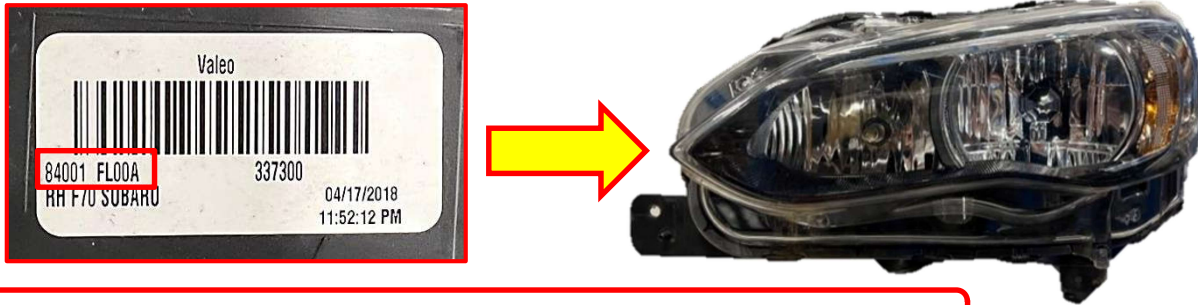
HEADLAMP INSPECTION: Locate the part numbers labeled on the both the left and right headlamp assemblies. The part identification label is located on the inner front portion of the headlamp. See the images below.

The example part identification label pictured above shows part number **84001FL00A**

Headlamps with part number **84001FL00B** or **84001FL01B** will not require replacement and can be reinstalled and adjusted. ALL other part numbers will require replacement and adjustment.
