| Safety Recall Campaign | 2023MY Sportage (NQ5a) |
| SC248 | September 2022 |

ALTERNATOR B+ TERMINAL NUT INSPECTION AND TIGHTENING (SC248)

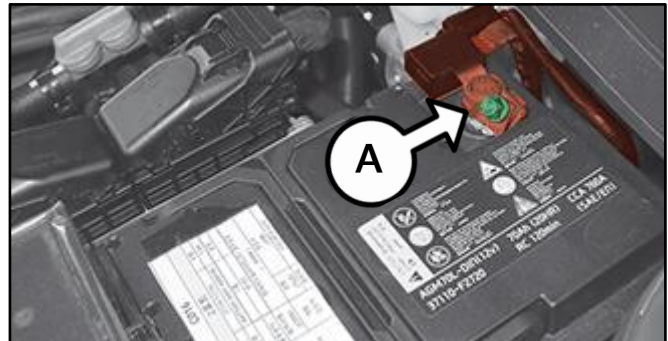
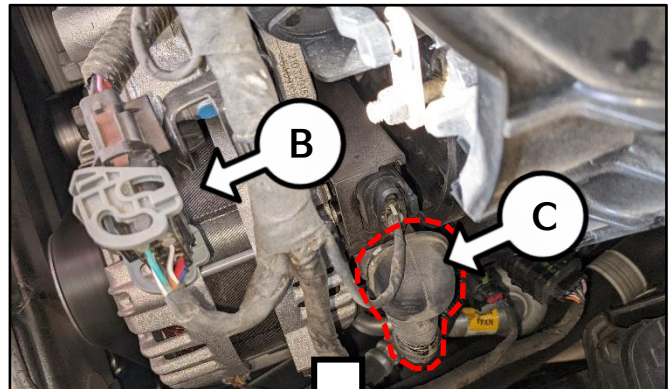
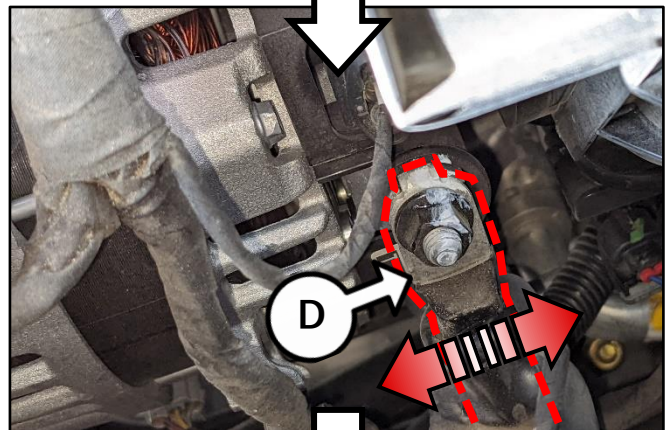
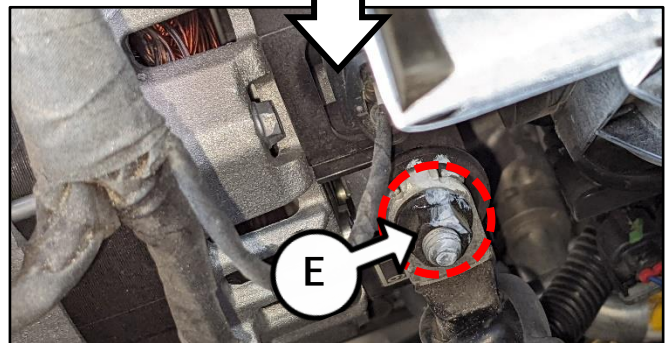
3. Locate the alternator (B) and pull down on the alternator "B+" terminal nut/cable cover (C).
4. Confirm the alternator B+ terminal cable (D) is secured tight by attempting to move the terminal cable end (push/pull - left to right).
- 5a. If the cable (D) was secured tight, then confirm that the alternator B+ terminal nut (E) is torqued to specification.
 - If the nut was found to be torqued to specification, then classify this condition as a **Pass (OK)**.
 - If the nut was found NOT torqued to specification, then classify this condition as a **Fail (NG)**.
- 5b. If the cable (D) was loose, then torque the alternator B+ terminal nut (E) to specification. Confirm cable is secured (push/pull-left to right) and classify this condition as a **Fail (NG)**.

Tightening torque for Alternator B+ Nut:
13.7 - 18.1 lb.ft (18.6 - 24.5 N.m)

6. Restore Alternator B+ terminal/nut cover and re-connect the battery negative (-) terminal. Confirm normal vehicle operation.
