ANB4 - Retrofitting Locking Caps on the Front Left and Right Headlights (Stop Delivery / Recall Campaign)

Model Line: **Panamera (971)**

Model Year: **As of 2017 up to 2022**

Concerns: **Caps on headlight**

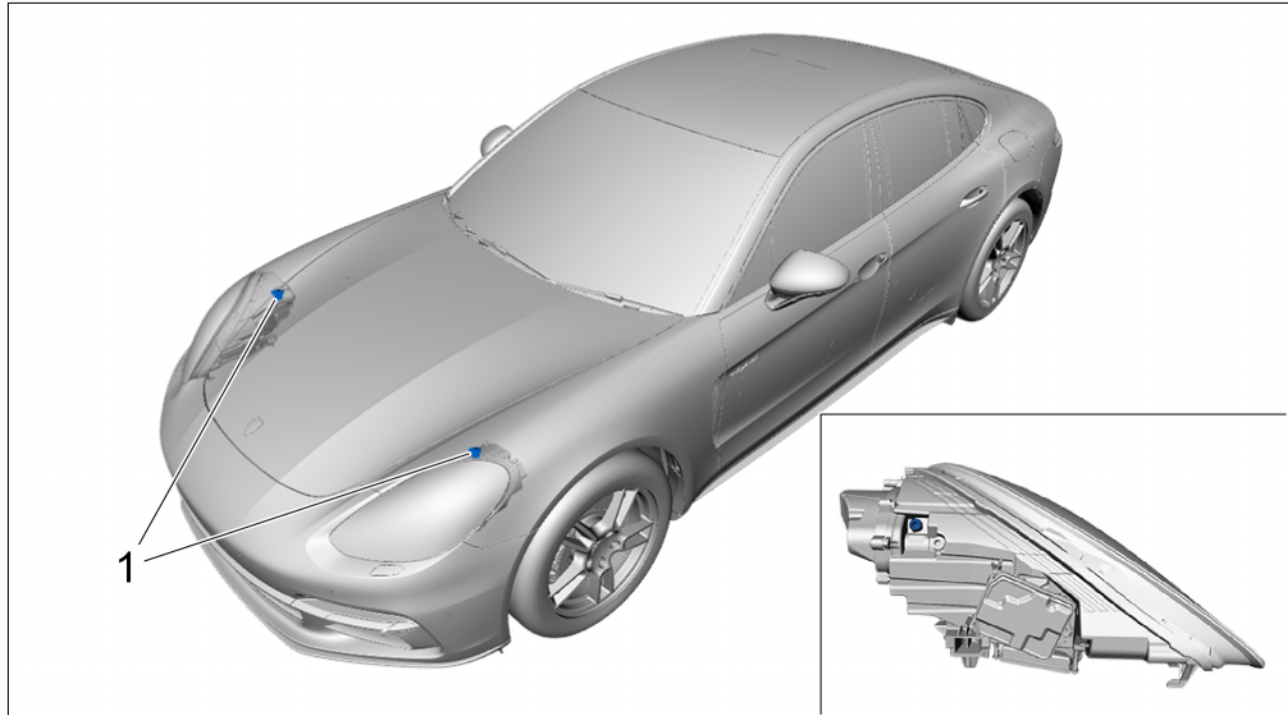
*Installation position of caps*

Information: **There is a possibility that a locking cap that prevents the adjustment of the headlights in the horizontal direction was not installed during vehicle assembly on the affected vehicles. If this is the case, certain legal requirements will not be met in the USA and Canada markets.**

1 – Cap (retrofit)

Action required: Check installation of the caps and retrofit a cap on the adjusting screw for horizontal adjustment on the left and right headlights if necessary.

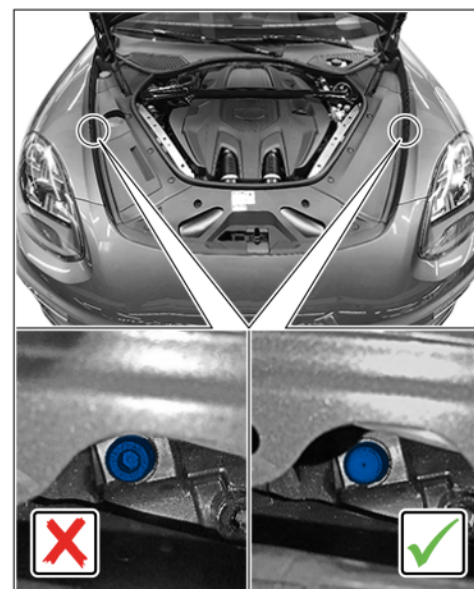
Adjusting screw for horizontal adjustment

3 Check that a cap is installed on the adjusting screw for the horizontal adjustment on the left and right headlight. ⇒ *Adjusting screw for horizontal adjustment*

Assessment		Action
(✓)	A cap is installed on the left and right headlight.	End of remedial action. Continue with Step 4.
(✗)	There is no cap or only one cap installed on one headlight.	Retrofit cap. Continue with Step 3.
