199/22 ENU ANB4

# ANB4 - Retrofitting Locking Caps on the Front Left and Right Headlights (Stop Delivery / Recall Campaign)

Model Line:	Boxster / Cayman (981) 718 Boxster / 718 Cayman (982)
Model Year:	As of 2012 up to 2022
Country / Market:	USA (C02) Canada (C36)
Concerns:	Caps in luggage compartment
Information:	There is a possibility that a locking cap that prevents the adjustment of the headlights in the horizontal direction was not installed during vehicle assembly on the affected vehicles. If this is the case, certain legal requirements will not be met in the USA and Canada markets.
Action required:	Check installation of the caps and retrofit a cap in the front luggage compartment on the left and right if necessary.
	Every vehicle is exactly assigned just two campaign scopes.
	$\Rightarrow$ To find out which scope is assigned to the vehicle, see PCSS Vehicle Information.
Affected	Only vehicles assigned to the campaign (see also PCSS Vehicle Information).

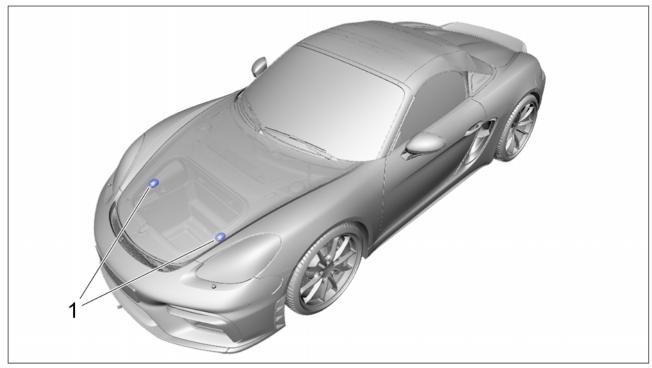
Installation position of caps (example 718 Spyder 982)

1 – Cap (retrofit)

4 Retrofit cap.

- 4.2 Press a cap  $\Rightarrow$  Cap -2- into the now existing opening in the front luggage compartment on the left and right until you hear a distinct click.
- 5 Install plastic box with tyre sealant compound and plastic box with tool kit.
- 6 Close front lid.
- 7 Enter the campaign in the Warranty and Maintenance booklet.
