ANB4 – Retrofitting Locking Caps on the Front Left and Right Headlights (Stop Delivery / Recall Campaign)

Model Line: **Cayenne (9PA)**

Model Year: **As of 2003 up to 2006**

Concerns: **Caps on main headlight**

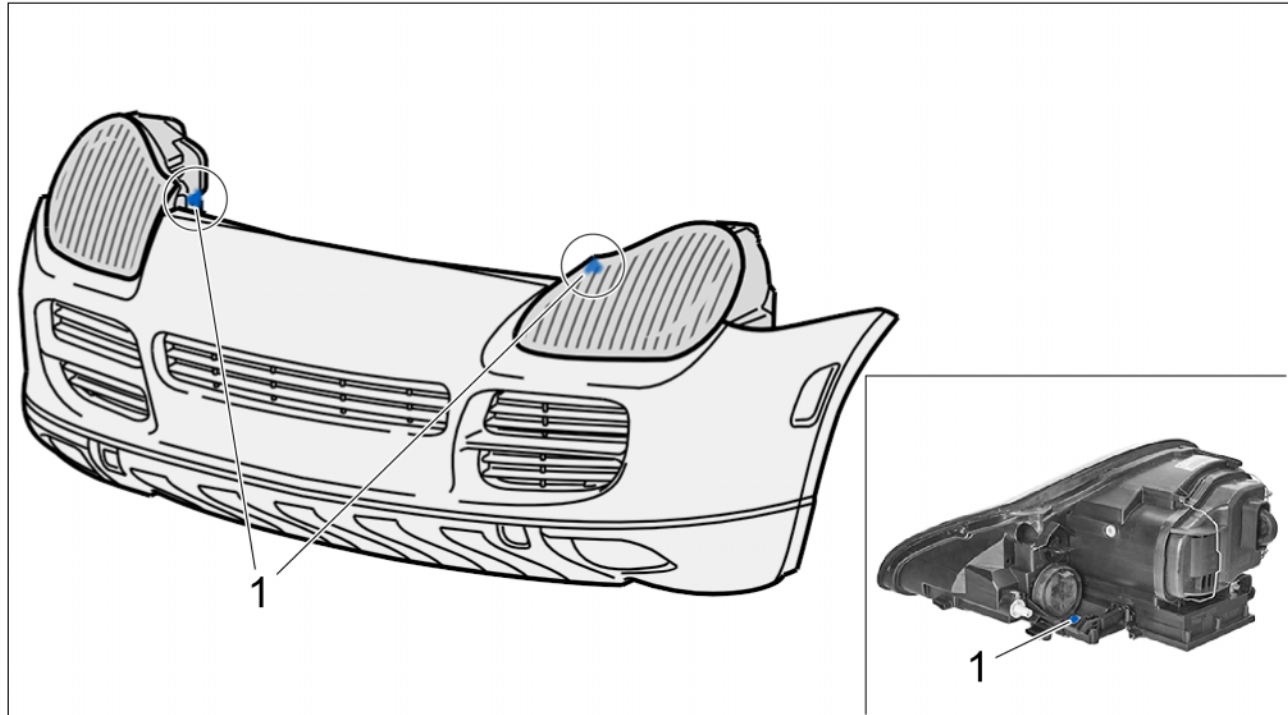
Installation position of caps

1 – Cap (retrofit)

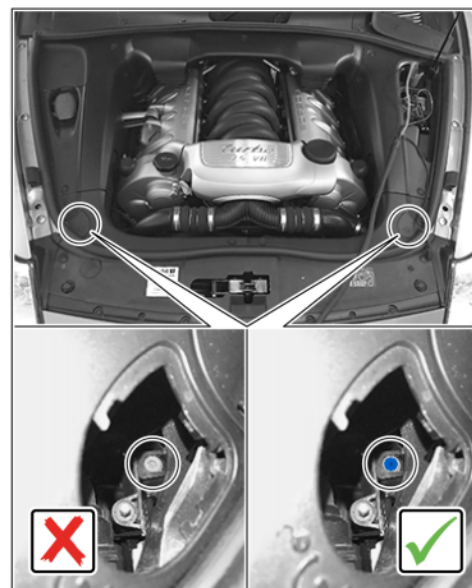
- 3 Check that a cap is installed to the horizontal adjustment screw on the left and right of the main headlamp. ⇒ *Check caps*

Check caps

Assessment	Action
(✓)	A cap is installed on the left and right of a headlight.	End of remedial action. Continue with Step 5.
(✗)	There is no cap or only one cap installed on one headlight.	Retrofit cap. Continue with Step 4.

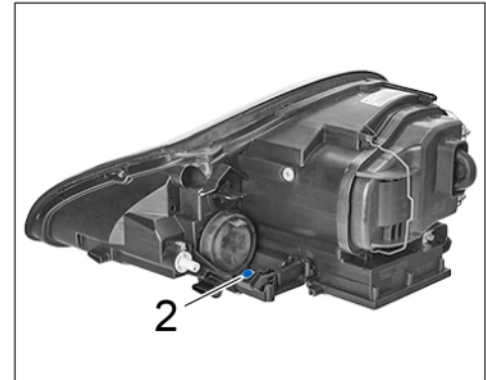
Installing cap (e.g. right headlight)

- 4 Press the cap on the left and right of the main headlight into the adjusting screw for horizontal adjustment ⇒ *Installing cap (e.g. right headlight)*-1-.
