TO: Mercedes-Benz Principals, General Managers, Sales Managers, Service Managers, Parts Managers	FROM: Anthony Washington, Department Manager, Regulations and Certifications
Re: Recall Campaign Launch Notification Model 907 (Sprinter) Model Year 2021 Replace Torsion Bar Linkage & Mounting Hardware	DATE: August, 2022

IMPORTANT RECALL CAMPAIGN INFORMATION

Campaign No. 2022080004, August, 2022

SUBJECT: **Model 907 Sprinter, Model Year 2021
Torsion Bar Linkage and Mounting Hardware**

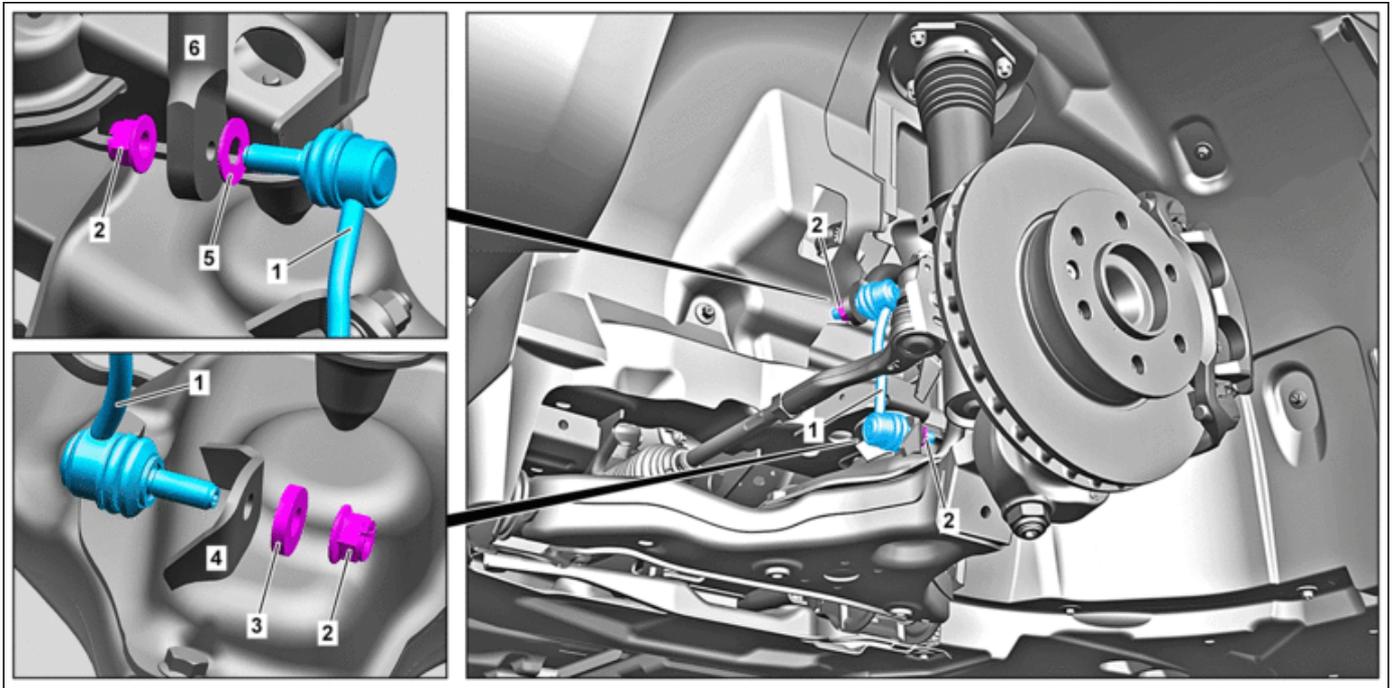
D32.35-A004-79

Shown on model 907 with code CB4 (Stage III stabilization), left side of vehicle

| 1 | Stabilizer bar linkage | 3 | Shim | 5 | Shim |
| 2 | Nut | 4 | Stop plate holder | 6 | Stabilizer bar |

◀	Check		
1	Check, whether the vehicle is affected by the measure.	Affected vehicles: Replace torsion bar linkage (code: VS3VADREH, acc. no.: 32 920 17) Model 907 ### ## as of 055804 up to 374997 with code CB4 (Stabilisation, stage III)	SM32.35-D-0023-01AAA
✕	Remove		
2 AR	Remove both front wheels.		AR40.10-D-1100TS
3	Remove nuts (2) from torsion bar linkages (1) on right and left side of vehicle.	If the threaded pin on the ball head turns too, ↓ counterhold the threaded pin.	
4	Remove torsion bar linkages (1).	i Remove shims (3, 5) too. The shim (5) may be attached to the wrong side of the torsion bar linkage (1). Replace torsion bar linkages (1).	
◀	Check		
5	Check shims (3, 5) for damage.	If shims (3, 5) are damaged, ↓ replace shims (3, 5).	
✕	Install		
6	Install new torsion bar linkages (1).	⚠ Observe installation position of torsion bar linkages (1). The torsion bar linkage (1) only have sufficient clearance when in the correct installation position. i Position shim (3) between lower nut (2) and stop plate holder (4), as shown. Position shim (5) between threaded pin of torsion bar linkage (1) and stabilizer bar (6), as shown.

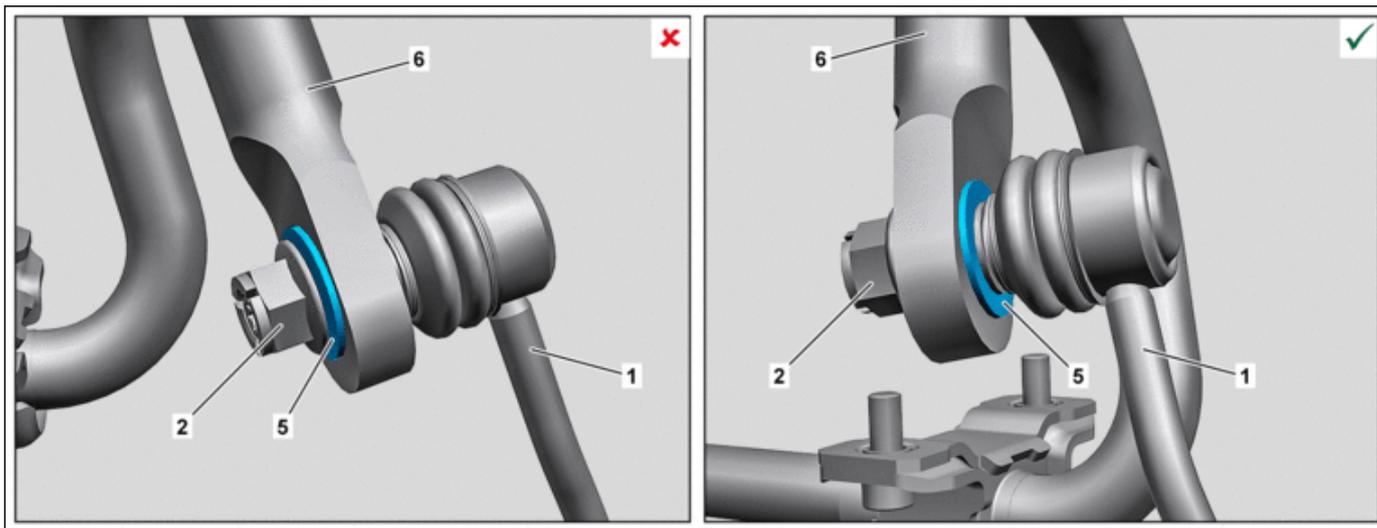
D32.35-A005-78

Shown on model 907 with code CB4 (Stage III stabilization), left side of vehicle

| 1 | Stabilizer bar linkage | 5 | Shim |
| 2 | Nut | 6 | Stabilizer bar |

7	Attach nuts (2) to torsion bar linkages (1) on right and left side of vehicle.		
Notice	Notes on self-locking nuts and bolts Note on calculation of tightening torque when using insertion or socket tools with various effective lengths		AH00.00-P-0001-01KOA AH00.00-P-0015-01CW BA32.35-Z-1002-02KTS BA32.35-Z-1003-02KTS
		<p>
