VOLUNTARY RECALL CAMPAIGN

Classification:	Reference:	Date:
AT22-010	NTB22-082	September 22, 2022

VOLUNTARY SAFETY RECALL CAMPAIGN 2022 FRONTIER, TCM REPROGRAM

CAMPAIGN ID #: R22A9, R22B1
APPLIED VEHICLES: 2022 Frontier (D41)

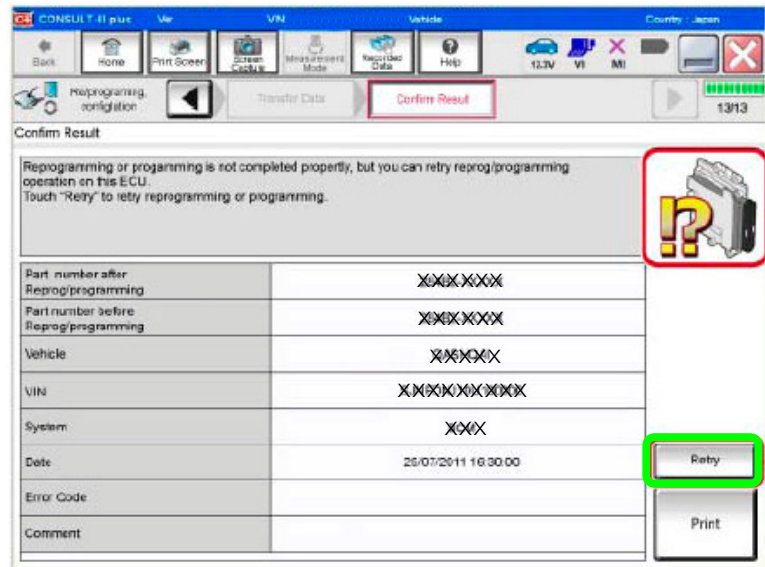
Figure 13

If reprogramming does not complete and the “!?” icon displays, as shown in Figure 13:

- Check battery voltage (12.0 V – 15.5 V).
- Ignition is ON, engine is OFF.
- External Bluetooth® devices are OFF.
- All electrical loads are OFF.
- Select retry and follow the on screen instructions.
- “Retry” may not go through on first attempt and can be selected more than once.

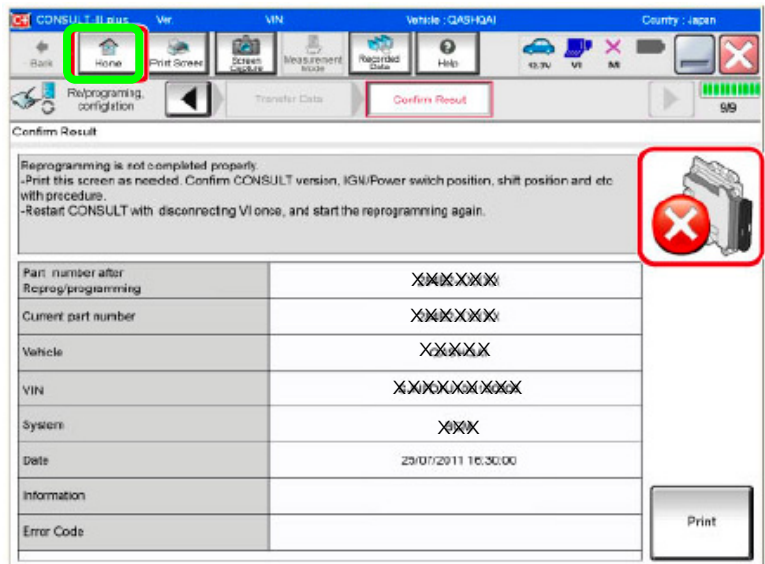
Figure 14

If reprogramming does not complete and the “X” icon displays, as shown in Figure 14:

- Check battery voltage (12.0 V – 15.5 V).
- CONSULT A/C adapter is plugged in.
- Ignition is ON, engine is OFF.
- Transmission is in Park.
- All C-III plus / VI cables are securely connected.
- All C-III plus updates are installed.
- Select Home, and restart the reprogram procedure from the beginning.
