VOLUNTARY RECALL CAMPAIGN

Classification:	Reference:	Date:
ST22-001A	NTB22-079A	November 30, 2022

VOLUNTARY SAFETY RECALL CAMPAIGN 2021 KICKS AND 2021 VERSA; STEERING COLUMN

CAMPAIGN ID #: PMA10
APPLIED VEHICLES: 2021 Kicks (P15)
2021 Versa (N18)

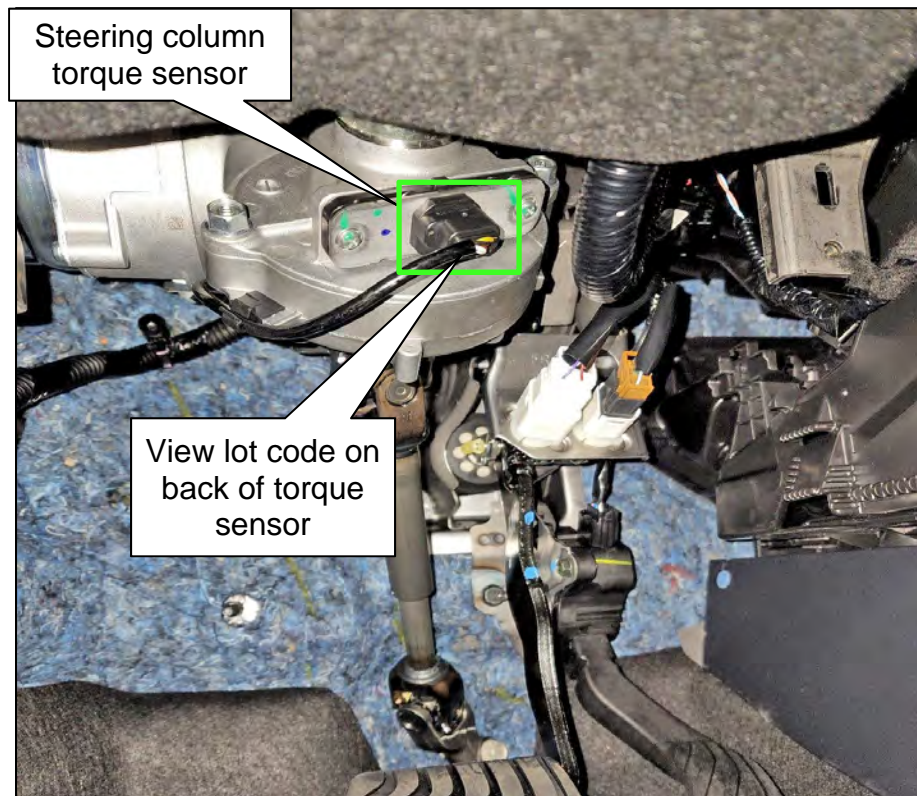
Figure 11

20. Locate the steering column torque sensor (Figure 11).

- The torque sensor lot code is located on the back side of the torque sensor and is visible by looking upward at the torque sensor.

IMPORTANT: DO NOT remove or disconnect the steering column torque sensor.

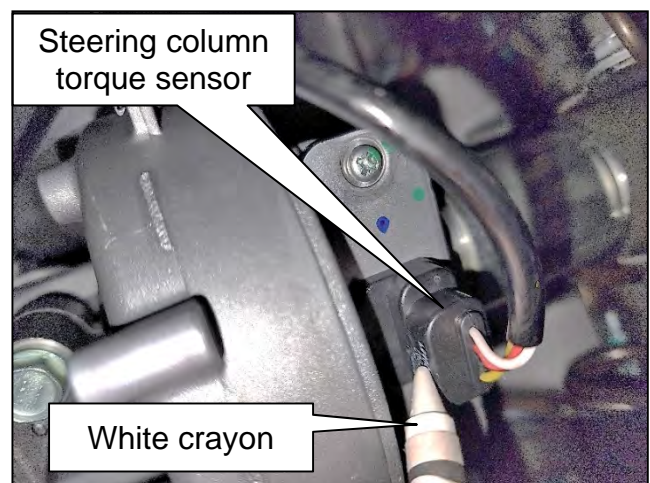
Figure 12

21. Highlight the lot code of the steering column torque sensor.

- Using a white crayon, with light pressure, rub the crayon over the lot code until the lot code is legible.
- Do NOT apply force to the torque sensor and torque sensor harness and connector when applying the crayon markings.

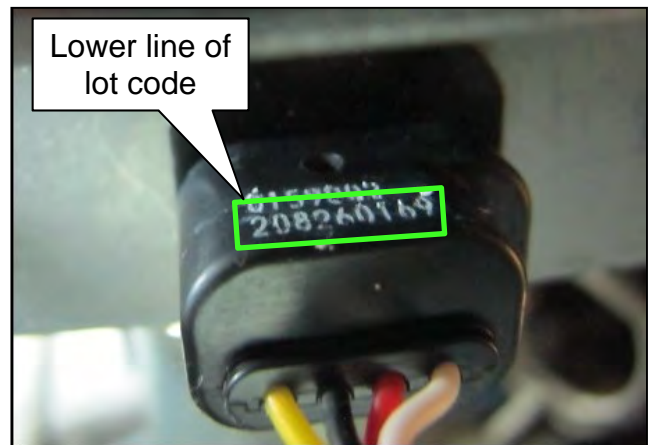
Figure 13

22. Document the lower line of the lot code on the repair order.

23. Review the first five (5) characters of the lot code obtained in step 22 and compare to the **LOT CODES** listed in **Table A**.

MODEL	MODEL YEAR	LOT CODES
Kicks, Versa	2021	21624, 21625, 21626, 21627, 21628

- If the first five (5) characters of the lot code matches one of the sets of numbers in **Table A**, replace the steering column assembly.
 - Refer to the ESM: **STEERING > STEERING SYSTEM > REMOVAL AND INSTALLATION > STEERING COLUMN > Removal and Installation**
 - Continue to step 24 on page 12.
- If the first five (5) characters of the lot code does NOT match one of the sets of numbers in **Table A**, steering column replacement is not necessary. Continue to step 24 on page 12.

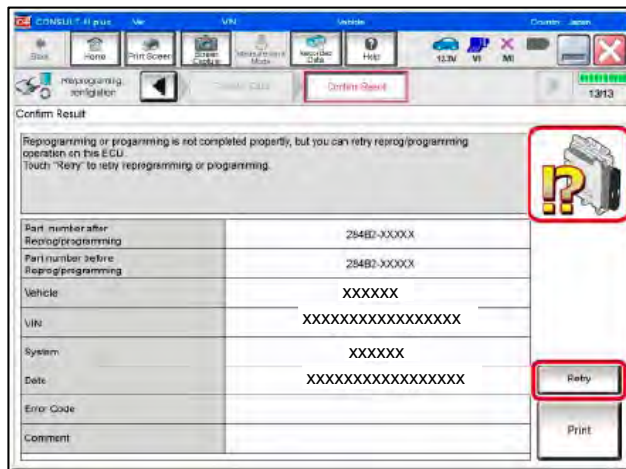
Figure 34

If reprogramming does not complete and the “!” icon displays as shown in Figure 34:

- Check battery voltage (12.0–15.5 V).
- Ignition is ON, engine OFF.
- External Bluetooth® devices are OFF.
- All electrical loads are OFF.
- **Select retry and follow the on screen instructions.**
- **“Retry” may not go through on first attempt and can be selected more than once.**

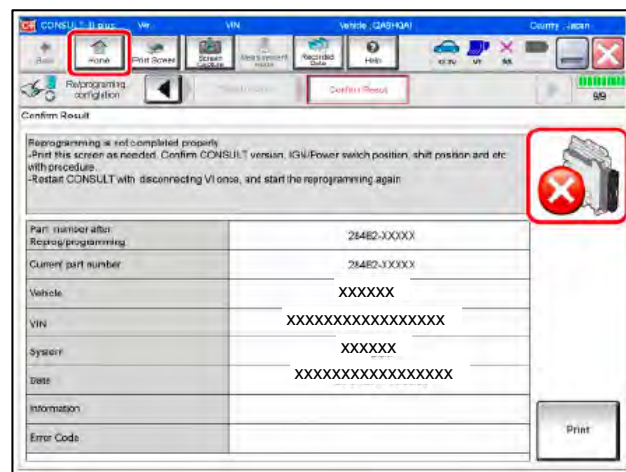
Figure 35

If reprogramming does not complete and the “X” icon displays as shown in Figure 35:

- Check battery voltage (12.0–15.5 V).
- CONSULT A/C adapter is plugged in.
- Ignition is ON, engine OFF.
- Transmission is in Park.
- All C-III plus / VI cables are securely connected.
- All C-III plus updates are installed.
- **Select Home, and restart the reprogram procedure from the beginning.**
