Product Safety Recall

N222378380 Rear View Camera Intermittent or Inoperative

Release Date: March 2023

Revision: 02

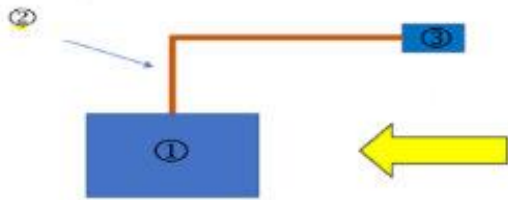
6275058

A11 Radio (1)

I.P. Coax (2)

I.P. to X219 Body In-line Connector

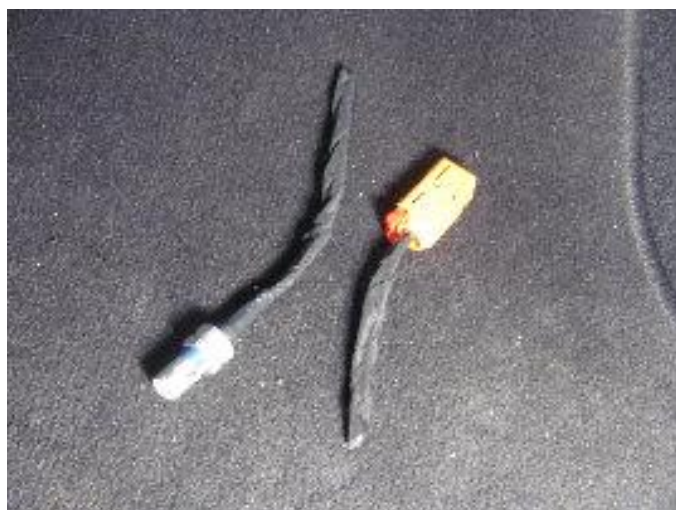
6178286

Note: Ensure that you service the orange VPM connector, not the radio coax.

4. Cut off the two connectors and discard. The unused coax can remain bundled with the body harness.
5. Route the new service coax cable along the body harness branch to the radio. Use care to not kink the coax cable, use smooth large radius bends.
6. Connect the new coax cable to the A11 radio and the X219 IP to Body Coax In-line Connection.

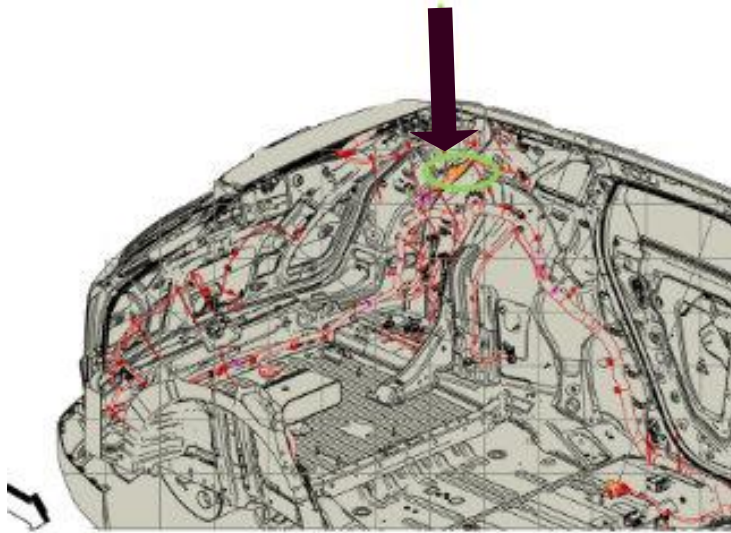
6244006

Note: XT5 vehicles equipped with RPO DRZ have an additional coax connection at X307 located in the left upper rear quarter panel area. Disable the existing coax and install the new coax as described in the steps below.

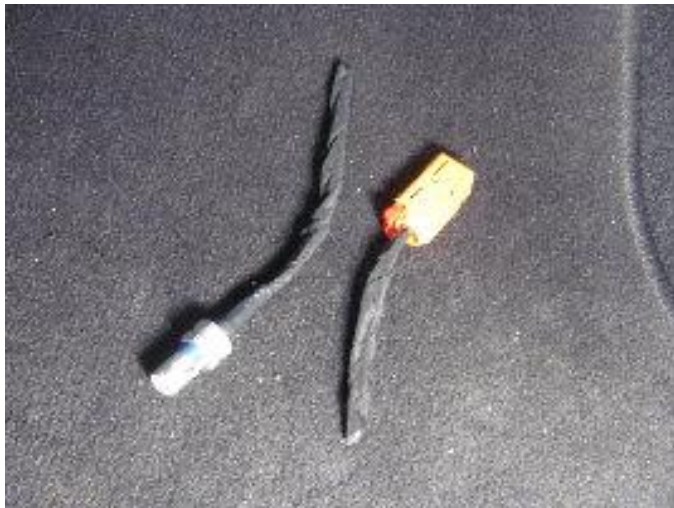
6178286

Note: Ensure you service the orange VPM connector, not the radio coax.

16. Cut off the two connectors and discard. The unused coax can remain bundled with the body harness.

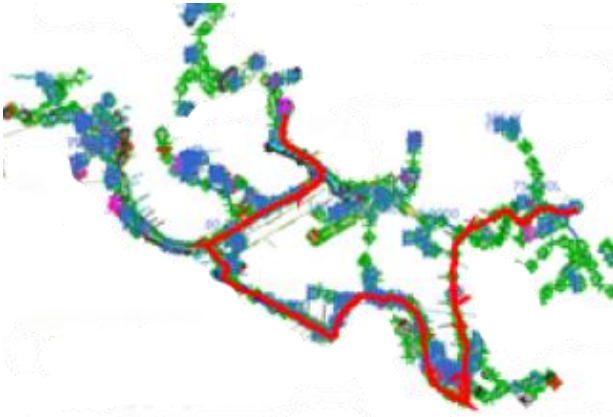
6178293

Coax Routing Shown in Red

19. Route the short side of the new coax to the rear headliner location.
