SIB 63 05 22

RECALL 22V-725: FRONT LAMPS

E-Series	Model Description	Production Date
G07	X7 Sports Activity Vehicle	March 9, 2022 - September 20, 2022

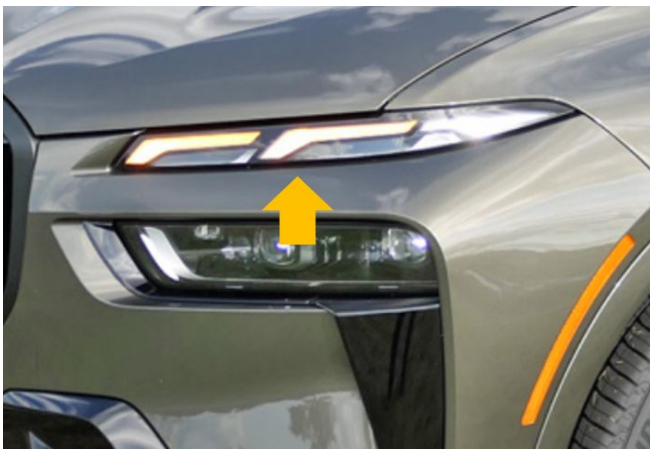
Due to an electronic control unit (ECU) programming issue, affected vehicles may not meet a US Federal Requirement regarding the interaction* between the side cornering lights (circled), the daytime running lights (DRL; alternatively the low beams); and the turn signals (arrow).

*When signaling a turn, the cornering light illuminates on the intended side and the DRL goes out. After the turn, the DRL illuminates and the cornering light is supposed to go out. Instead, the cornering light remains on.

Software error in the FLM (Front Light Electronic Module).

Program the vehicle using ISTA version **4.37.4x**.
