# RRC-18-22-002-1: Retorque Knuckle to Upper Control Arm Fasteners, EDV

<b>Document Type</b>	Safety Recall Bulletin
<b>Date</b>	October 7, 2022
<b>Affected Region(s)</b>	USA
<b>Affected Model(s)</b>	EDV
<b>Model Year(s)</b>	2022
<b>Approximate Build Dates</b>	December 2021 - September 2022

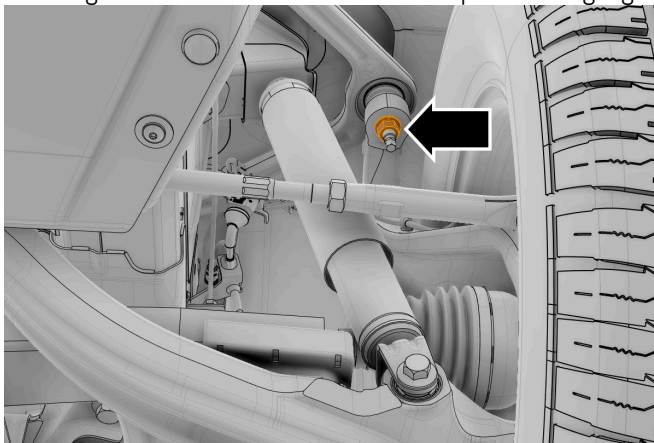
2. Working in the front of the wheelwell: Inspect the highlighted fastener.

**Note:** LH side shown.

- If the fastener is loose, or can be freely spun by hand, perform the [Replace Components](#) section on the affected side.
- Set a torque wrench to 20 Nm and attempt to tighten the fastener. If the fastener moves before 20 Nm is achieved, perform the [Replace Components](#) section on the affected side.
- If the fastener is not loose and does not move before 20 Nm is applied, perform the [Retorque Fastener](#) section on the affected side.

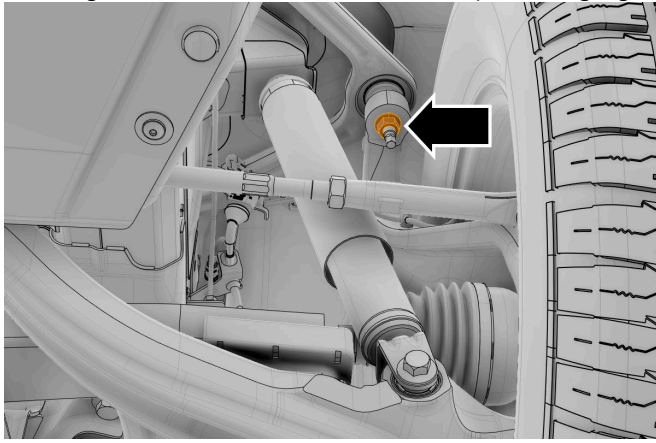
2. Working in the front of the wheelwell: Torque the highlighted fastener to 120 Nm.

**CAUTION:** When using a torque wrench with an offset socket, rotate the offset socket to exactly 90° from the body of the torque wrench. Other angles will cause an inaccurate torque measurement.

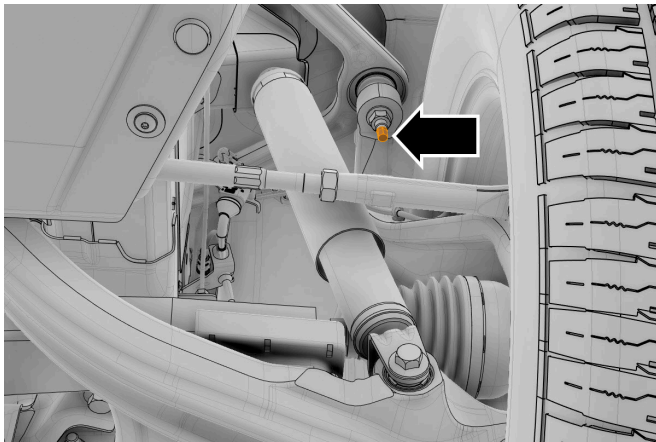
**Note:** If necessary: Use a wrench to hold the highlighted area while installing the fastener.

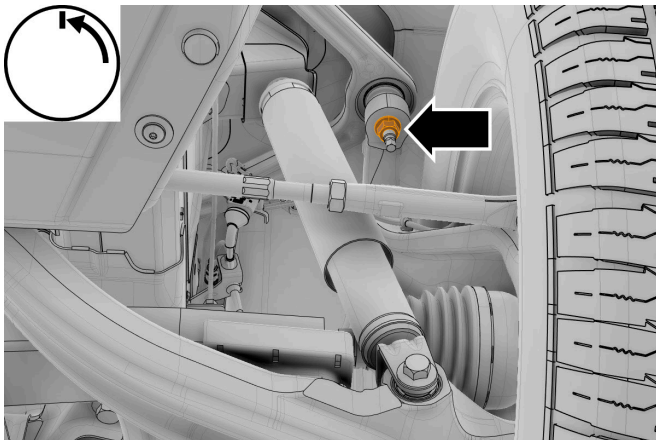
3. Loosen the nut 1/4 turn.

4. Repeat step 2 in this section.
