RRC-18-22-001-1: Retorque Knuckle to Upper Control Arm Fasteners, R1T and R1S

Document Type	Safety Recall Bulletin
Date	October 7, 2022
Affected Region(s)	USA
Affected Model(s)	R1T, R1S
Model Year(s)	2022
Approximate Build Dates	August 2021 - September 2022

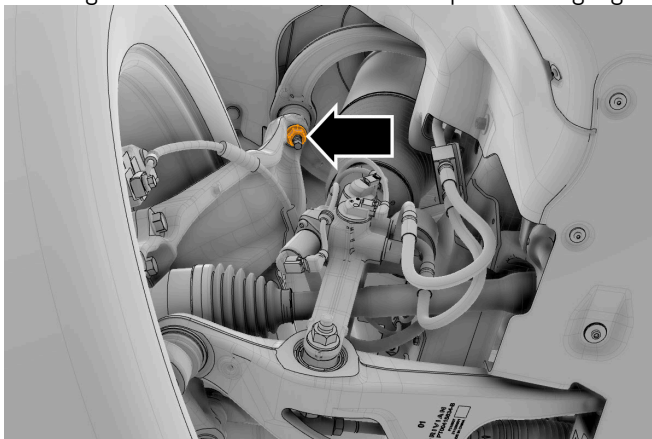
3. Working in the rear of the wheelwell: Inspect the highlighted fastener.

Note: LH side shown.

- If the fastener is loose, or can be freely spun by hand, perform the [Replace Components](#) section on the affected side.
- Set a torque wrench to 20 Nm and attempt to tighten the fastener. If the fastener moves before 20 Nm is achieved, perform the [Replace Components](#) section on the affected side.
- If the fastener is not loose and does not move before 20 Nm is applied, perform the [Retorque Fastener](#) section on the affected side.

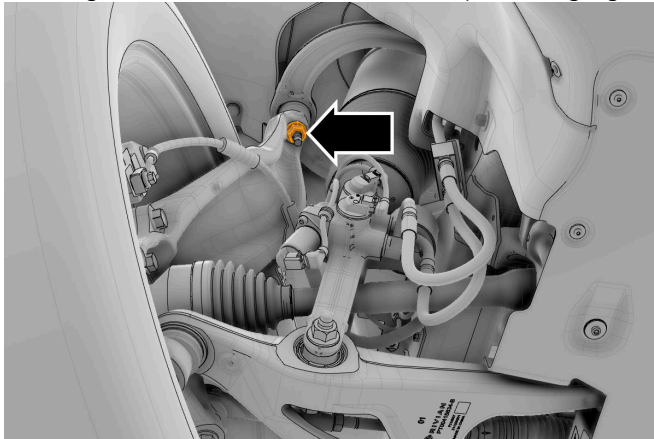
3. Working in the rear of the wheelwell: Torque the highlighted fastener to 120 Nm.

**CAUTION:** When using a torque wrench with an offset socket, rotate the offset socket to exactly 90° from the body of the torque wrench. Other angles will cause an inaccurate torque measurement.

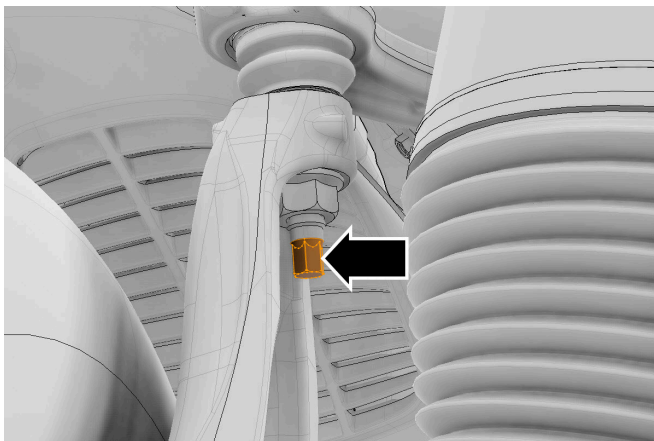
**Note:** If necessary: Use a wrench to hold the highlighted area while installing the fastener.

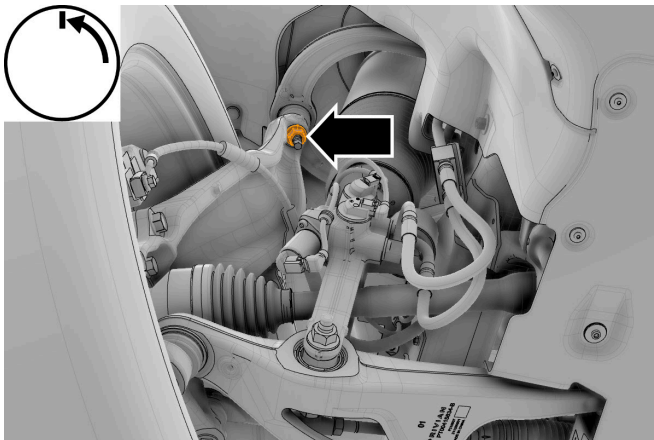
4. Loosen the nut 1/4 turn.

5. Repeat step 3 in this section.
