SIB 11 02 22

RECALL 22V-752: REPLACE CLUTCH COVER SCREWS

2022-11-10

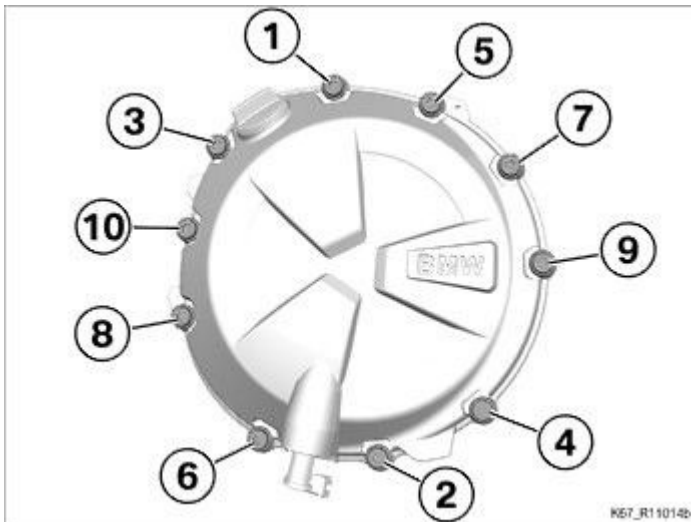
The clutch cover screws were produced with too much protective coating which can cause the screws to back out causing oil to oil leak onto the catalytic converter.

- Mark all the screws currently installed.
- Check for oil leaks or traces of oil visible between the clutch cover and crankcase.
 1. If there is a leak the repair including a gasket exchange is required.
- Replace the screws 2 by 2, following the sequence as shown below.

- Remove screws 1 and 2.
- Clean screw points (screw head contact and especially thread).
 1. Treat bore / thread with suitable cleaning spray.
 2. Clean head contact on the clutch cover with rag.
 3. Blow clean bore / thread with air gun.
- Install new screws and tighten in the correct sequence as shown with 3Nm + 90°.
- Repeat steps for screw pairs 3/4; 5/6; 7/8; 9/10.
